RIC 2007

Dissimilar Metal Butt Welds

Ted Sullivan, SLS
Division of Component Integrity
Office of Nuclear Reactor Regulation
March 15, 2007

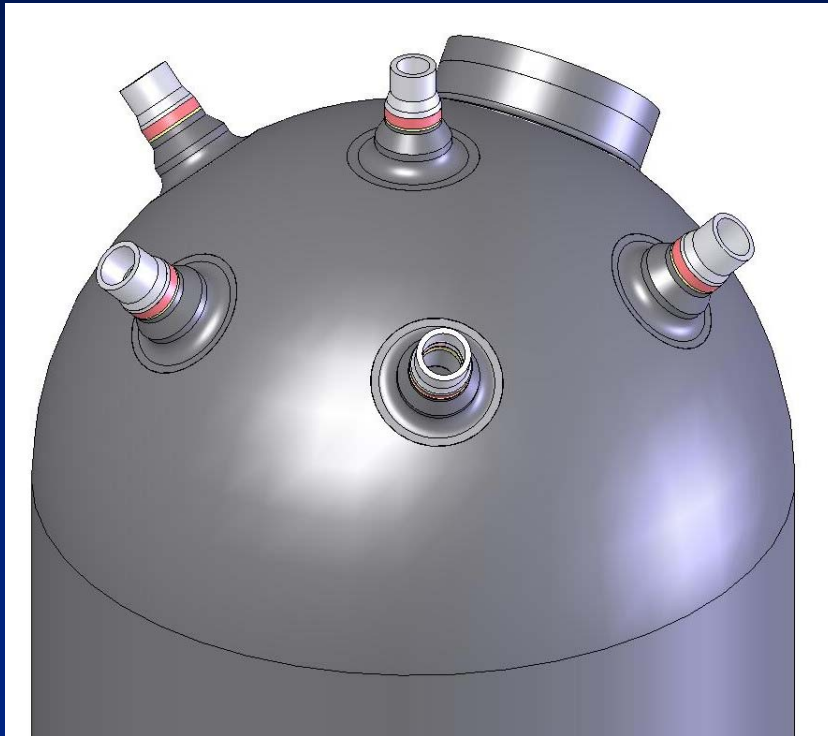
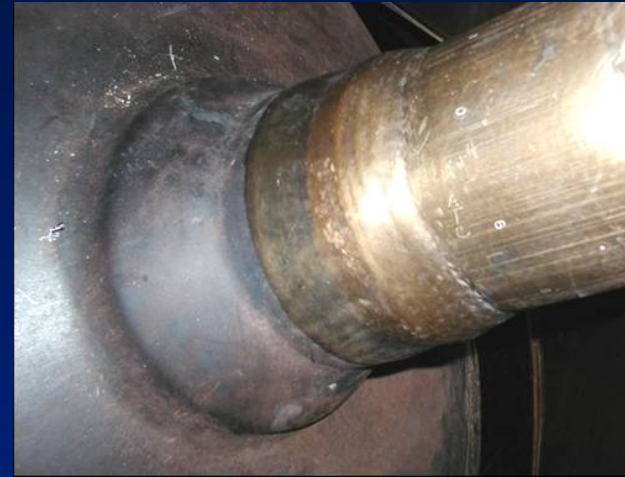
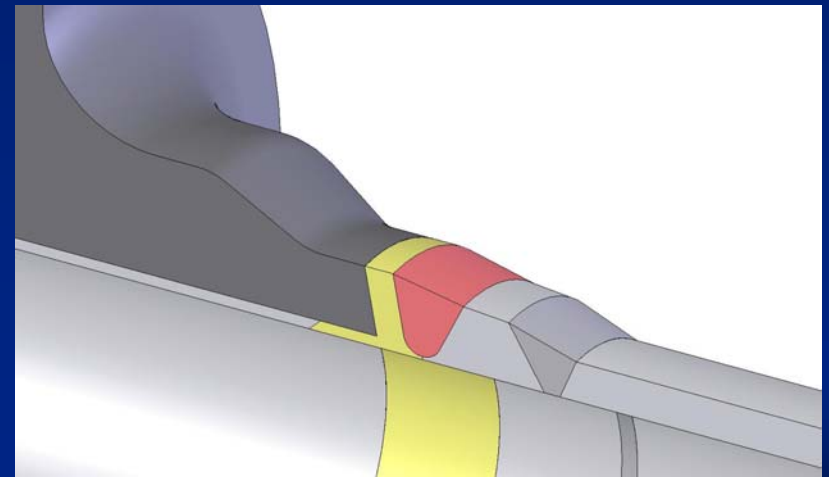
Pressurizer Top Head Nozzles

- Dissimilar metal welds made with Alloy 82/182 have experienced cracking since mid-1980s
- Cracking in Alloy 82/182 butt welds has been experienced at many plants since 2000
- In October 2006, extensive circumferential flaws were identified in pressurizer nozzle welds at Wolf Creek

- Inspections at Wolf Creek performed prior to weld overlay mitigation per industry program known as MRP-139
- Flaws found in pressurizer safety, relief, and surge nozzle welds
- NRC performed fracture mechanics analyses to understand possible behavior of flaws if left in service

- There may be little or no time between leakage and rupture due to flaw size and nozzle configurations,
- Inspections/mitigations need to be accelerated from current industry schedule for some plants, and
- Enhanced RCS leakage monitoring with action levels to shut down and visually inspect welds necessary until inspections/mitigations completed
