## What we could learn from the Forsmark unit 1 event 25 July 2006

Per Bystedt  
Swedish Nuclear Power Inspectorate

RIC 2008

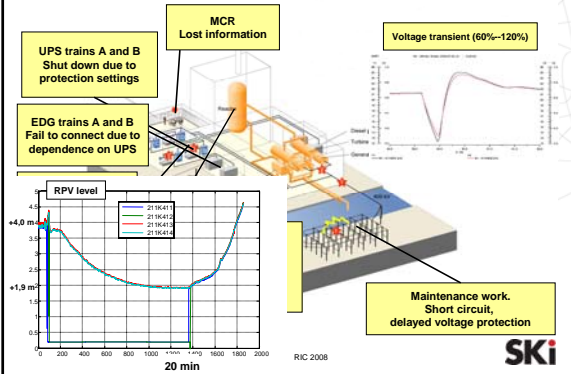
## Main sequence of event, 25 July 2006

- A short circuit in 400kV switchyard occurred during maintenance. Protection on low voltage was delayed
- A voltage transient (between 60% and 120%) was distributed into the onsite-power system
- The protective settings of the UPS were not sufficiently selective. 2 out of 4 UPS stop. CCF
- Connection of EDG was depending on bus bar powered from UPS. 2 out of 4 EDG do not connect
- Essential information lost or ambiguous in MCR
- Excessive steam blow-off from RPV. Some relief valves stayed open. Level turned at +1,9 meter at 20 minutes
- Unit cooled with 2 out of 4 ESF trains with AFW, LHSI and CS powered by EDG:s
- Offsite power to safety bus bars restored at 22 minutes

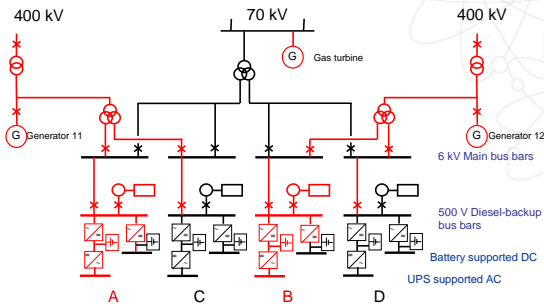
**Electrical diagram – about 1 minute into the event  
(powered / not powered)**

- Design weaknesses
  - UPS were not set to cope with a "design basis" transient
  - EDG connection were depending on power from UPS
  - Information in MCR effected by power loss
  - Unclear "fail safe state" at power loss
- Administrative weaknesses
  - Deficient routine at switchyard maintenance
  - Generator breaker low frequency protection (47,5Hz) not properly installed
  - Start of local gas turbine failed. Testing omissions
