San Onofre Unit-3 RFO-15

Rejectable PT indication in an Alloy-52 CEDM overlay repair weld

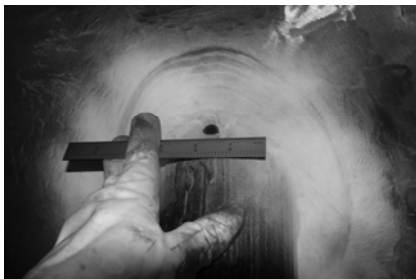
PT defect in CEDM #64 repair weld

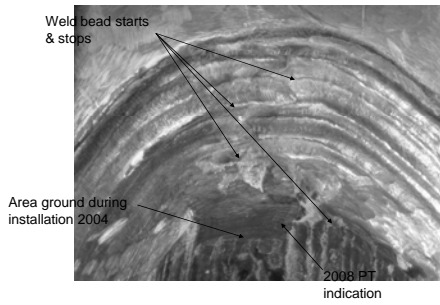
- Records show that a PT indication was ground out in this area during fabrication
- Observation reveals area contains numerous weld bead interfaces
 - Weld bead starts & stops prone to void formation
 - Evidence of prior grinding at the defect location
- Replica of defect captured a small surface pore
 - “comma” shape pore approximately 1/16w x 1/32d
 - Weld porosity considered to be the likely cause
 - Could be repaired by grinding & weld buildup

Observed features in defect area

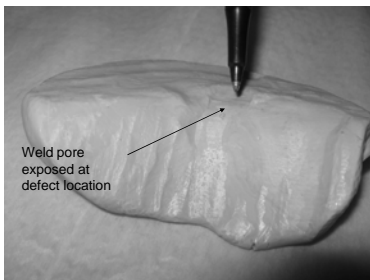
Replication of defect

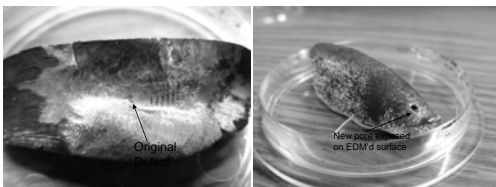
CEDM 64 Boat Sample

- Sample extracted & cavity is re-welded
 - Actual head work completed in ~10-hours
 - 14 days after detection
 - extensive tool & procedure qualification
 - Did not impact the outage length
 - Emergent project resulted in about 3 Rem
 - Sample at 2.5 mR, very low contamination

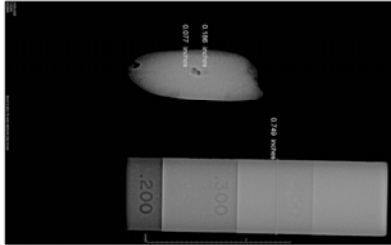
On site radiograph shows void
