Regulatory Response to Lessons from Operating Experience

Examples from Finland

Regulatory Information Conference
8.-10.3.2011

Petteri Tippiä
Director
Nuclear Reactor Regulation
STUK

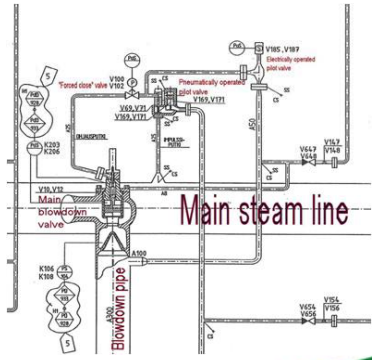
Olkiluoto 1 & 2 Failure of Safety System Components due to inadequate qualification of slightly modified replacement parts
