# 2014 Regulatory Information Conference

## **Degradation of Boron in Spent Fuel Pool at Taiwan's BWR NPPs**

Gung-Min Ho  
Section Chief

Department of Nuclear Regulation  
Atomic Energy Council, Taiwan

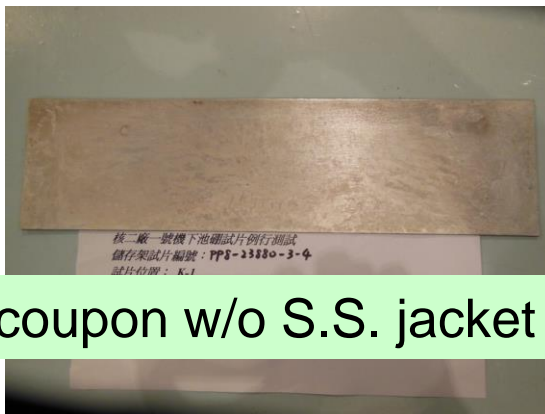
- Unlike the coupons of Chinshan, the Holtec Boral coupons at Kuosheng are jacketed in stainless steel.
- The non-jacketed coupons of the other manufacturer, ENSA, at Kuosheng had shown noticeable blisters, which is similar to Chinshan's operating experience

coupon w/o S.S. jacket

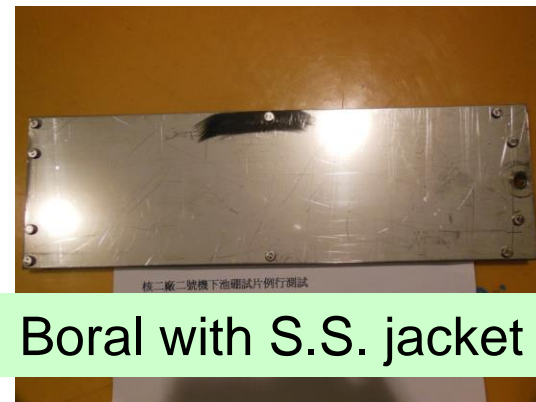
Boral with S.S. jacket

- Up to 2013/12/31, totally 20 boral test coupons have been examined. Recently examined coupons showed blisters near the edge of the coupons.
- The Holtec Boral coupons at Kuosheng do not show any blister or bulge. It is quite possible that no blister could form in the jacketed coupon.
