Office of Nuclear Reactor Regulation

Baffle-Former Bolt Degradation

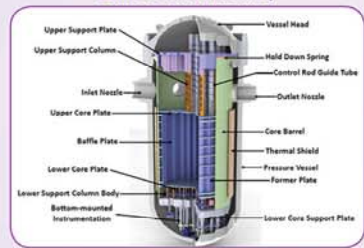
Baffle-Former Assembly

The vertical baffle plates are bolted to the inner surface of horizontal former plates, which themselves are bolted to the inner surface of the core barrel. Typically, there are eight levels of former plates distributed along the height of the core barrel. The baffle-former bolts secure the baffle to the former plates.
