South Texas Project Electric Generating Station P.O. Box 289 Wadsworth, Texas 77483

July 11, 2003  
NOC-AE-03001557  
10CFR50

South Texas Project  
Units 1 & 2  
Docket Nos. STN 50-498, STN 50-499  
Additional Information Regarding STP's Commitment to Investigate and Repair  
Bottom Mounted Instrumentation Penetration Indications

# South Texas Project Status Report on Resolving the Unit 1 BMI Issue

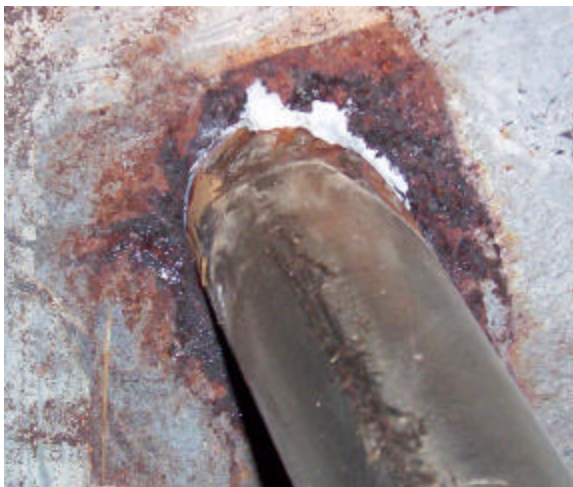
Figure 1 (Nozzle 46)

The bottom head of the reactor was inspected on April 12, 2003 as a routine part of the station's regular bare metal inspection of the reactor vessel bottom penetrations. The inspection is part of the RCS Pressure Boundary Inspection for Boric Acid Leaks program, OPGP03-ZE-0033. The bottom head of the reactor is contained in an insulating box structure with no insulation directly in contact with the bottom head. The inspection is accomplished by removing some of the insulation panels forming the box. Three different vantage points are used to inspect all 58 BMI nozzles. The inspection found small amounts (150 milligrams on nozzle 1 and 3 milligrams on nozzle 46) of white residue around Bottom Mounted Instrument (BMI) nozzles number 1 and 46 at the annulus between the nozzle and the bottom head, (Figure 1 and Figure 2).

Nozzle 46 had two cracks. Each crack was axially oriented to the J-groove weld. One crack extended above and below the J-groove weld but did not penetrate the inside diameter of the nozzle. The second crack was smaller, did not extend above or below the J-groove weld, and did not penetrate the inside diameter of the weld.

South Texas Project performed half-nozzle repairs on both Bottom Mounted Instrument nozzles number 1 and 46, using an Alloy 690 material with demonstrated superior corrosion resistance compared to the original Alloy 600 nozzle. The repair relocated the pressure boundary to the outside of the reactor pressure vessel surface where future visual and non-destructive examinations can be readily performed. The upper section of the original Alloy 600 nozzle remains in service as a non-pressure boundary component.

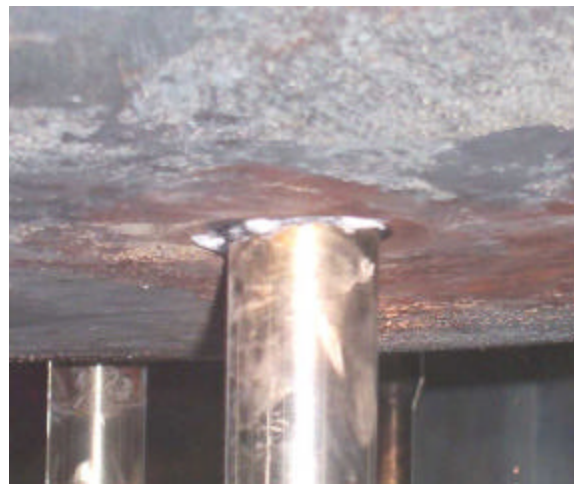
Figure 2 (Nozzle 1)

Nozzle 1 had three cracks. Each crack was axially oriented to the J-groove weld. One crack extended above and below the J-groove weld and penetrated the inside diameter of the nozzle. The second and third cracks were much smaller and on the outside diameter of the nozzle close to the initial weld passes. The second and third cracks did not extend above or below the J-groove weld and did not penetrate the inside diameter of the weld.

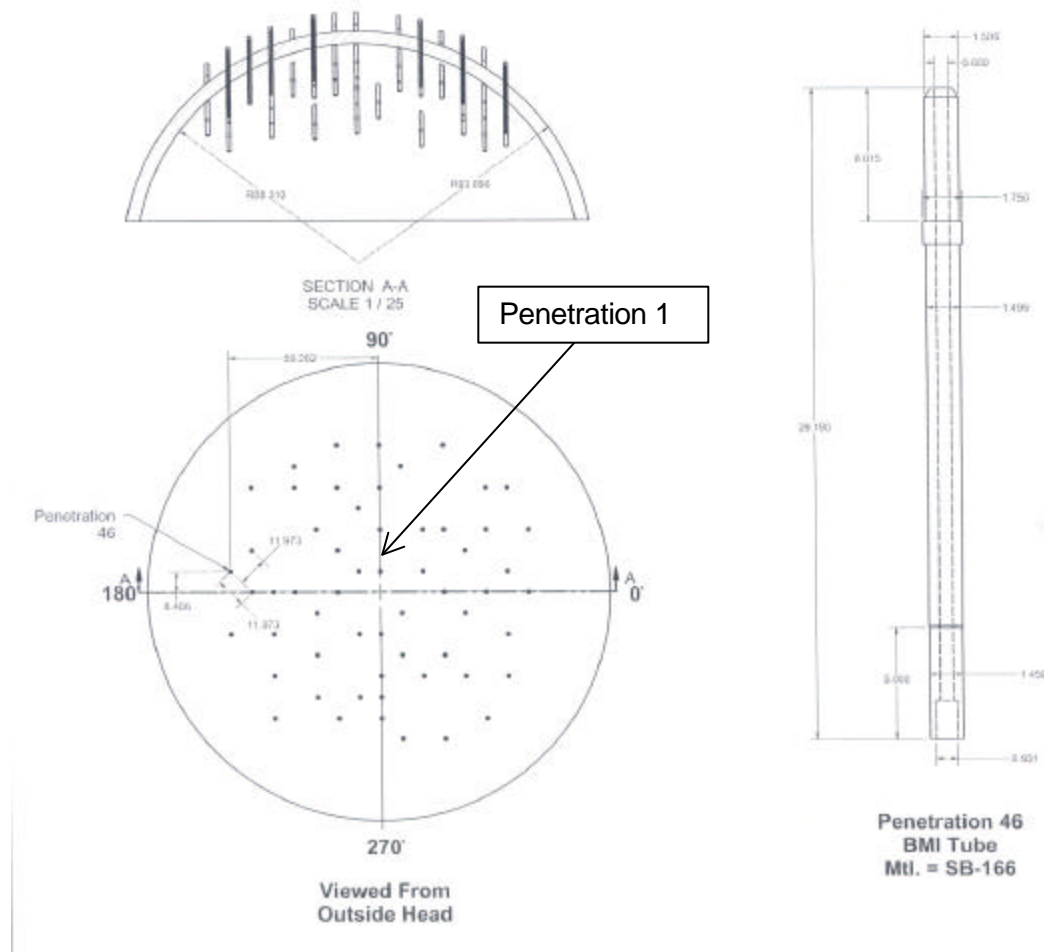
Nozzle number 1 is located about 8.5 inches due north of the center of the bottom head. The nozzle is nearly perpendicular to the reactor bottom head. Penetration number 46 is about 8.5 inches north of the east-west center line and just over 59 inches west of the bottom head center (Figure 3). Nozzle number 46 penetrates the head at 42.6 degrees.

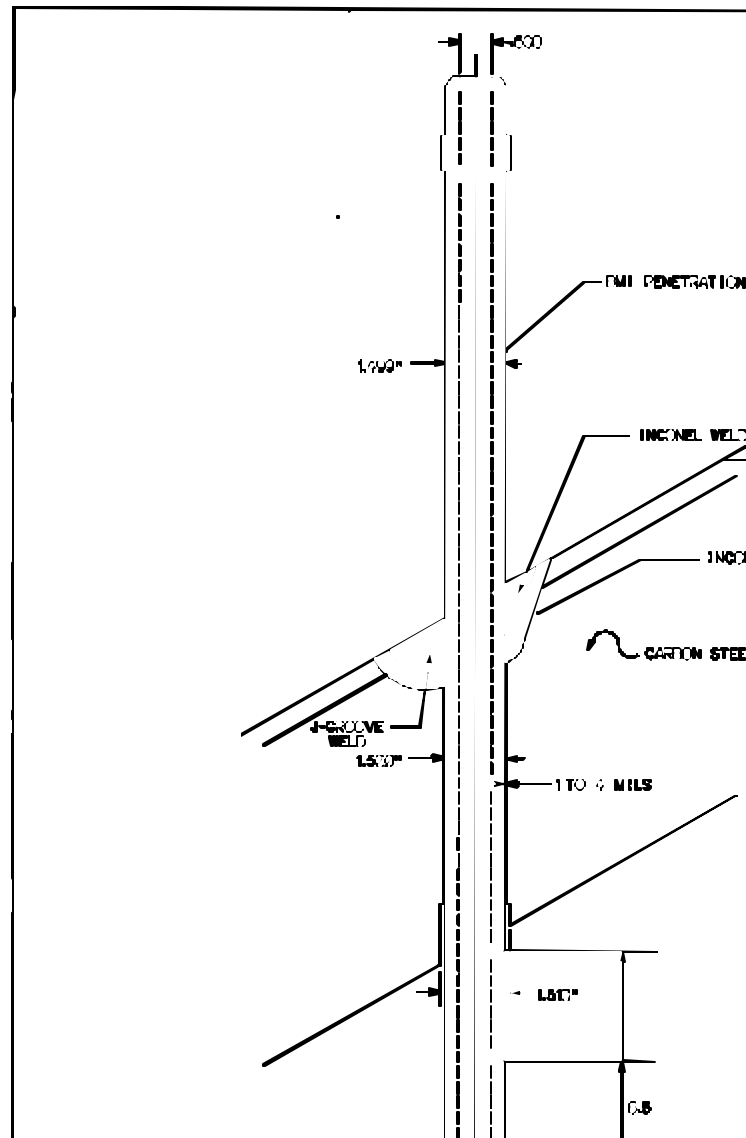
weld repairs being made with either 182 or 82 weld material. The vessel itself is 5.38-inch thick low alloy carbon steel with 0.22 inches of stainless steel cladding on the interior surface. Each penetration bore in the reactor bottom head is nominally 1.5 inches in diameter. There is an open annulus between the nozzle and the reactor head below the J-groove weld. Figure 4 provides a simplified view of a typical nozzle configuration

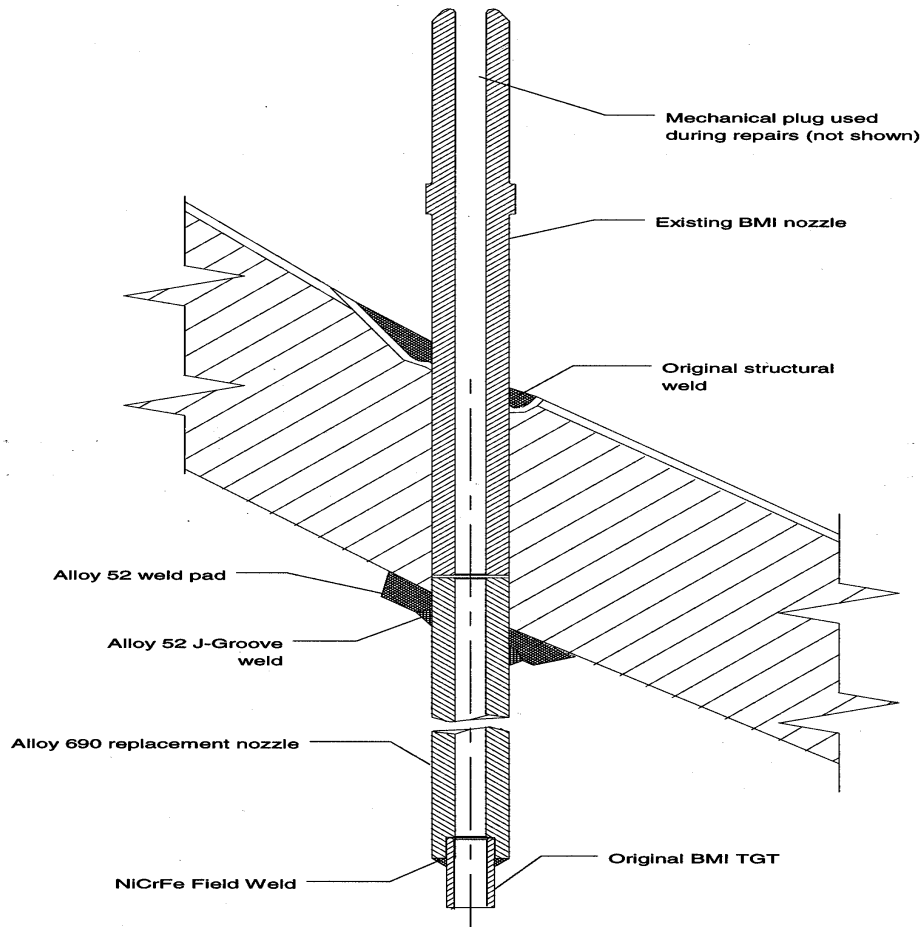
FIGURE 5

Typical  
Half-Nozzle Repair/Replacement  
Design

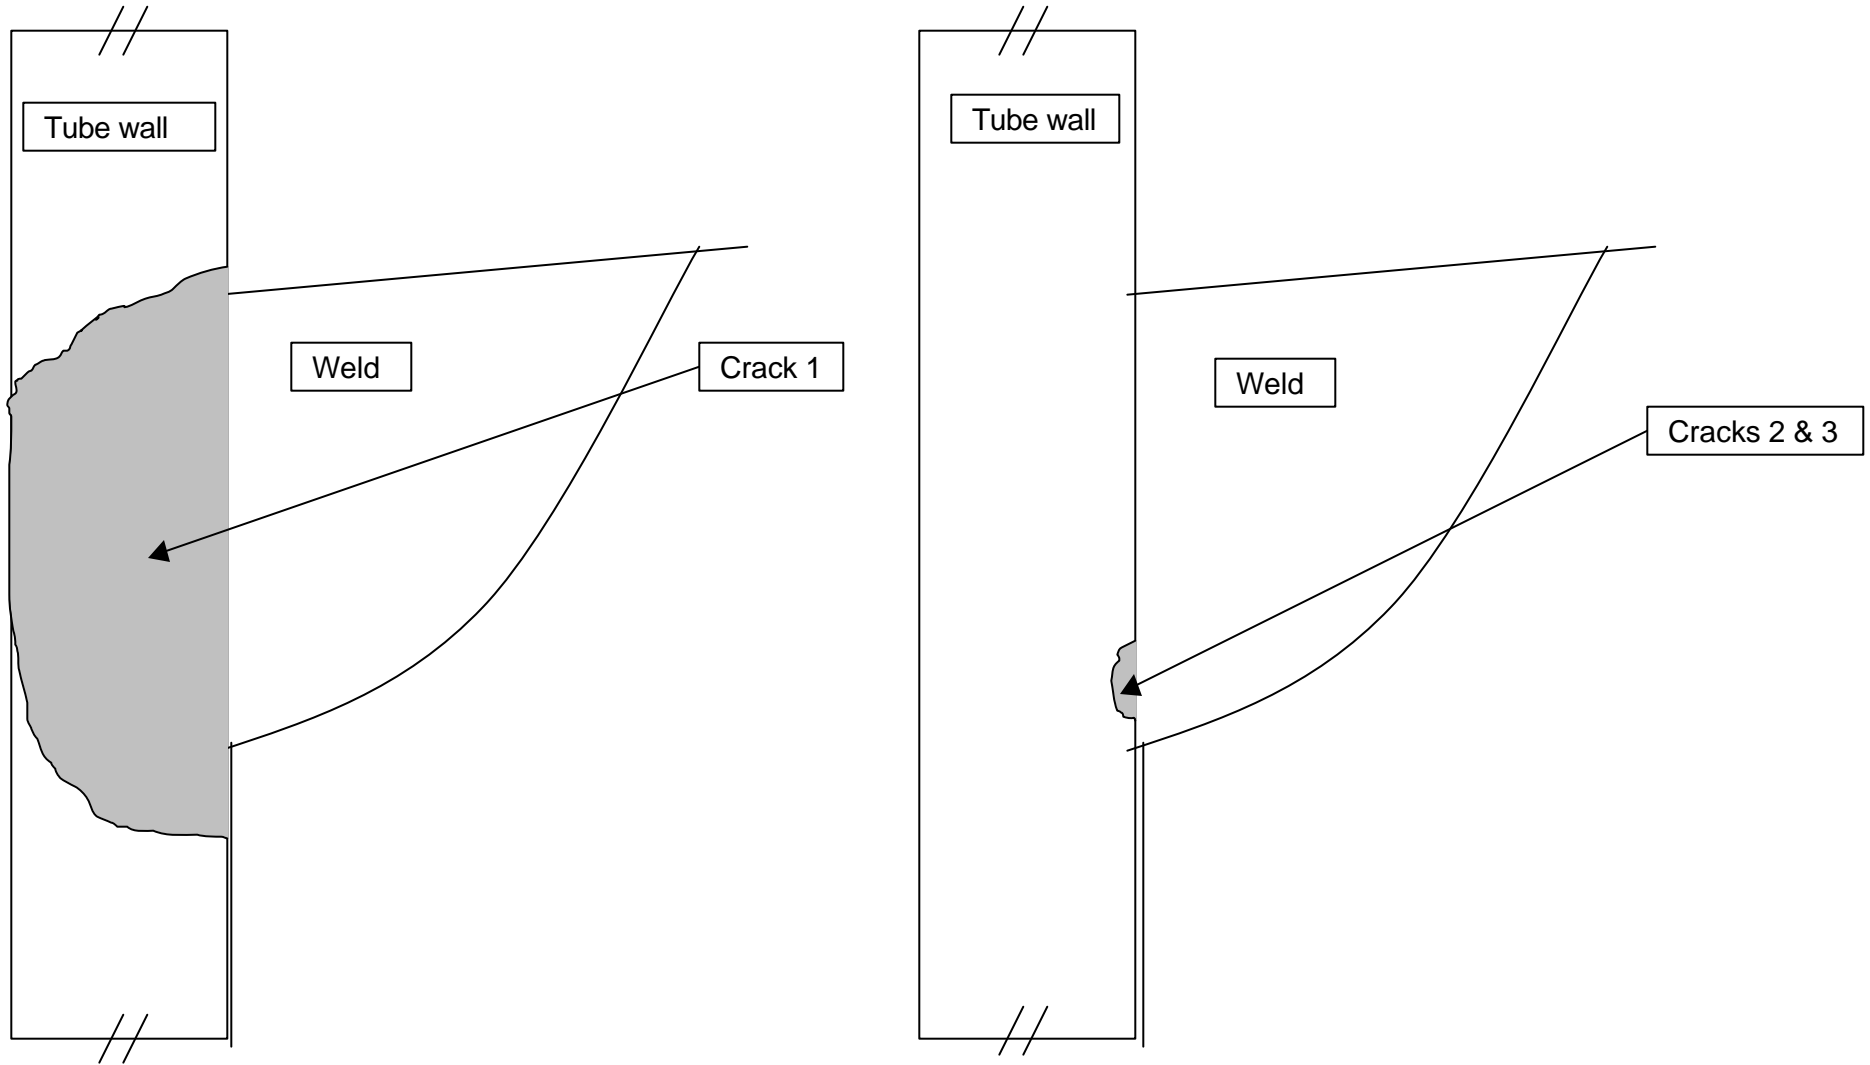
# South Texas Project Status Report on Resolving the Unit 1 BMI Issue – Attachment 5 Two Dimensional Representation of Cracks in Nozzle 1

All three probes confirmed the presence of five cracks, three in nozzle 1 and two in nozzle 46. Attachments 5 and 6 are two-dimensional representations of the cracks. There were no cracks indicated in any of the remaining nozzles, and no circumferential cracks were found. In addition, the UT probes indicated anomalous conditions at the nozzle weld interface in all of the nozzles, possibly indicating lack of weld fusion or some other anomalous weld condition. The possible significance of lack of fusion in the BMI nozzle welds is discussed later in Section V. E. 4. The extensive data derived from the primary UT inspection are electronically recorded for detailed analysis and preserved as a baseline for future UT inspections.
