South Texas Project
Units 1 & 2
Docket Nos. STN 50-498, STN 50-499
Additional Information Regarding STP's Commitment to Investigate and Repair
Bottom Mounted Instrumentation Penetration Indications

South Texas Project Status Report on Resolving the Unit 1 BMI Issue

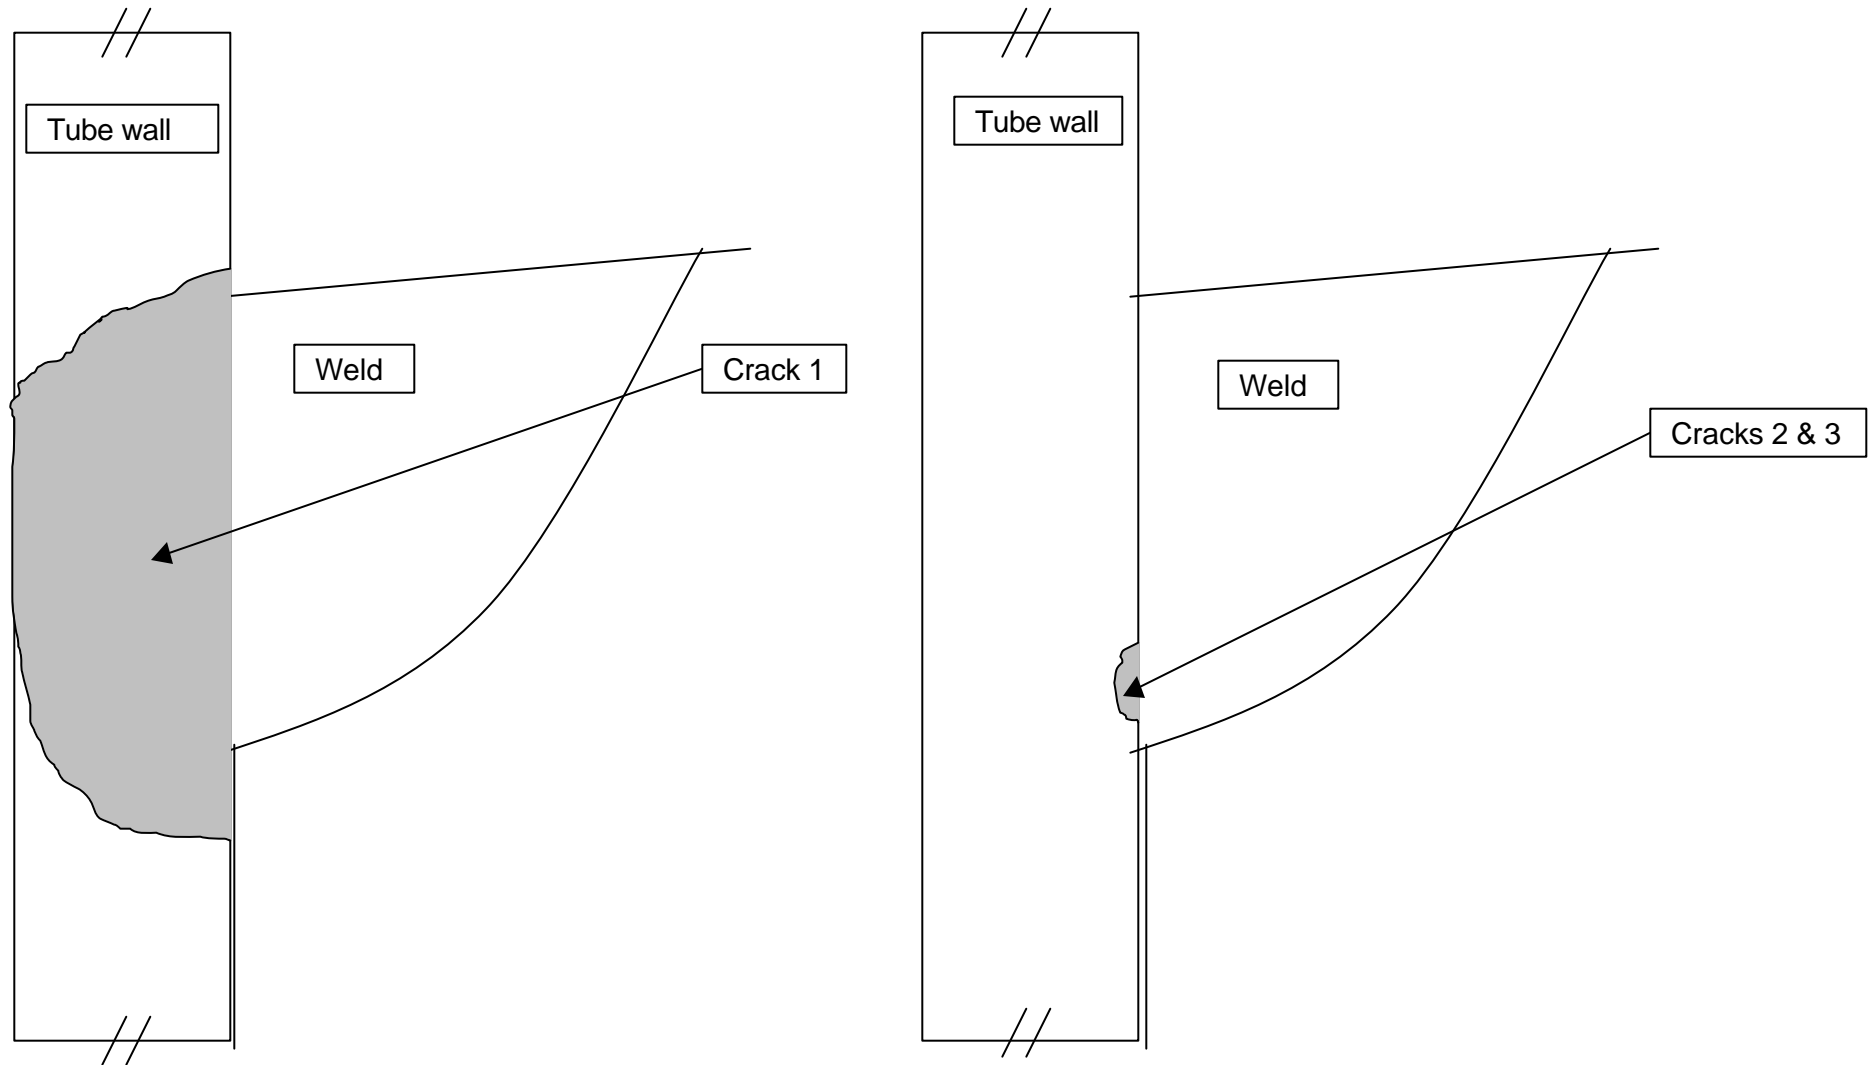
South Texas Project Status Report on Resolving the Unit 1 BMI Issue – Attachment 5 Two Dimensional Representation of Cracks in Nozzle 1

Nozzle 1 had three cracks. Each crack was axially oriented to the J-groove weld. One crack extended above and below the J-groove weld and penetrated the inside diameter of the nozzle. The second and third cracks were much smaller and on the outside diameter of the nozzle close to the initial weld passes. The second and third cracks did not extend above or below the J-groove weld and did not penetrate the inside diameter of the weld.

The pressure was then raised to 150 psi. There were no bubbles observed at nozzle 46. However, bubbles were seen at nozzle 1 at the azimuth of the large crack in the nozzle detected by UT in the fillet region of the J-groove weld at a rate of about 1 bubble per second. The bubble test confirms the fact that the cracks believed responsible for the observed reactor coolant leakage are extremely tight.
