October 15, 2003
NOC-AE-03001610
10CFR50.73

South Texas Project
Unit 1
Docket Nos. STN 50-498, STN 50-499
Supplement to Licensee Event Report 03-003
Bottom Mounted Instrumentation Penetration Indications

4. TITLE
Bottom Mounted Instrumentation Penetrations Indications – Supplement to LER dated 6/11/2003

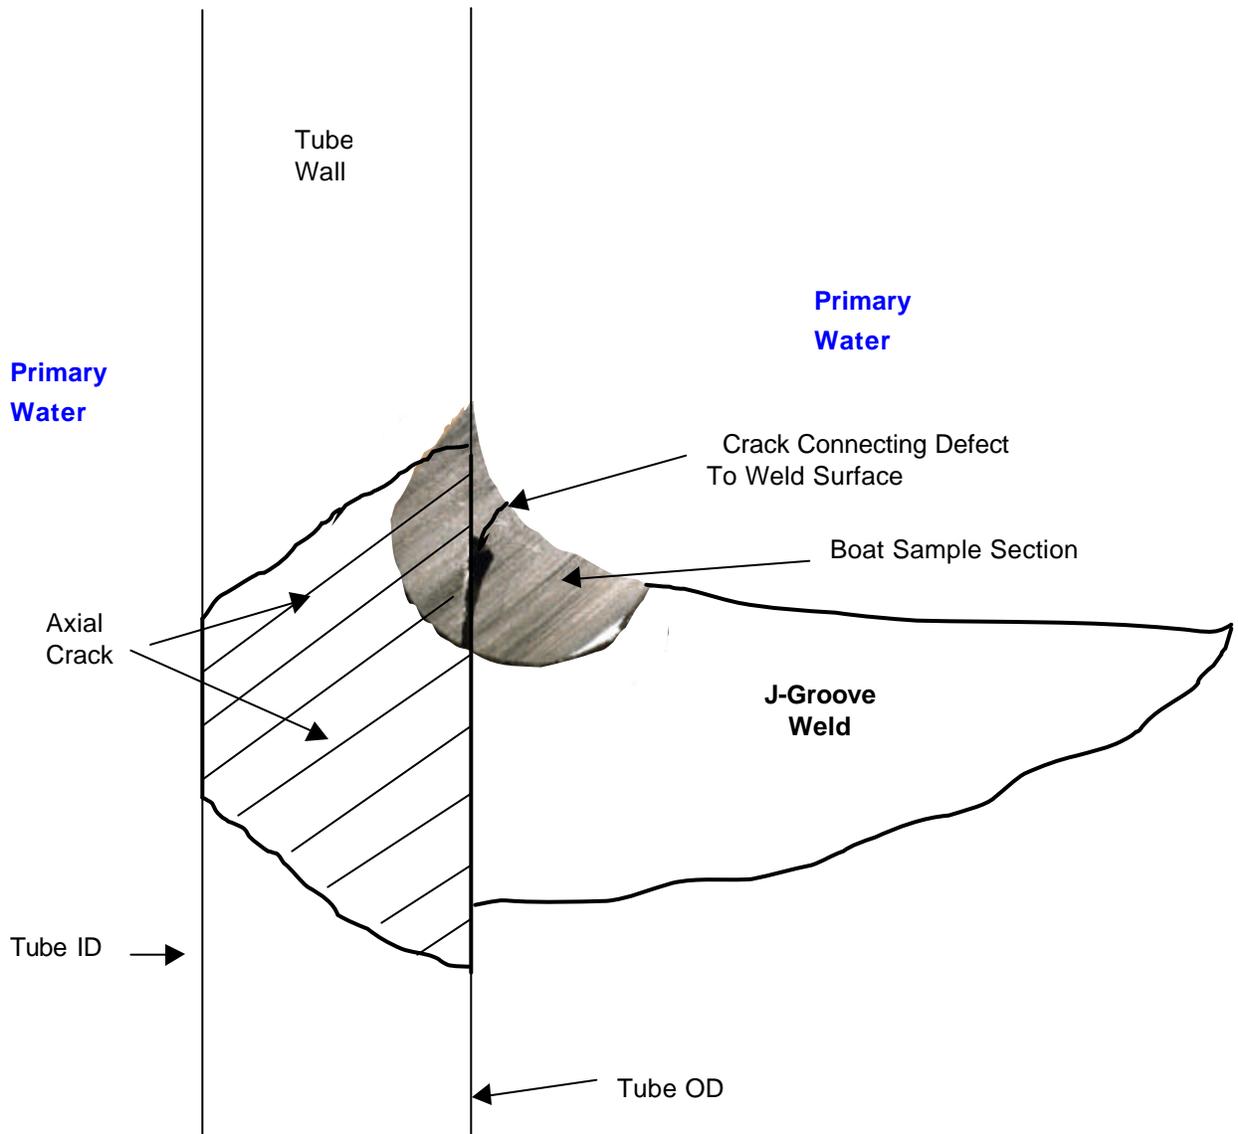
Composite Drawing Showing Axial Crack, Weld Flaw, and Weld Crack

The boat sample from Penetration #46 was designed to capture as much tube material as possible in an attempt to harvest a portion of a crack not connected to the ID of the nozzle. The margins for error associated with positioning the EDM equipment through 70 feet of water resulted in a shallow cut in Penetration #46. The resulting undersized sample was either inadvertently discarded or completely consumed in the margins of the EDM cutting tool. The boat sample from Penetration #1 captured material and defects from the J-groove weld and J-groove/tube interface, as designed. A composite drawing showing the axial crack, weld flaw and weld crack is attached.

The boat sample from Penetration #1 contained a portion of the large through-wall axial crack in the tube, three "discontinuities" which were confirmed to be lack of fusion resulting from slag inclusions, and one crack at the helium bubble location which connects the surface of the J-groove weld to the largest area of lack of fusion.

The crack in the weld that connects the surface of the J-groove weld to the largest area of lack of fusion is singular and unique. The 0.2-inch long crack spans an 80 mil ligament separating the lack of fusion void from the surface of the J-groove weld in the ground fillet transition at the tube/J-groove weld interface. The length of the crack spans and is limited to the width of the lack of fusion void. The section of the boat sample containing this crack was broken in the laboratory to expose the crack face for examination. Tenacious deposits obscured the crack face, and gradually more aggressive attempts to remove the deposits also attacked and distressed the metal surface. The crack exhibits some intergranular characteristics. To some reviewers, the nature of the oxide deposits suggests hot cracking. Fatigue could also be a factor in the development of this crack. However, the precise mechanism responsible for initiating and propagating this crack could not be determined.

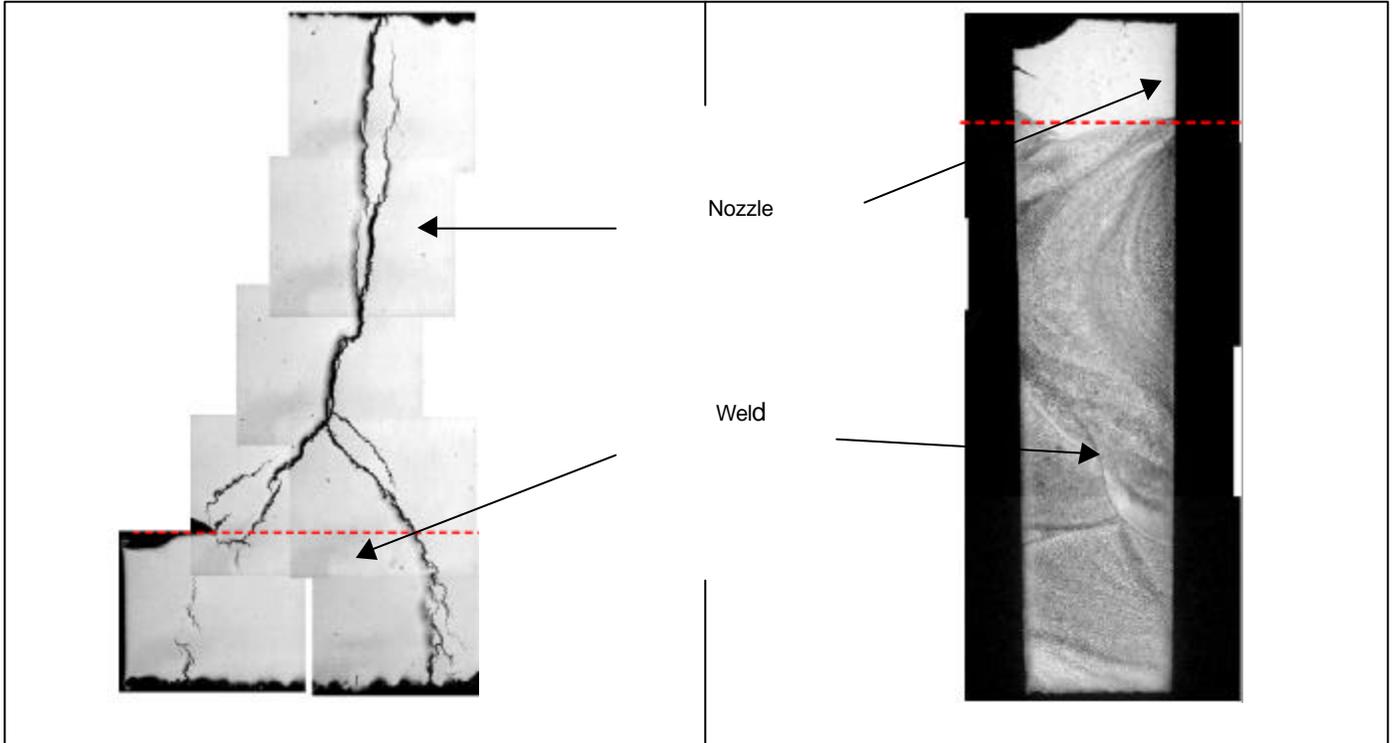
Photographs of First and Last Face Grind

Earlier UT results identified an axial crack in Penetration #1 which penetrated the ID of the nozzle and extended from just above to just below the J-groove weld. The boat sample from Penetration #1 successfully captured a part of the upper portion of this crack in the region of the tube/J-groove weld interface. The intergranular nature of this crack exhibits classic primary water stress corrosion cracking (PWSCC) characteristics. The extent of the crack was examined by progressively grinding away thin layers of the section of the boat sample. The orientation of the ground surface was such that more weld material and less

tube material was exposed at each successive grind. The initial exposed surface consisting of nearly all tube material contains a crack that extends into the weld material then stops. As successive layers are ground away, exposing more weld and less tube, the extent of the crack becomes smaller and smaller. The final ground surface, which consists almost entirely of weld material, reveals no crack at all in the weld and a small vestige of crack in the remaining small bit of tube. Photographs of the grinds of the first face and the last face are attached.

The axial crack in the tube appears to grow from the EDM surface out to the tube/J-groove interface since it branches and connects two of the three voids, at least at this location in the boat sample. This fact might suggest ID initiated PWSCC. However, neither of the two cracks in Penetration #46, the other leaking BMI penetration, connects to the ID of the tube. A supplemental ET examination of the ID surface was performed specifically to confirm the UT results that the flaws did not penetrate the ID. ET established that the cracks did not connect to the ID. Based on this fact STPNOC has concluded that the PWSCC axial crack in the tube is OD initiated. The crack most likely originated on the OD of the tube in the highly stressed region of the flooded weld defects.
