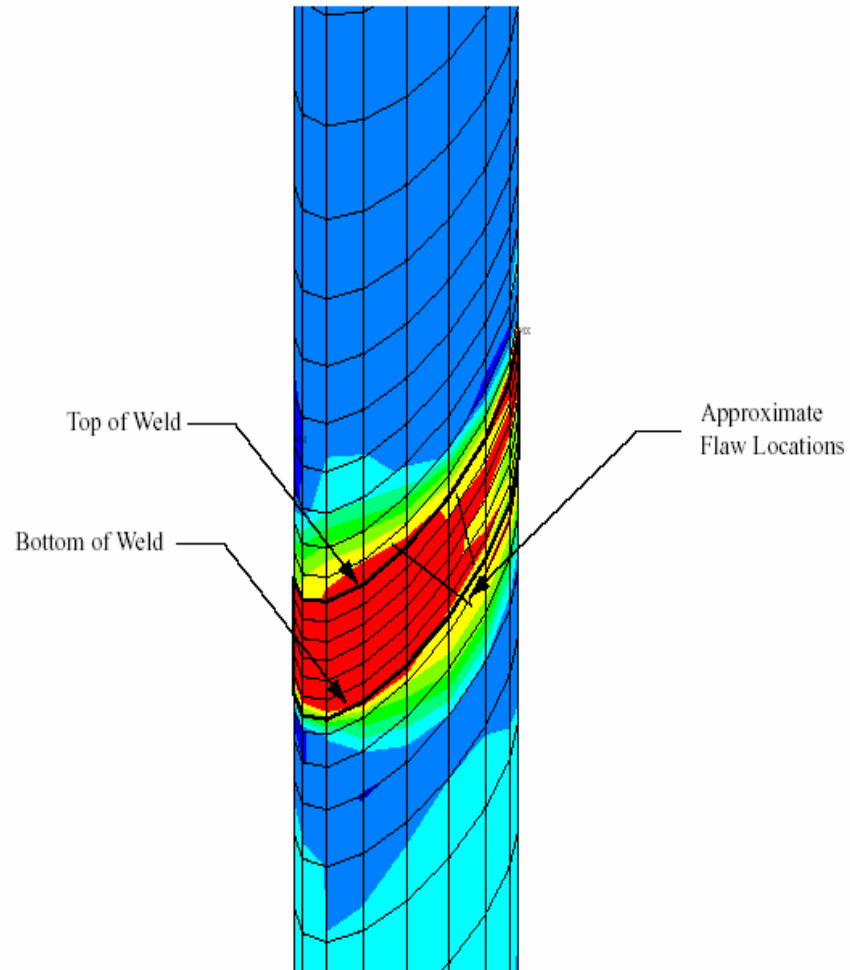
Flaw Locations and Stresses

- Residual stresses favor axial crack orientation
- No circumferential cracks

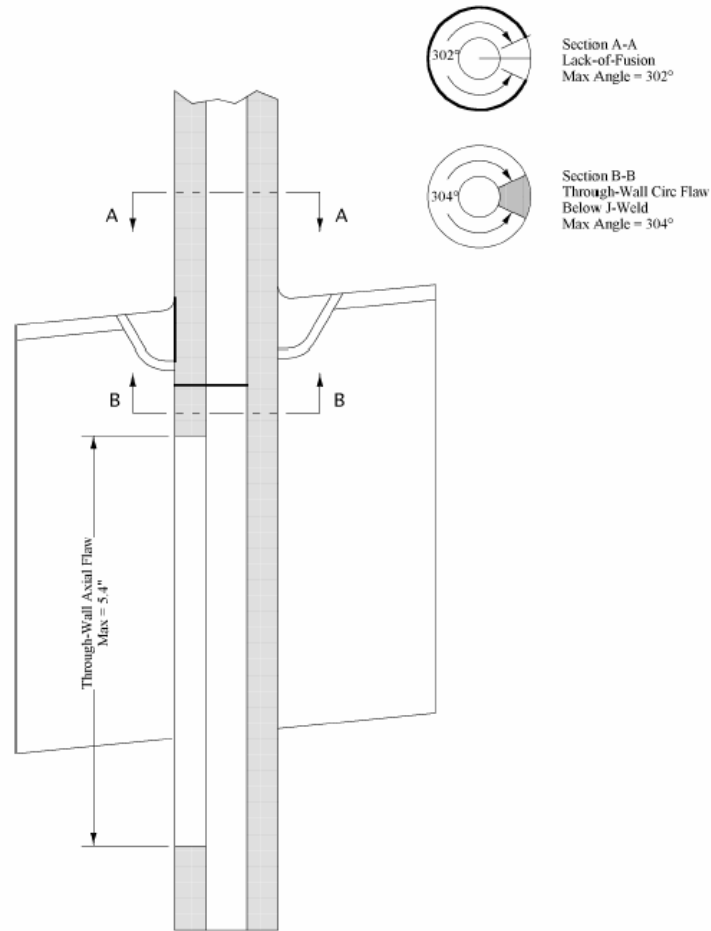
Limiting Flaw Size

- Residual stresses favor axial crack orientation
- No circumferential cracks
- Robust design
- Limiting flaw size

Locations of Analyzed Axial and Circumferential Flaws
