REPAIR PLAN

Half-Nozzle Repair

Analyses Supporting Repair

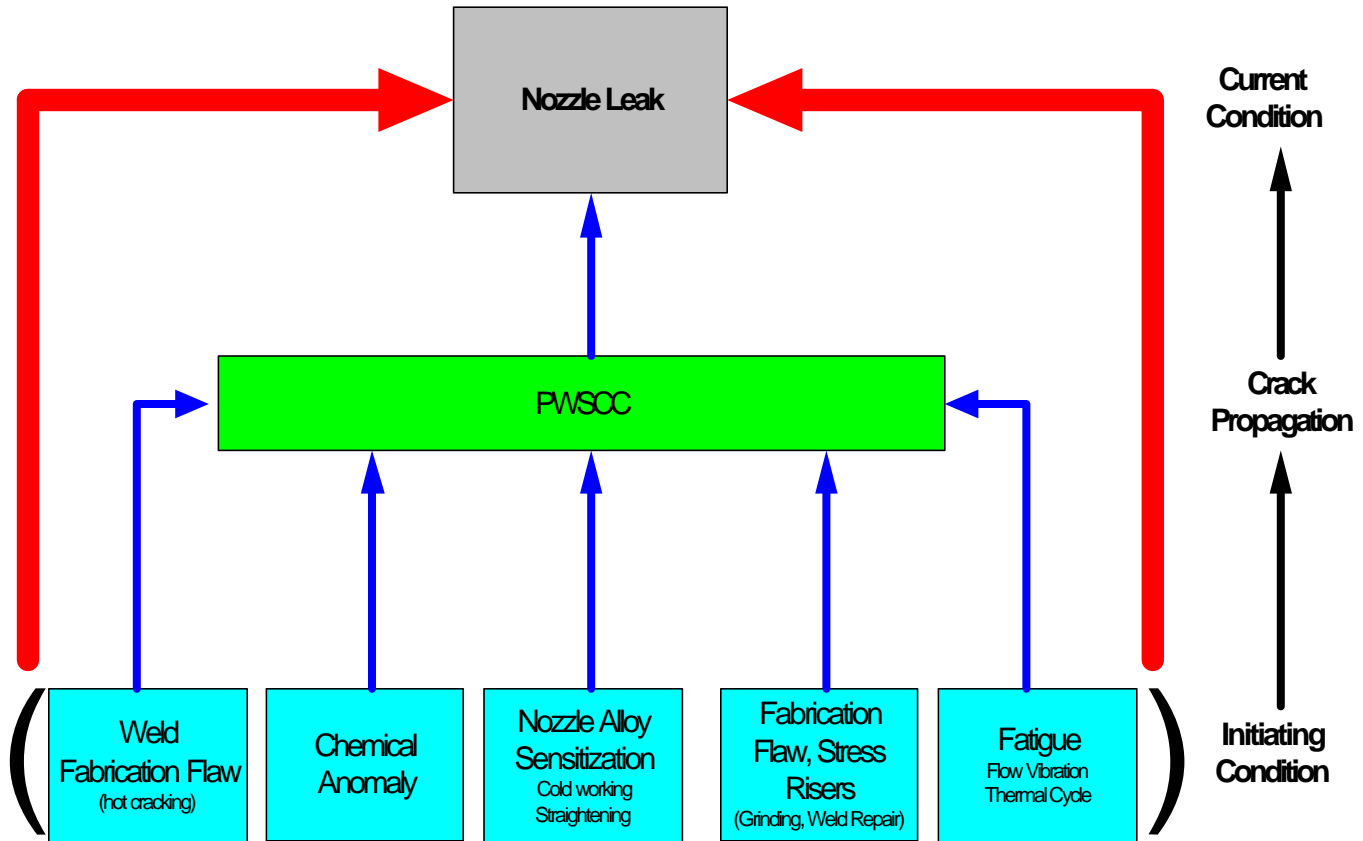
Root Cause Focus

Most Likely Causes

- Residual fabrication stresses
 - J-groove weld grinding, welding, welding rework
- Lack of J-groove weld fusion to nozzle OD
- Weld cracking; fabrication defects / contaminants
- Combination of one or more with PWSCC
