Integrity Assessment for Reactor Vessel Head Penetration Nozzles at B&W-Design Plants

Presented by
S. Fyfitch
Framatome ANP

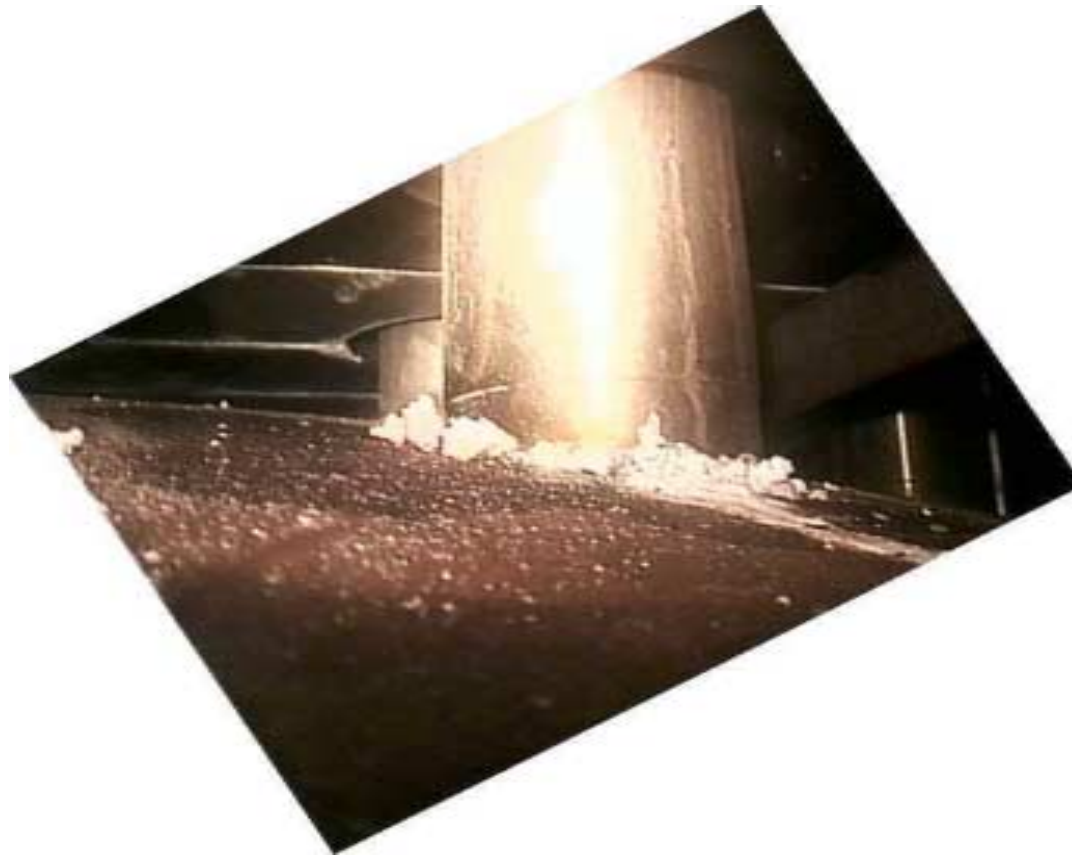
ONS-1 RV Head Showing Boric Acid At CRDM Nozzle 21

- All eight thermocouple nozzles contained flaws predominantly axial in orientation
 - Five nozzles identified as leaking
 - ID cracking observed on all eight nozzles
 - Cracking penetrated into all eight nozzle welds
- CRDM nozzle 21 did not contain ID flaws
 - Flaws in weld material, predominantly axial/radial in orientation, identified as leak source
 - Flaw propagated through the weld area along the nozzle OD

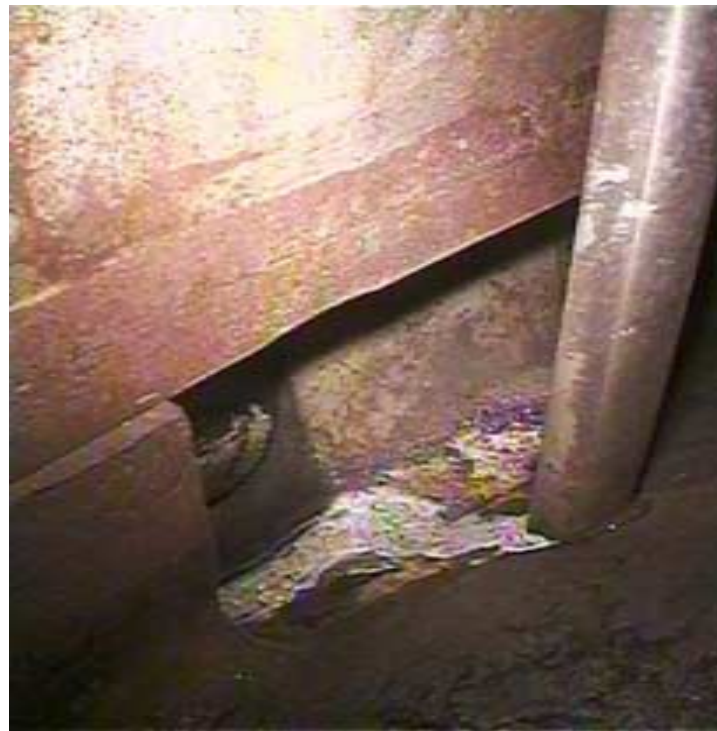
ONS-1 RV Head Showing Boric Acid At Thermocouple Nozzle
