Oconee Unit 1 & Unit 3 Reactor Vessel Head Leakage

Cracking of RV Head Penetrations
Due to Primary Water Stress
Corrosion Cracking (PWSCC)

M.R.Robinson, Duke Power Company

April 12, 2001

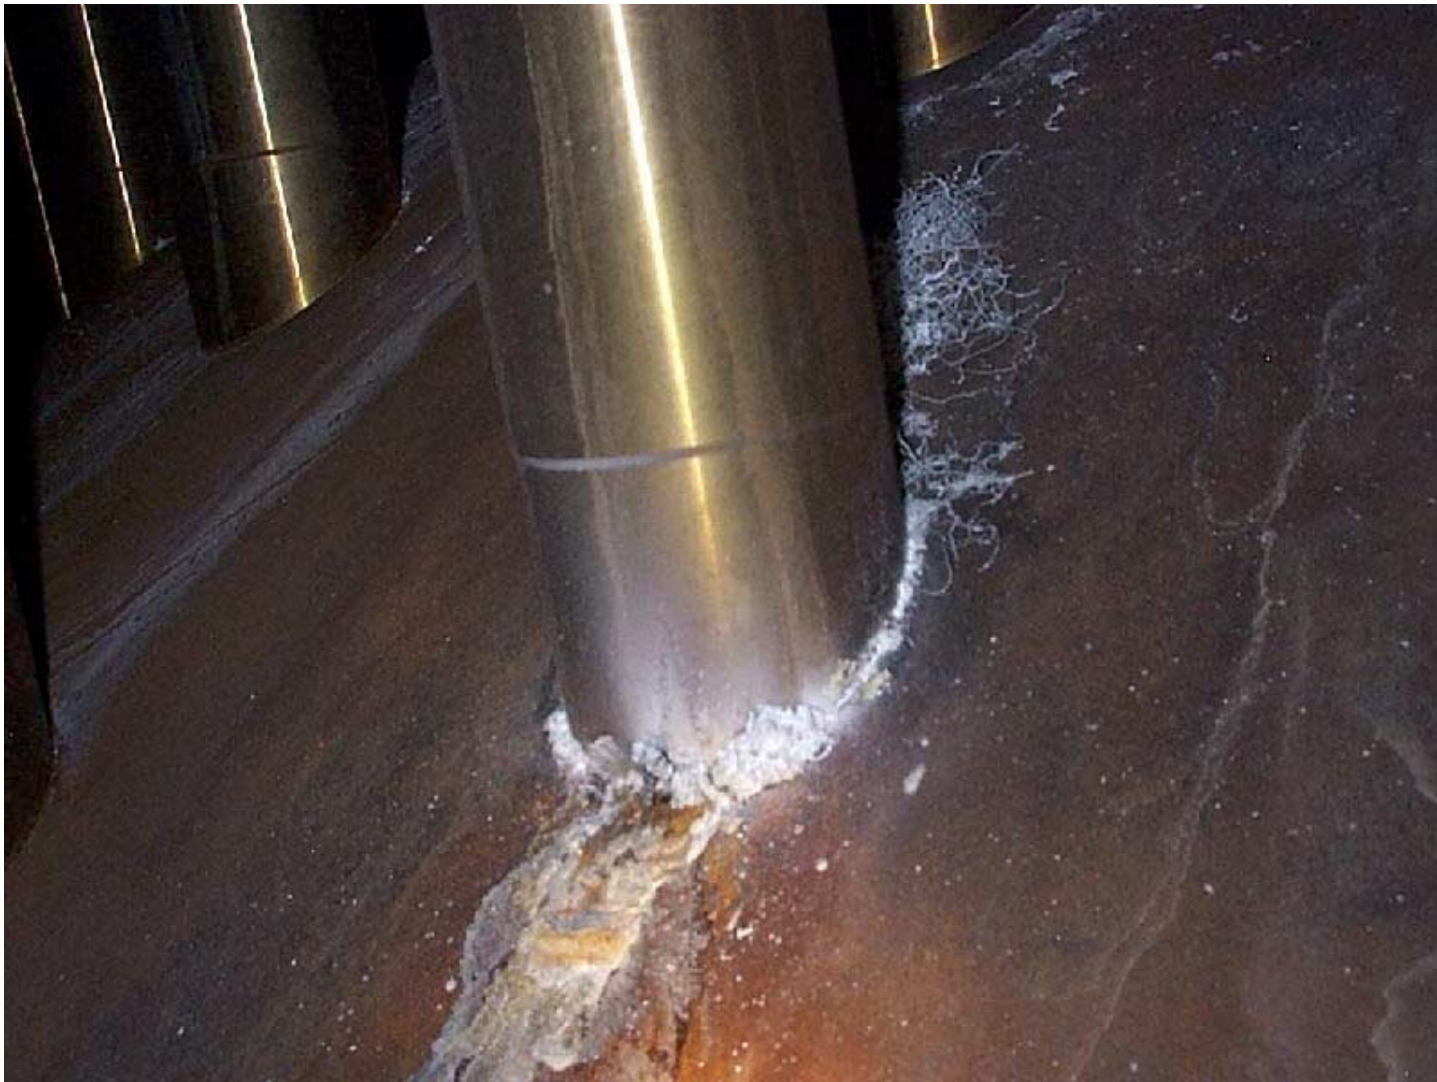
CRDM Nozzle #56

Nozzle	
#56	<ul style="list-style-type: none"> ▪ 3 Axial and 1 Circumferential Cracks ▪ 1 axial thru wall, One 38% thru wall, One 11% thru wall ▪ Thru wall is 1.7” long, mid depth .75” long, shallow is 1.6” long ▪ Circ crack above weld near high side and about 2.4” long
#3	<ul style="list-style-type: none"> ▪ 7 Axial and no circumferential cracks ▪ No Axial thru wall, all between 33% and 65% thru wall ▪ All between .3” and 1” long ▪ Areas of crazed cracking below weld at high side
#7	<ul style="list-style-type: none"> ▪ 1 Axial and no Circumferential Cracks ▪ Axial is 87% thru wall, 2.3” long ▪ Areas of crazed cracking below weld at high side

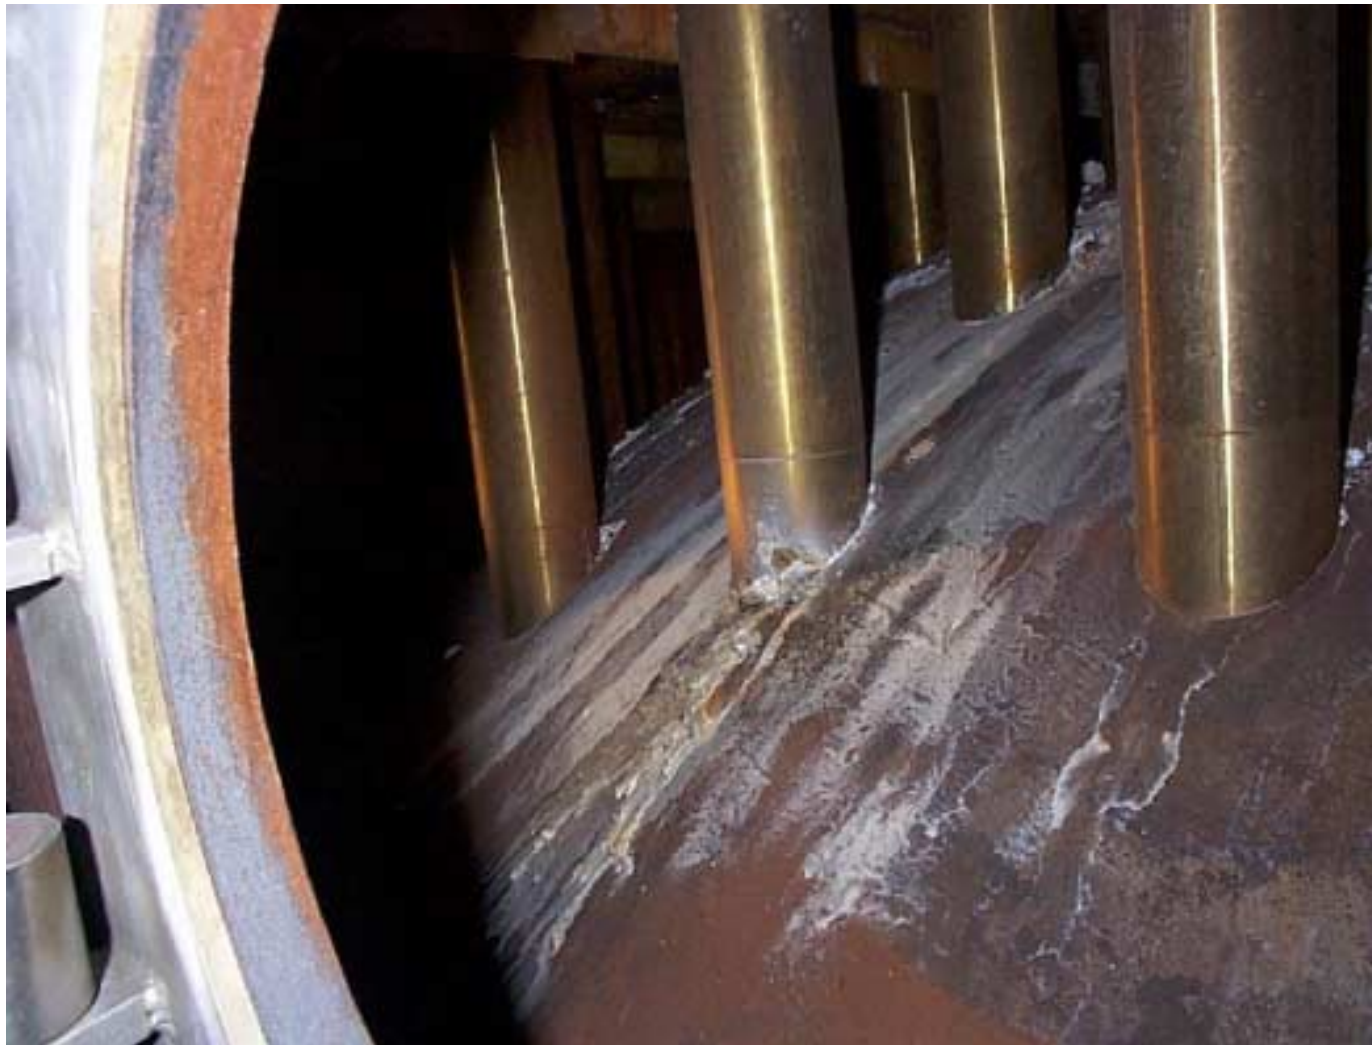
CRDM Nozzle #50

- ◆ Confirmed two (2) above the weld circumferential cracks
 - Nozzle 56 crack was thru wall
 - Nozzle 50 except for pin hole indications on ID was not thru wall
 - Inspection and metallurgical results indicate the circumferential cracks were O.D. initiated.

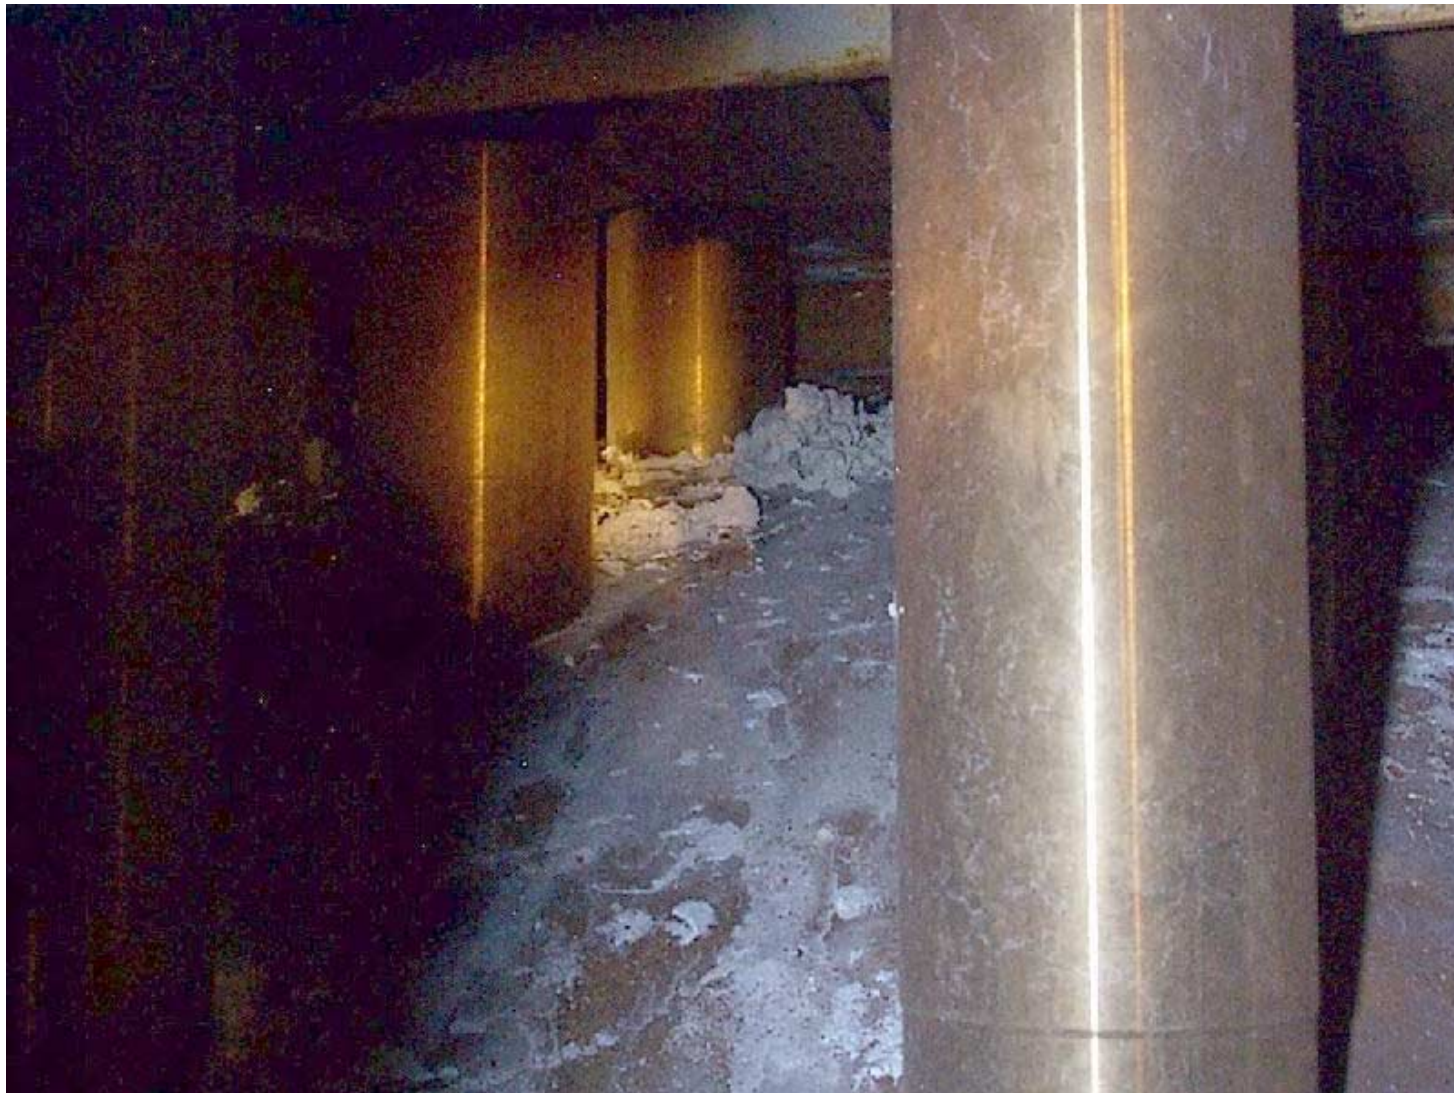
CRDM Nozzle #11

Nozzle	
# 11	<ul style="list-style-type: none"> ▪ 7 Axial and 3 Circumferential Cracks ▪ 3 Axial thru wall, 2 > 75% thru wall, 2 about 50% thru wall ▪ 3 thru wall are 3" long, 2 > 75% are 3" long, 2 about 50% < 1" long ▪ All circ below weld, 1 is 10%, 1 is 57%, 1 is 70% thru wall ▪ Deep circ crack is about 5.3" long, mid circ crack is 3.9" long ▪ Areas of craze cracking above and below weld at high side
#23	<ul style="list-style-type: none"> ▪ 6 Axial and 2 Circumferential Cracks ▪ 2 Axial thru wall, 4 are 30% to 67% thru wall ▪ 2 thru wall are .6" and 3.8" long, 4 are 0.5" to 1.1" long, both circ below weld, 1 is 77% thru wall, other is 67% thru wall ▪ Circ cracks are about 2" long ▪ Areas of crazed cracking above weld at high side

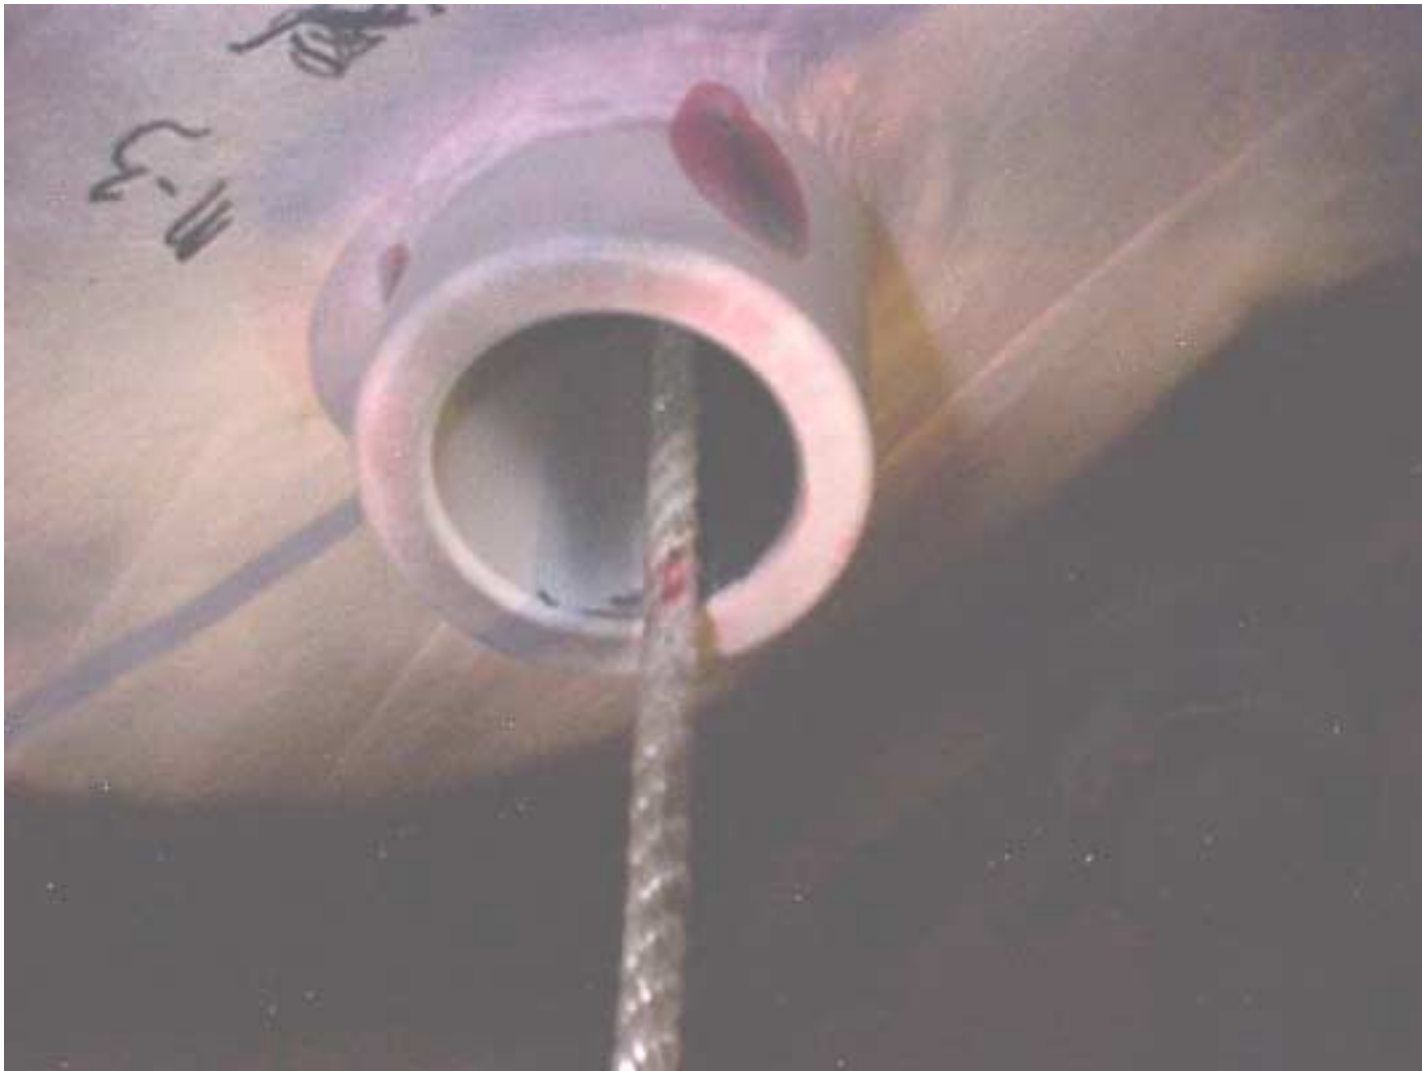
CRDM Nozzle #56

- ◆ Boat sample in the area of circ crack that was found above the weld after the weld repairs were completed
- ◆ Boat sample contained a face of the circ crack along with 3 small axial cracks that intersect the circ crack
- ◆ Section through the axial crack confirms crack is totally intergranular with small intergranular branches
- ◆ Scanning electron microscopy of the circ crack face revealed only intergranular morphology.
- ◆ There are no tears or other indications of the origin of the circ crack
- ◆ Circ crack is indicative of PWSCC

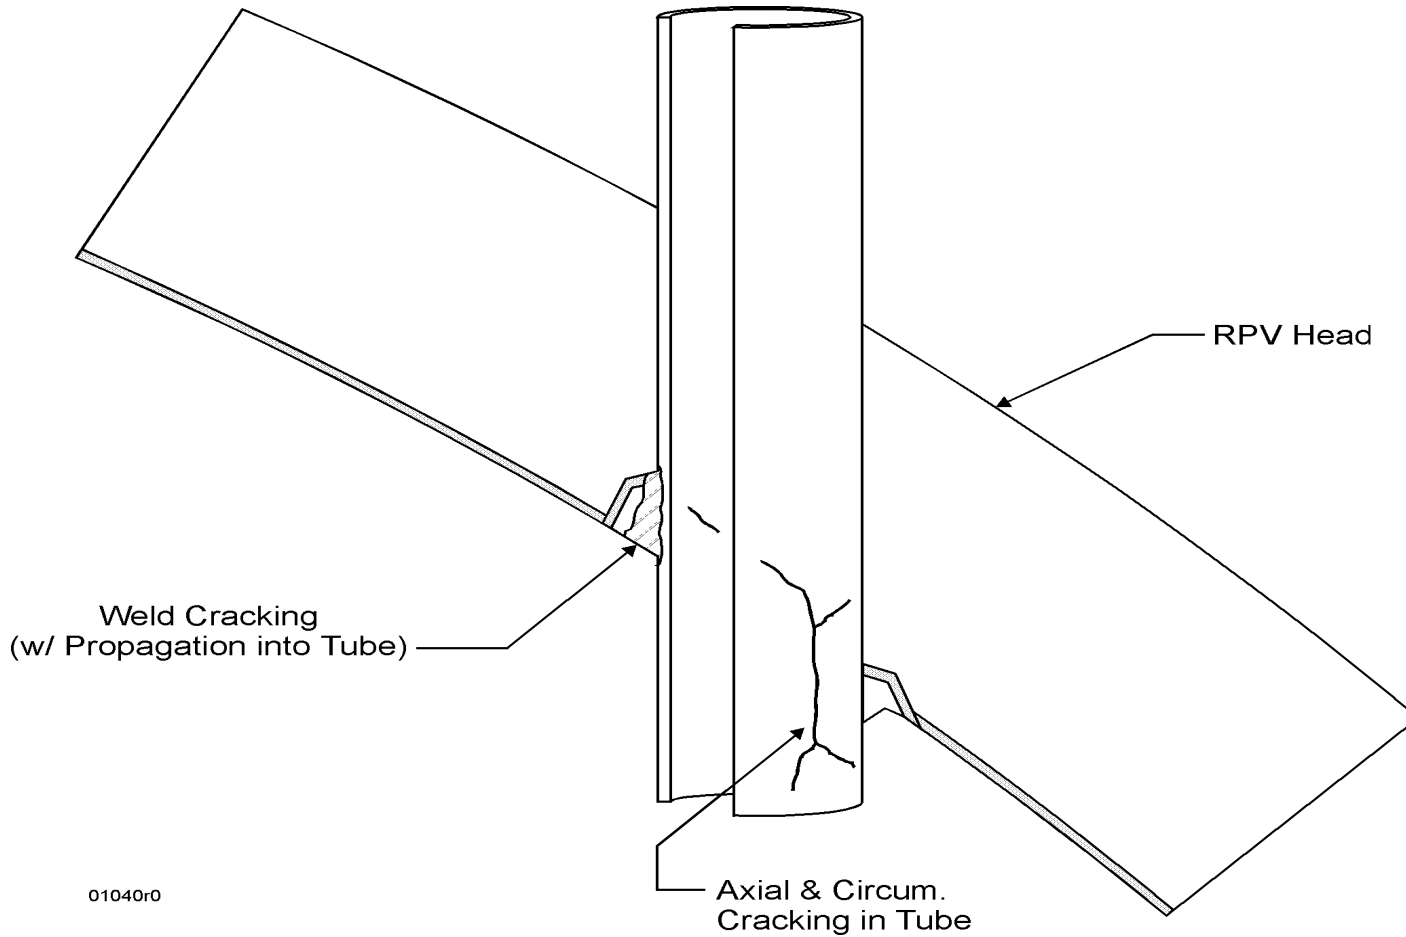
CRDM Nozzle Cracks at ONS 1 & 3

- ◆ Total of 48 indications in the nine leaking CRDMs
 - 39 are axial and located beneath the weld at the uphill and downhill
 - 16 indications thru wall (39%), all are axial, and occur on 6 of 9 nozzles
