Dominion Nuclear Connecticut, Inc.
Millstone Power Station
Rope Ferry Road
Waterford, CT 06385

Millstone Nuclear Power Station, Unit No. 2
Reply to Request for Additional Information
Related to NRC Bulletin 2001-01

Millstone Nuclear Power Station, Unit No. 2

Reply to Request for Additional Information
Related to NRC Bulletin 2001-01

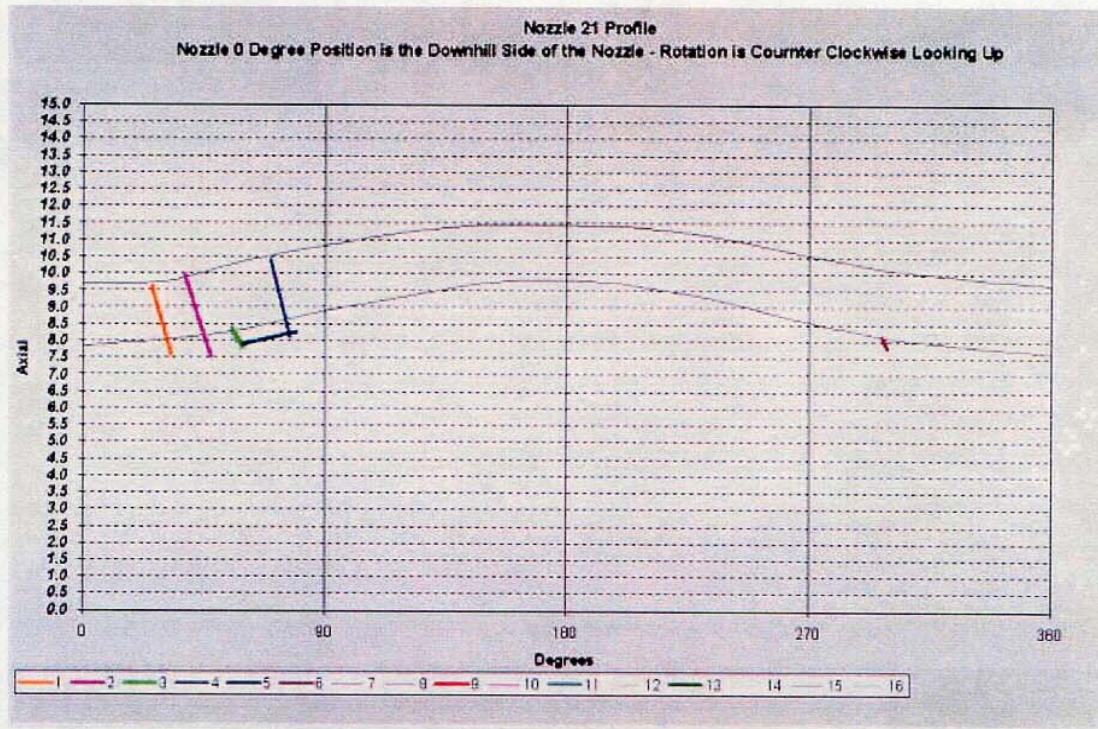
Indication No.	1	2	3	4	5	6
Location	OD Downhill	OD Downhill	OD Downhill	OD Downhill	OD Downhill	OD Downhill
Orientation	Axial	Axial	Axial	Axial	Circ	Axial
Length (in.)	2.04	2.44	.59	2.28	.77	.37
Depth (in.)	.20	.19	.19	.09	.18	.15

Figure 1 Location of UT indications in Nozzle 21 from 2R14 Inspection

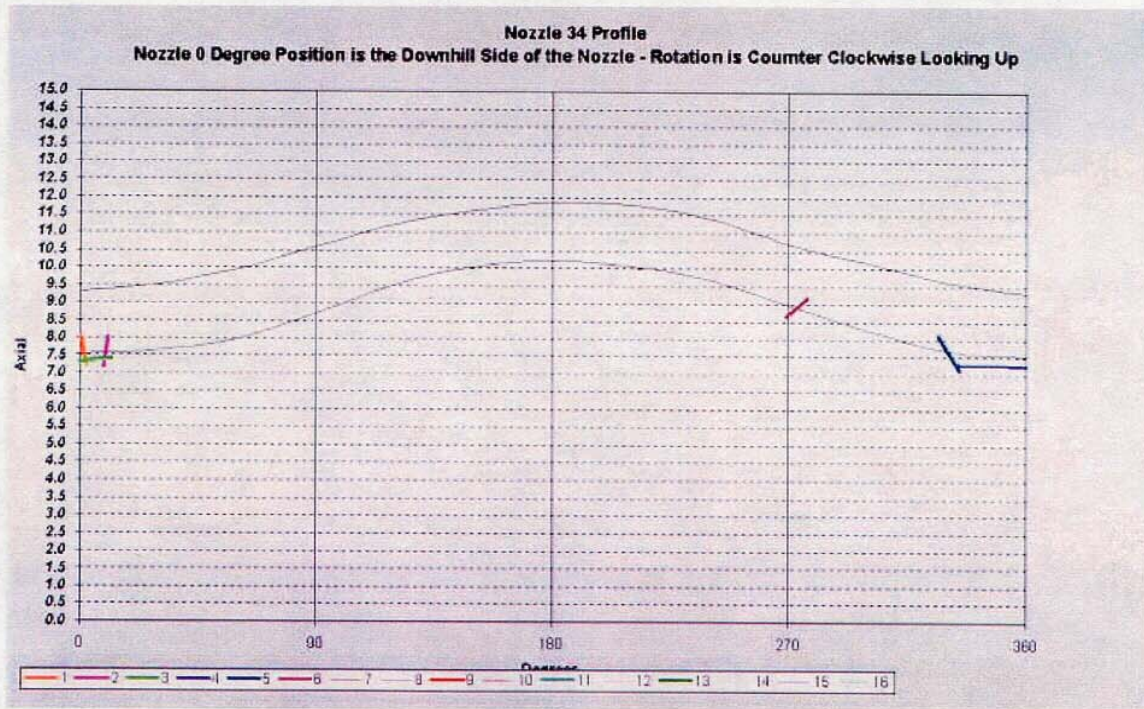
Figure 2 Location of UT indications in Nozzle 34 from 2R14 Inspection

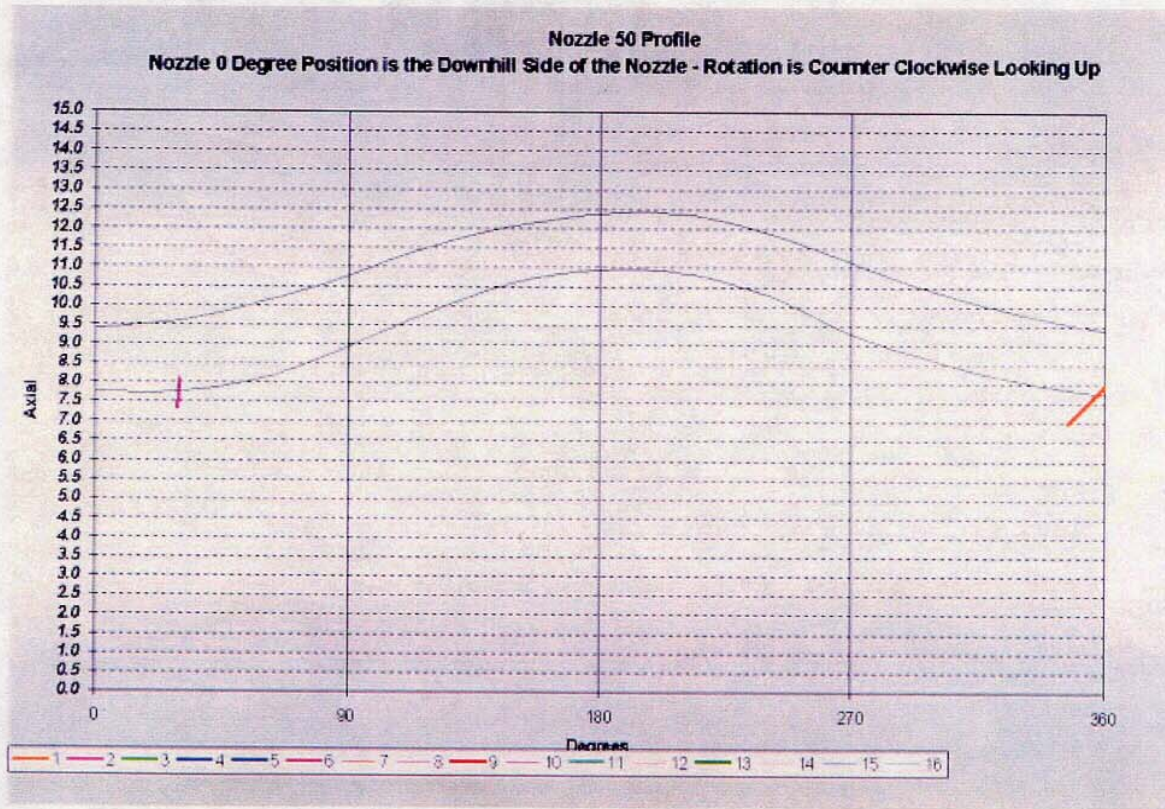
Figure 3 Location of UT indications in Nozzle 50 from 2R14 Inspection
