**DAVIS-BESSE REACTOR VESSEL HEAD DEGRADATION  
LESSONS-LEARNED TASK FORCE REPORT**

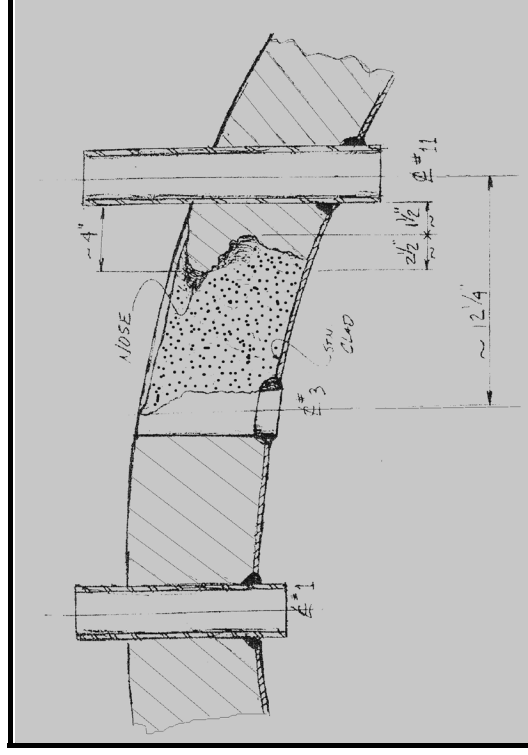
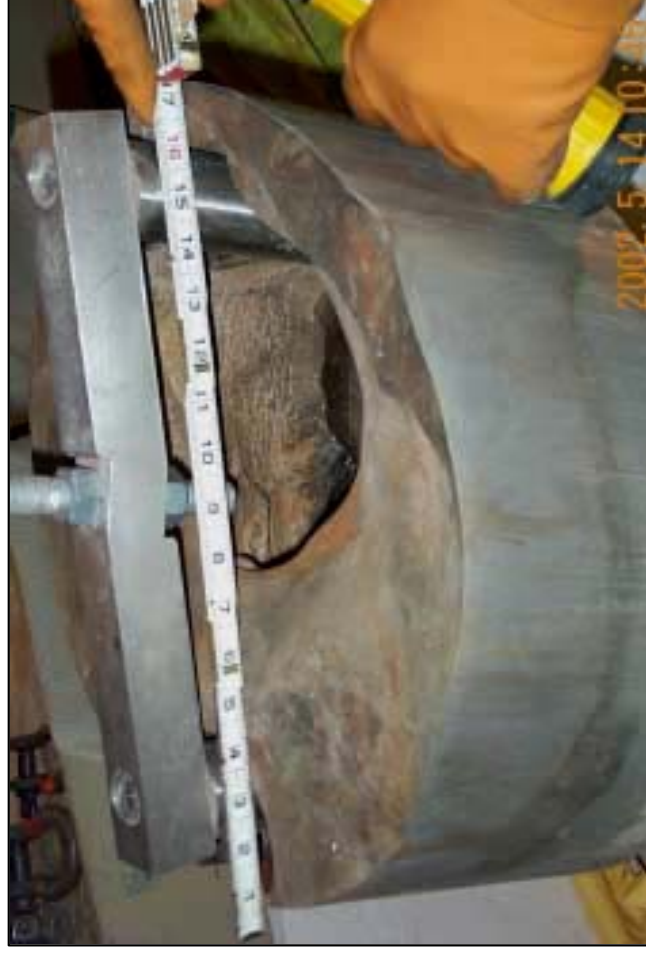
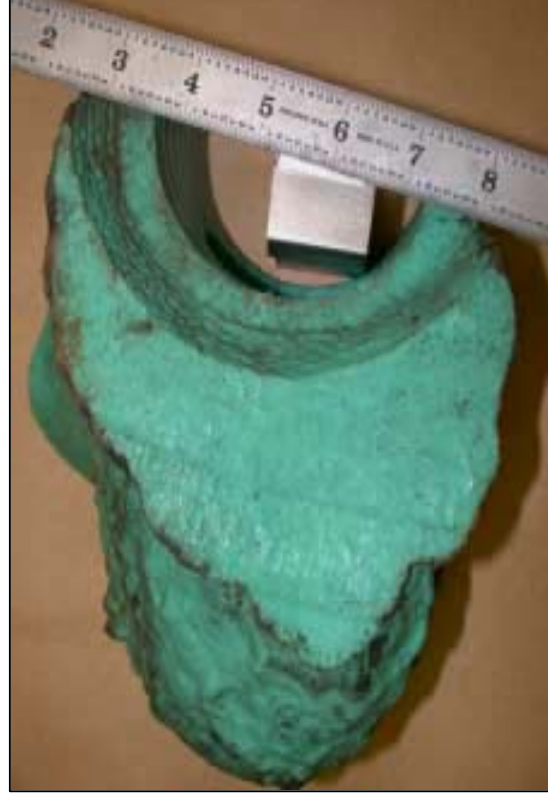
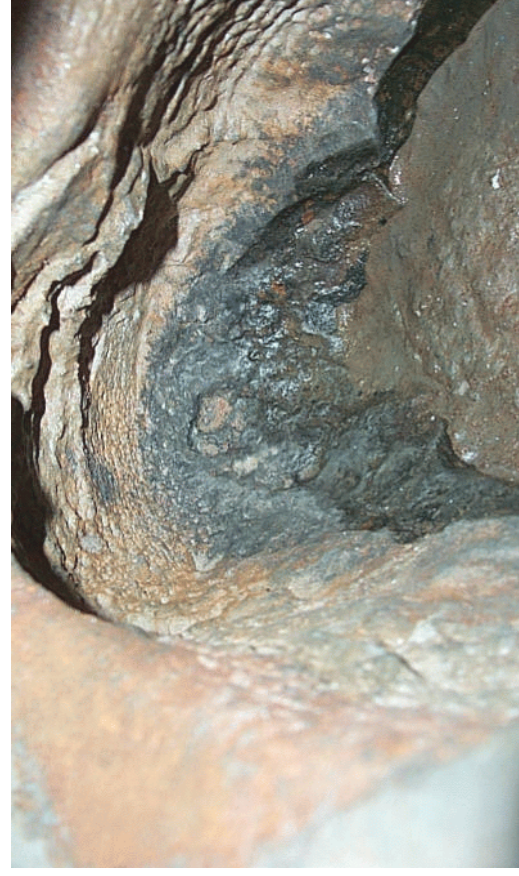
Figure 2-4  
DBNPS VHP NOZZLE NO.3 DEGRADATION CAVITY

On March 5, 2002, the licensee for DBNPS in Oak Harbor, Ohio, discovered a cavity in the RPV head, adjacent to VHP Nozzle 3. Davis-Besse Nuclear Power Station is a pressurized water reactor (PWR) plant. A schematic of a typical PWR reactor is shown in Figure 2-1. The DBNPS Nuclear Steam Supply System (NSSS) was fabricated by the Babcock & Wilcox (B&W) Company. Typical B&W RPV head and VHP nozzle design and fabrication details are depicted in Figures 2-2 and 2-3. Details of the degradation cavity in the DBNPS RPV head are shown in Figure 2-4.

Degradation Between Nozzle#3 and Nozzle#11.  
The Sketch Provided by the Licensee

Nozzle #3 Area Cut Away From Reactor Head

Rubberized Impression of Cavity

Close-Up View of Cavity

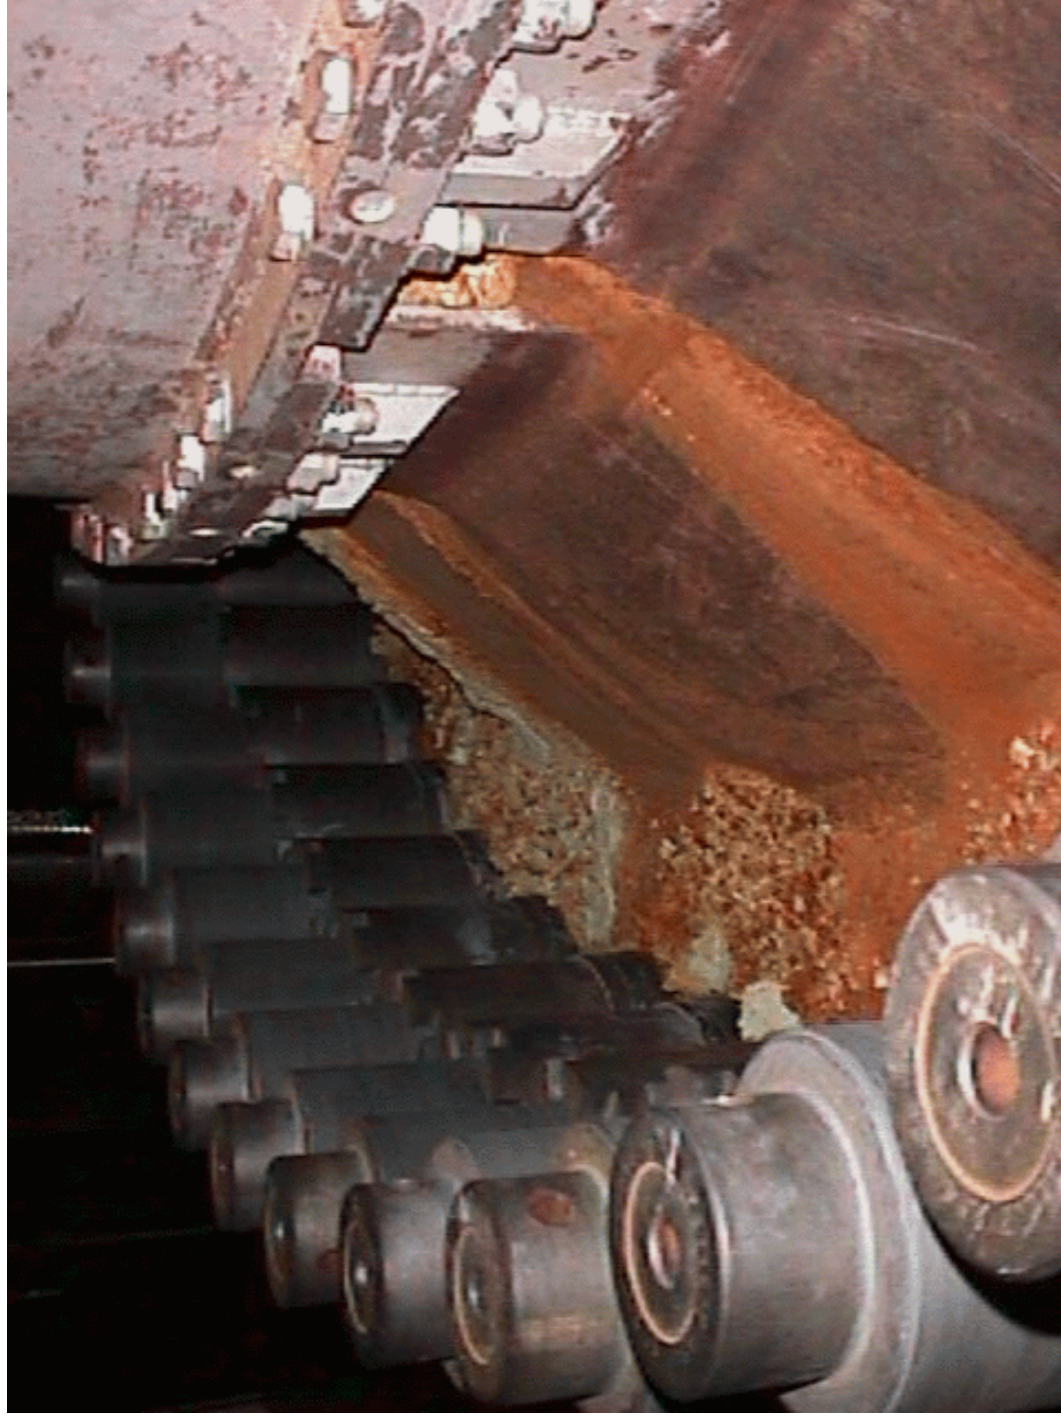
**Figure 2-5 BORIC ACID DEPOSITS ON RPV HEAD FLANGE**

Prior to the DBNPS VHP nozzle leakage and RPV head degradation event, there were two other significant boric acid degradation events previously at DBNPS. One of these involved the head vent flange to Steam Generator No. 2 (1993), while the other involved the pressurizer spray valve (1998). In addition to these events, the plant experienced CRDM flange leakage throughout its operating life, which resulted in the accumulation of boric acid deposits on the RPV head. At some point in the latter half of the 1990s, the combination of flange leakage and leakage through VHP Nozzle 3 caused the formation of the wastage cavity that was discovered in March 2002. As previously discussed, the mechanism for the cavity formation clearly involved corrosion due to the presence of boric acid. It is also likely that the degradation leading to the cavity formation had progressed over several years. As described elsewhere in this report, there were also indications that significant boric acid degradation was present in the DBNPS containment, most notably red/brown deposits on the containment radiation monitor filter elements and other components. As subsequently observed in videotapes documenting the condition of the RPV head from 1996 onward, the accumulation of boric acid deposits and corrosion products on the top of the RPV head (particularly in the region of VHP Nozzle 3), precluded effective visual examination for leakage from cracked VHP nozzles. Figure 2-5 shows a picture of boric acid deposits on the DBNPS RPV head flange region from Refueling Outage (RFO) 12 (2000). Figure 2-6 depicts boric acid deposits on the RPV head found during

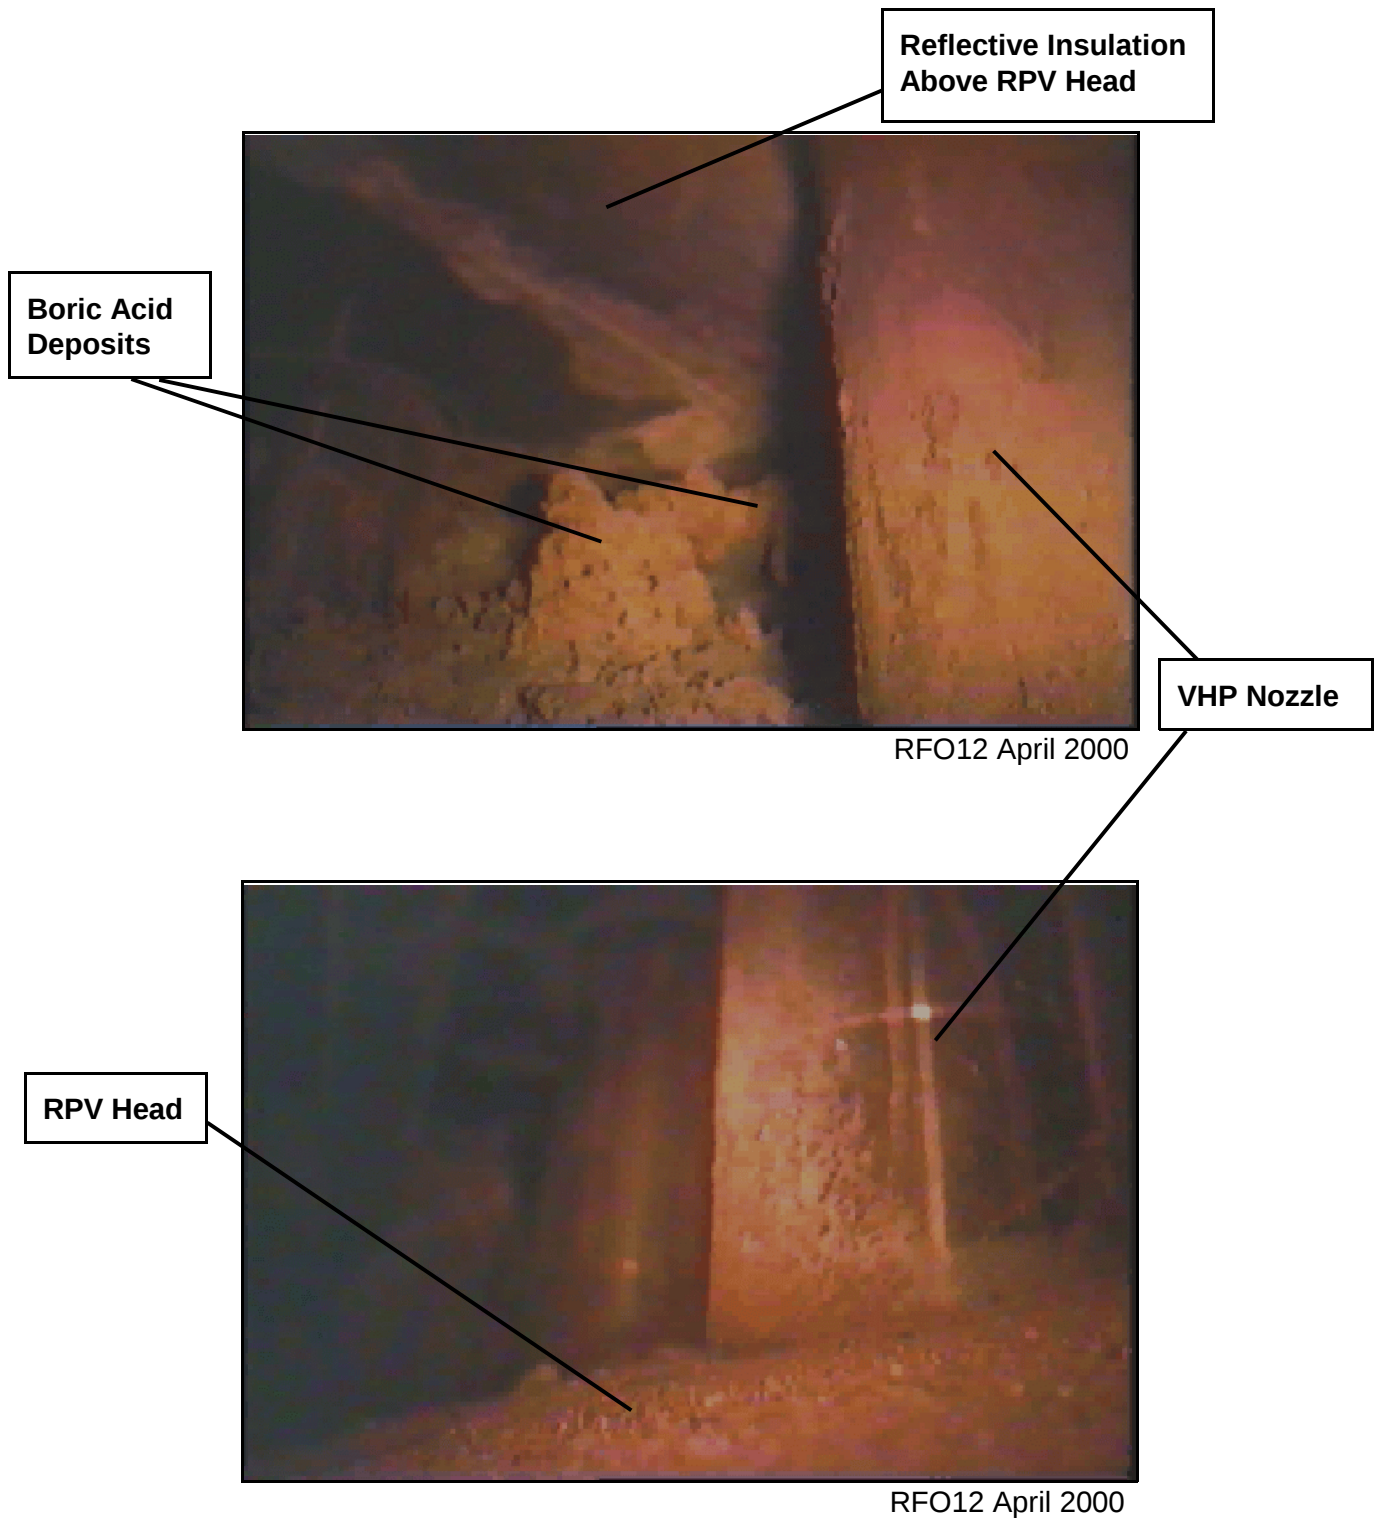
**Figure 2-6**

Refueling Outage 12 (2000)

**BORIC ACID DEPOSITS ON THE RPV HEAD (top) AND  
AREA RELATIVELY FREE OF DEPOSITS (bottom)**
