**SUBJECT:** Calvert Cliffs Nuclear Power Plant  
Unit Nos. 1 & 2; Docket Nos. 50-317 & 50-318  
15-Day Response to NRC Bulletin 2002-01, "Reactor Pressure Vessel Head Degradation and Reactor Coolant Pressure Boundary Integrity"

**15-DAY RESPONSE TO NRC BULLETIN 2002-01**

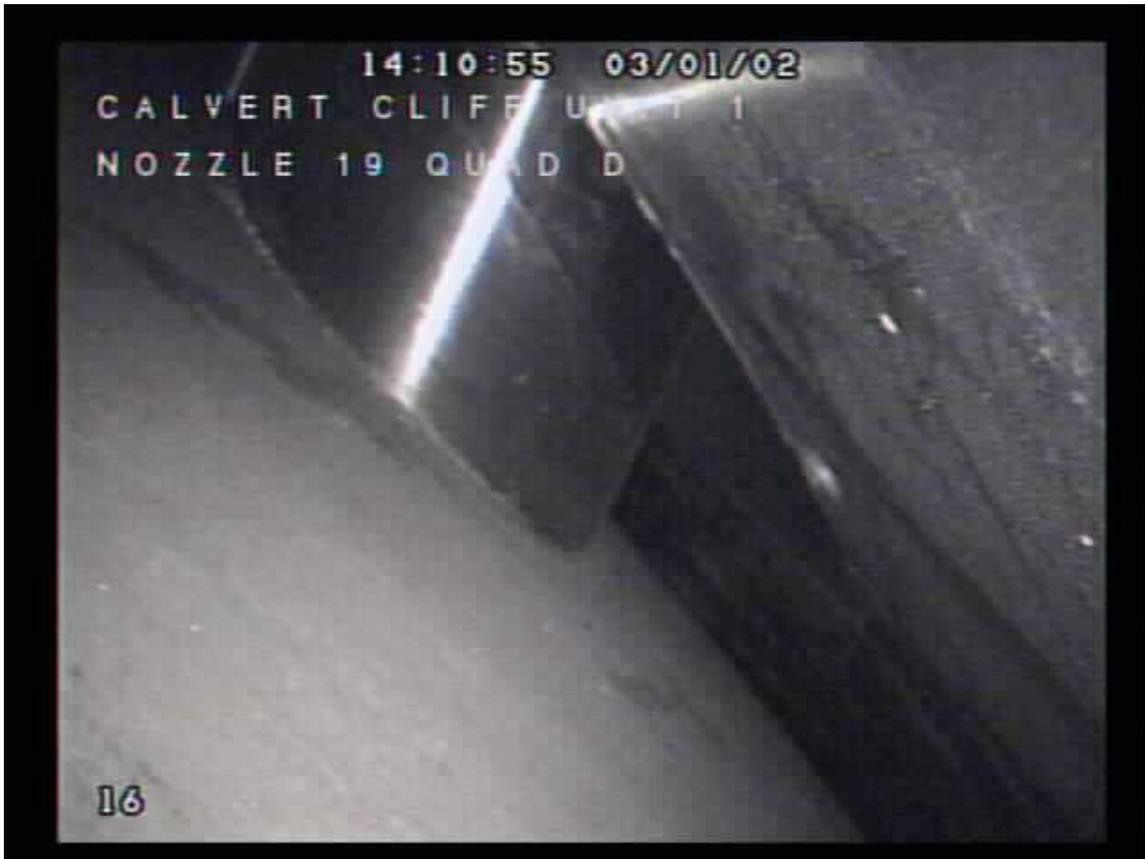
Figure 1  
Pictures Taken During Calvert Cliffs Unit 1 Reactor Pressure Vessel Head Inspection

The recently completed inspection performed on Unit 1 would have identified any corrosion on the top of the reactor vessel head. Figures 1 through 4 show sample pictures taken during the inspection. These pictures are a very good representation of what was found during the inspection.

There was no evidence of corrosion or significant accumulations of boric acid. As discussed in our response to Requested Information C below, we have had leakage of reactor coolant onto the head in the past. The generally excellent condition of the head, as shown in the photographs in Figures 1 through 4, demonstrate the effectiveness of our BACI program that identifies the extent of any boric acid leakage onto the head and cleans any boric acid off of the low alloy steel head surface. We conclude the maintenance and inspection program was successful in discovering and rectifying leakage. We believe the program continues to ensure a clean head for both Unit 1 and Unit 2.

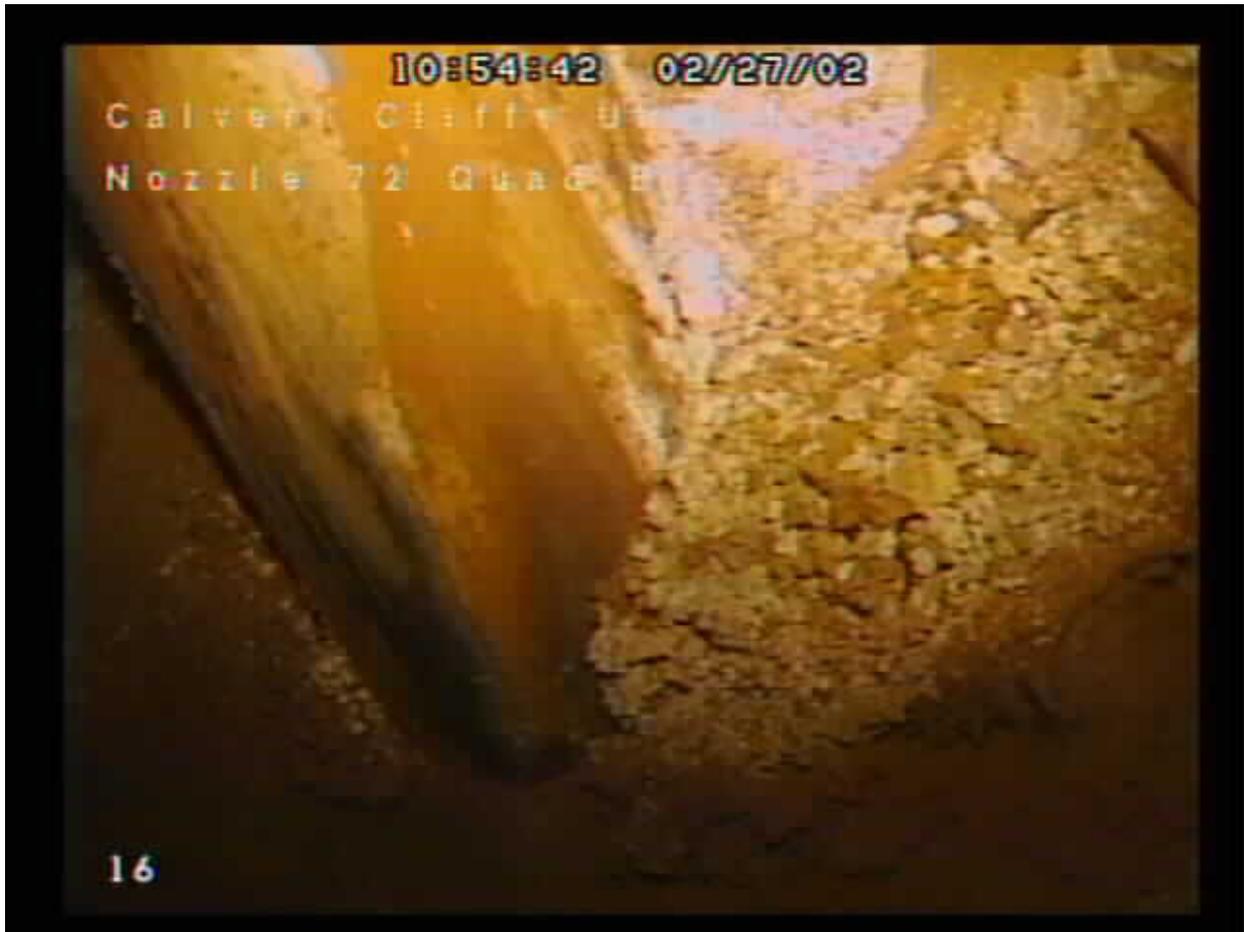
Figure 4  
Pictures Taken During Calvert Cliffs Unit 1 Reactor Pressure Vessel Head Inspection

As mentioned in response to Requested Information A above, a small amount of boric acid from a previous leakage event was identified during the recently completed bare metal inspection of the Unit 1 head (Figure 4). It was determined that the source of this accumulation of boric acid was the 1994 ICI leak (which occurred prior to the changes in the BACI program). The relatively small amount of boric acid residue adjacent to and nearby two ICI penetrations was removed. The underlying steel around the penetrations was examined for evidence of corrosion. No evidence of structurally significant corrosion, pitting or wall thinning was identified.
