SUBJECT: POINT BEACH NUCLEAR PLANT
NRC INSPECTION REPORT 50-266/01-04(DRP)

Report No: 50-266/01-04(DRP)

Facility: Point Beach Nuclear Plant, Unit 1

Dates: February 5 through 12, 2001

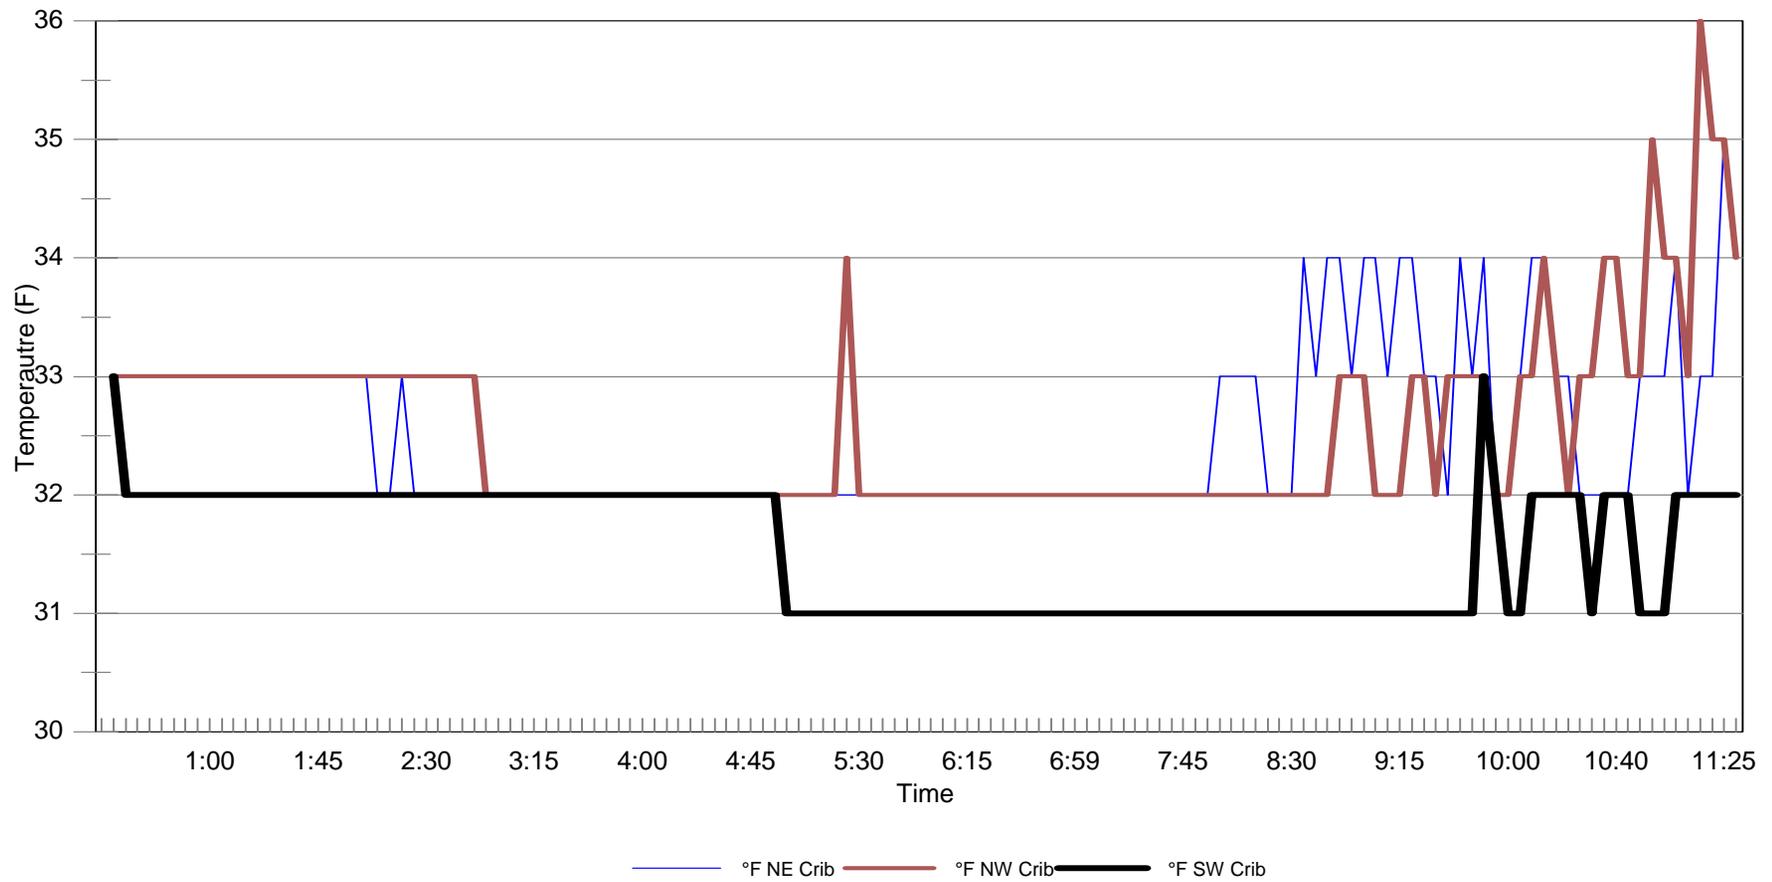
Intake Crib Temperatures February 5, 2001

On February 6, 2001, the inspector requested and reviewed the recorded water temperatures at the intake crib and forebay as indicated on the control room temperature recorder for the previous 36 hours. The temperatures recorded on the morning of February 5, indicated that the intake crib water temperatures were 32°F or below for several hours. The inspector reviewed the operator's log which indicated that although one adjustment to the seal well valve was made early in the morning, no significant efforts were made to operate the ice melt valves to increase recirculation flow to the intake crib and ultimately increase the water temperatures above 32°F as specified in Procedure OI-38. The attachment to this report depicts the intake crib water temperatures based on the near intake crib RTDs. Prior to 1:00 a.m. on the morning of February 5, one of three operable RTDs located near the intake crib indicated 32°F and by two hours later, all three RTDs indicated 32°F. Shortly before 5 a.m., operators

performed a 2 percent adjustment to the seal well valve to recirculate warmer water to the intake crib. This adjustment resulted in a brief increase in the intake crib water temperature as indicated on one RTD which then quickly returned to 32°F. During this time period, the indicated temperature on one of the other RTDs decreased to 31°F. At approximately 7:00 a.m., an NRC inspector questioned the duty shift supervisor as to why more adjustments had not been made to the seal well valves in efforts to increase the intake crib temperatures as required by OI-38. The duty shift supervisor indicated that such operations were about to commence and shortly thereafter such actions were performed. As a result, the near intake crib RTDs began to indicate fluctuating and increasing water temperatures above 32°F, after some expected time delay.

Based on the review of the available data, operator logs, and instructions provided in OI-38, the inspector concluded that additional efforts should have been made earlier on the morning of February 5, in efforts to increase the intake crib water temperatures above 32 degrees as specified in OI-38. The lack of aggressiveness in responding to the lowering intake crib water temperatures was of concern based on the extensive evaluations and conclusions documented in the RCE and the associated corrective actions. As documented in RCE 00-007, ice melt components must be operated in a preventative mode because there is only limited capability in the system to increase near intake crib water temperatures and melt the ice once ice formation and blockage has begun. This was the case during the plant trip which occurred in January 2000 event. Although the weather conditions experienced on February 5, were not as severe as during the January 2000 event, the inspector concluded that operators had not taken timely actions to operate the circulating water system in the ice melt mode in order to direct sufficient heated flow to the intake crib.

In response to the inspector's observations, the licensee initiated CR 01-0440 to document inconsistent ice melt operations. The inspector also noted that the licensee had previously performed an effectiveness review of the adequacy of the corrective actions identified in the CR pertaining to intake crib freezing event. These effectiveness reviews are discussed in Section 02.03.d of this report.
