SUBJECT: SALEM NUCLEAR STATION - NRC SPECIAL INSPECTION
REPORT NO. 05000272/2003006; 05000311/2003006

IR 05000272/2003-006; 05000311/2003-006; 06/02/2003 - 08/06/2003; Salem Nuclear Power Station, Unit 1 and Unit 2; Special Inspection of Leak In Unit 1 Spent Fuel Storage Pool.

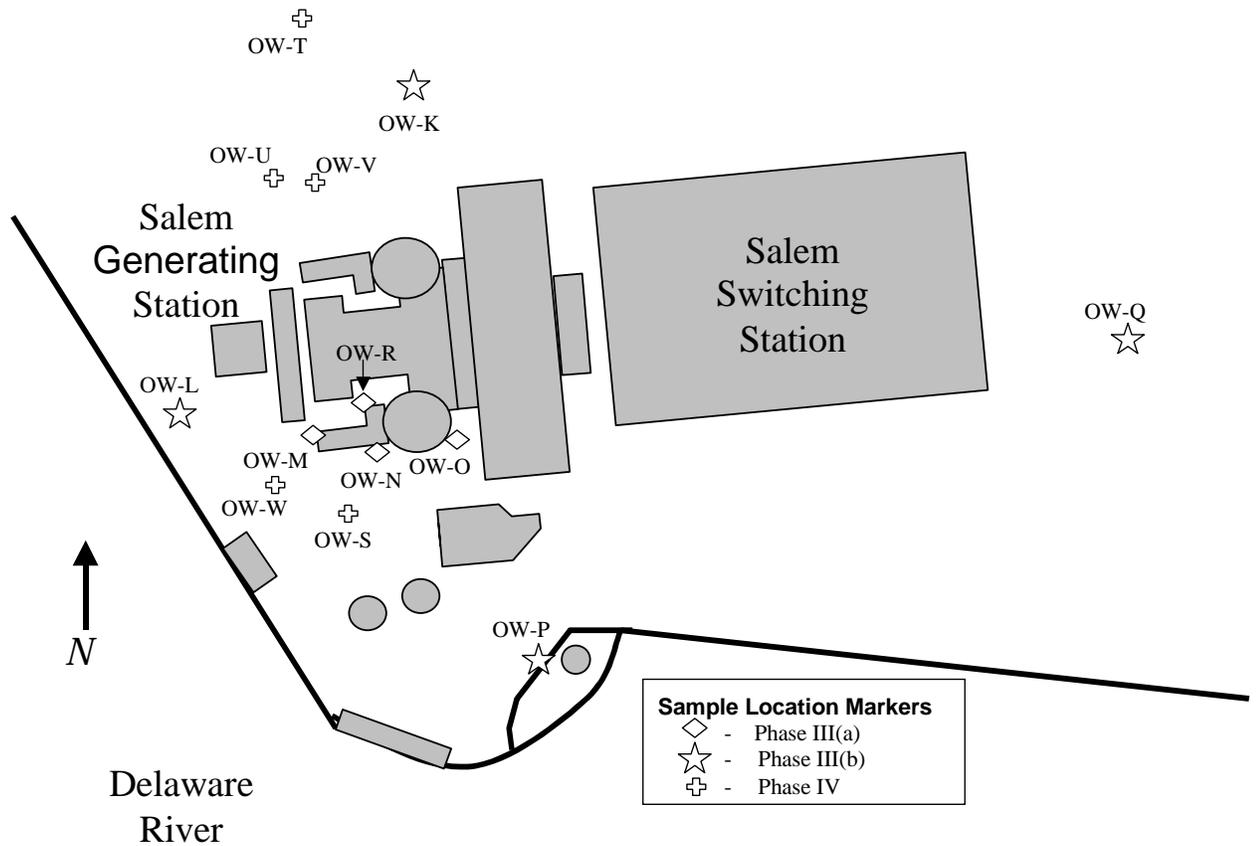
**Attachment 3
Figure 1
Sample Locations**

Figure 1 depicts observation well (OW) sample locations for ground water sampling. See Table 1 for results. Locations R, M, N, O are located inside the coffer dam. (Figure provided by PSEG)
