**SAN ONOFRE:
FAR OUTSIDE THE NORM**

**February 7, 2013
Dan Hirsch, Lecturer,
UC Santa Cruz;
President,
Committee to Bridge the Gap**

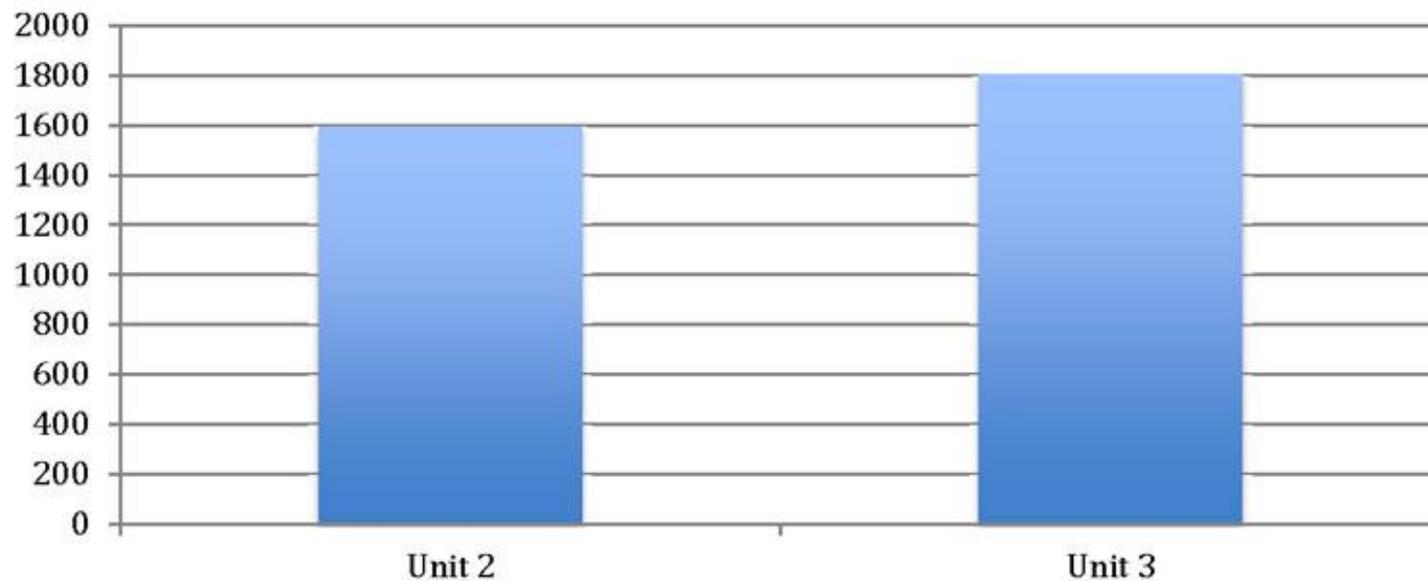
Damaged Steam Generator Tubes at San Onofre

FIRST: “The wear in Unit 2 is far less extensive than the wear in Unit 3” and “Unit 3 had more than 300 tubes with the unexpected tube-to-tube wear; Unit 2 only had two tubes exhibiting minor tube-to-tube wear.”

**SAN ONOFRE UNIT 2
HAD 1595 DAMAGED
TUBES, APPROXIMATELY
400 TIMES THE MEDIAN.
SAN ONOFRE UNIT 3
HAD 1806.**

It would be unwise to permit restart of San Onofre Unit 2 with its crippled steam generators that need repair or replacement without in fact repairing or replacing them.

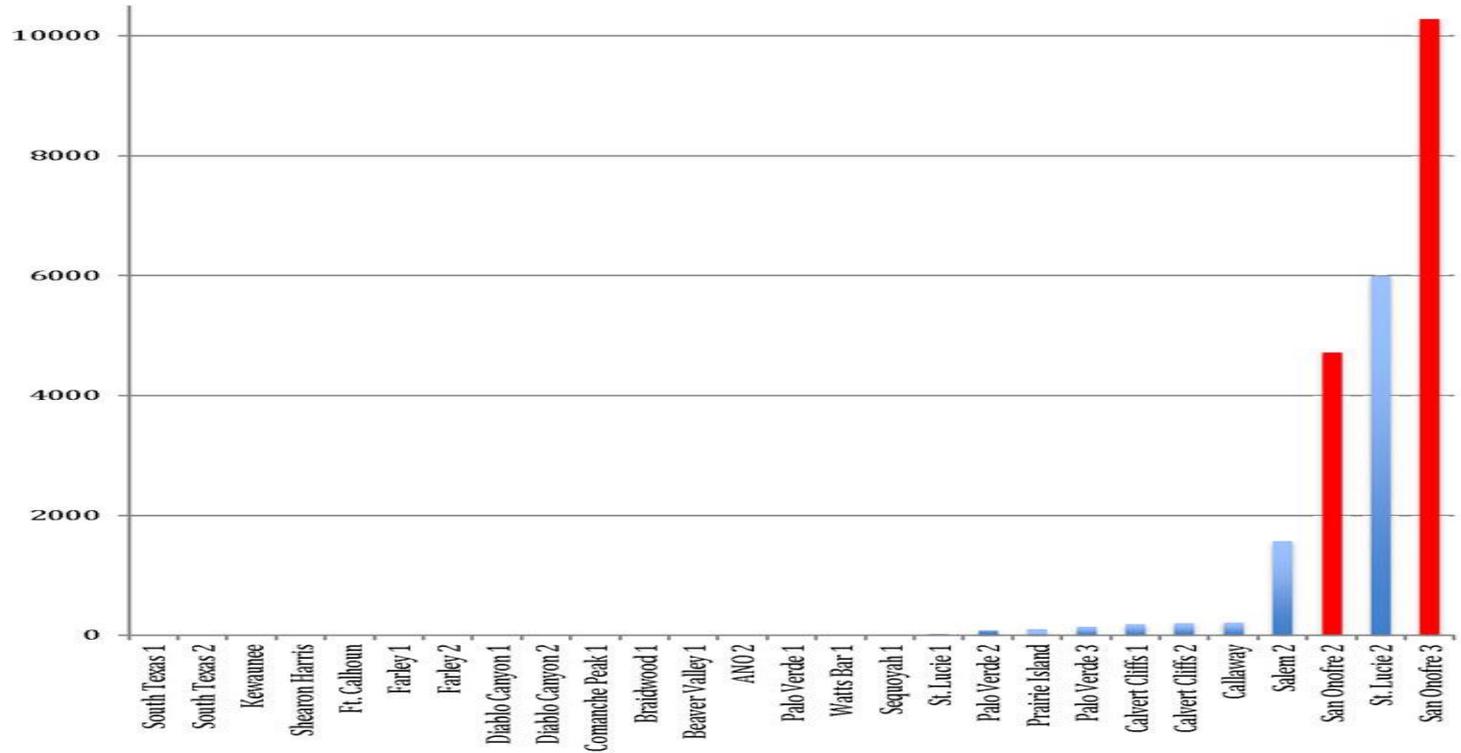
Number of Indications of Wear on Steam Generator Tubes

**THE MEDIAN NUMBER OF WEAR INDICATIONS ON STEAM GENERATOR TUBES AFTER ONE CYCLE OF OPERATION IS—
FOUR.**

**SAN ONOFRE UNIT 2 HAD
4721, GREATER THAN A
THOUSAND TIMES MORE. SAN
ONOFRE UNIT 3 HAD 10,284.**

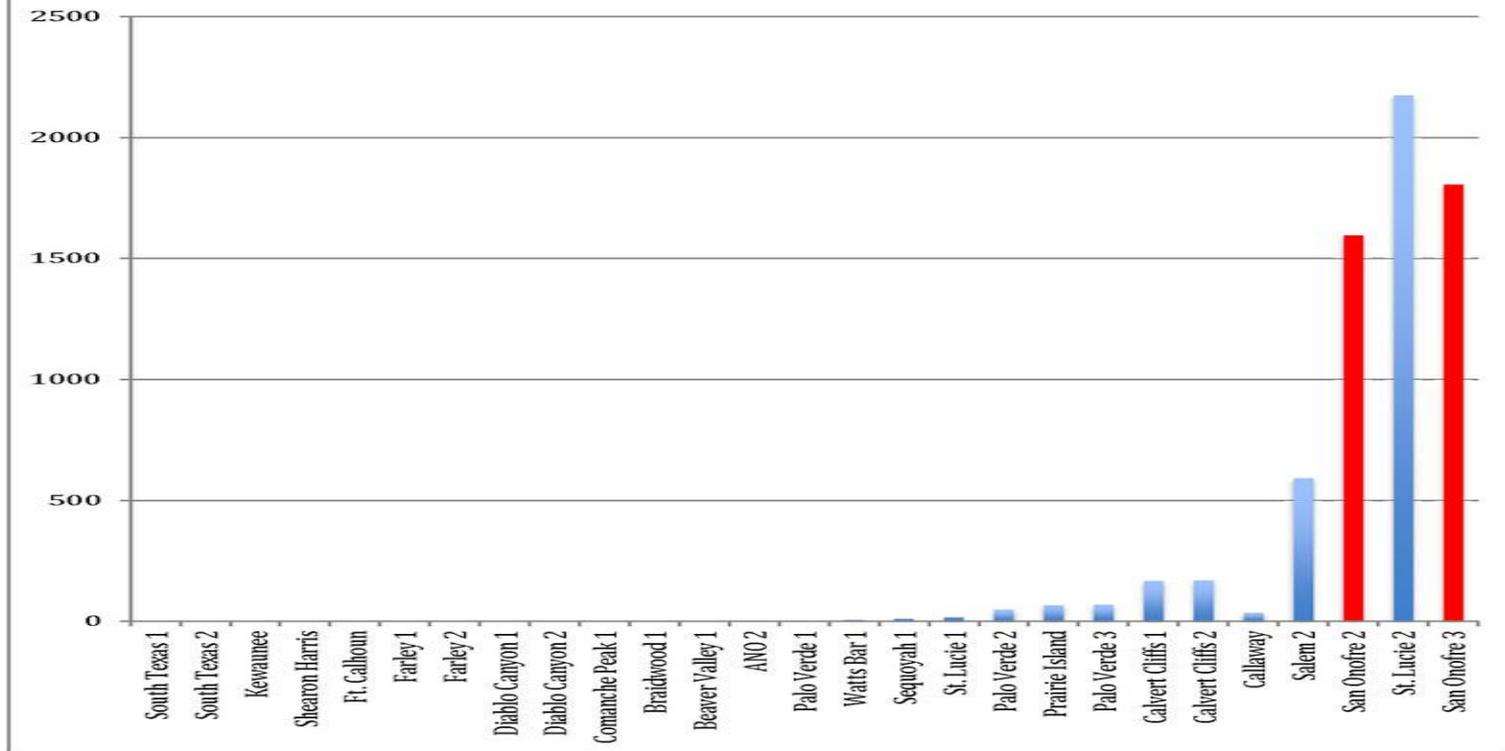
Number of Damaged Steam Generator Tubes

**THE MEDIAN NUMBER OF STEAM
GENERATOR TUBES SHOWING
WEAR AFTER ONE CYCLE OF
OPERATION NATIONALLY IS—
FOUR.**

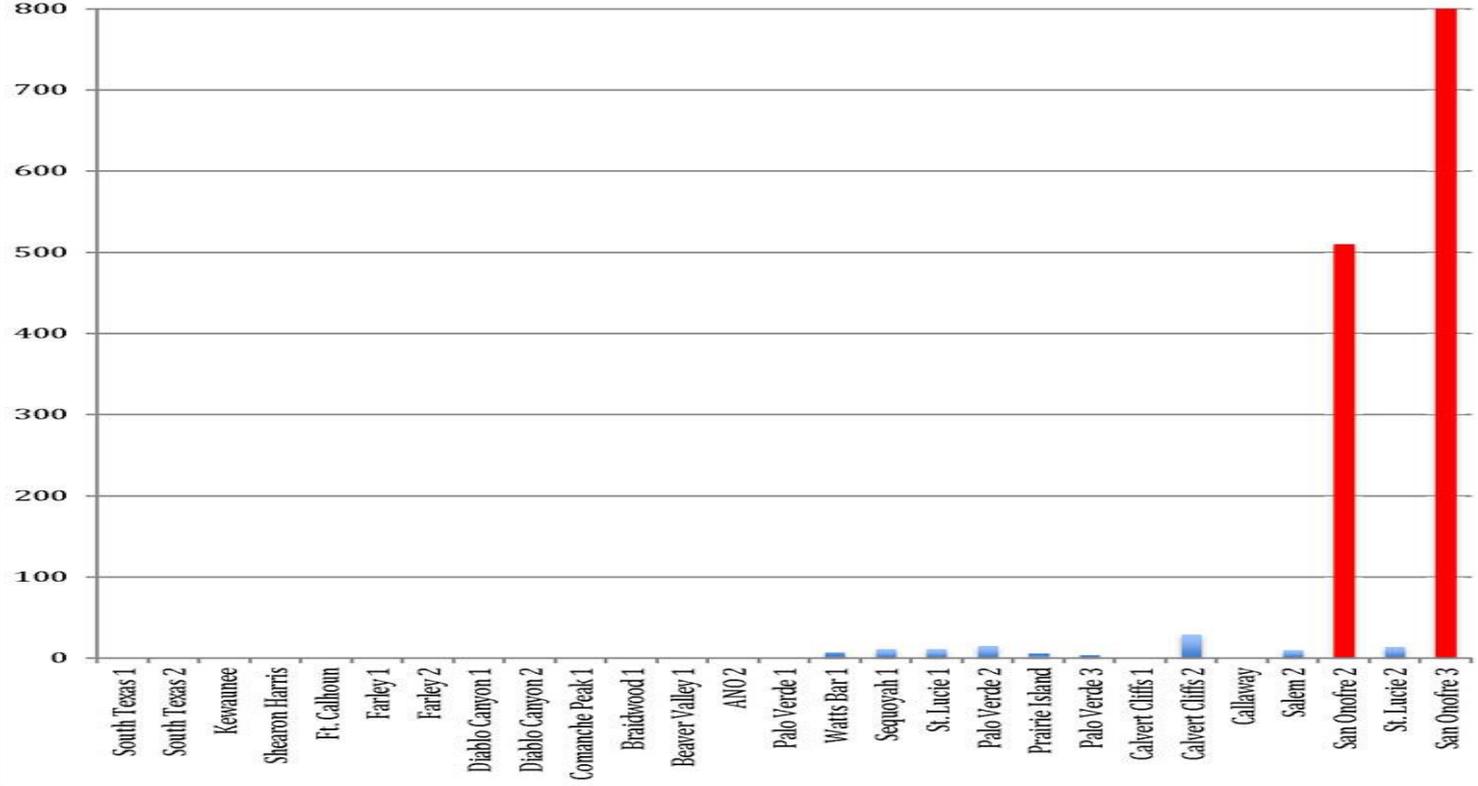
Number of Steam Generator Tubes Plugged

**THE MEDIAN NUMBER OF
STEAM GENERATOR TUBES
THAT WERE PLUGGED AFTER
ONE CYCLE OF OPERATION IS—
ZERO.**

**SAN ONOFRE UNIT 2 HAD 510;
UNIT 3 HAD 807.**
