# Davis-Besse Reactor Pressure Vessel Head Degradation

Overview, Lessons Learned, and NRC Actions Based on Lessons Learned

# Davis-Besse Reactor Pressure Vessel Head Degradation: Overview

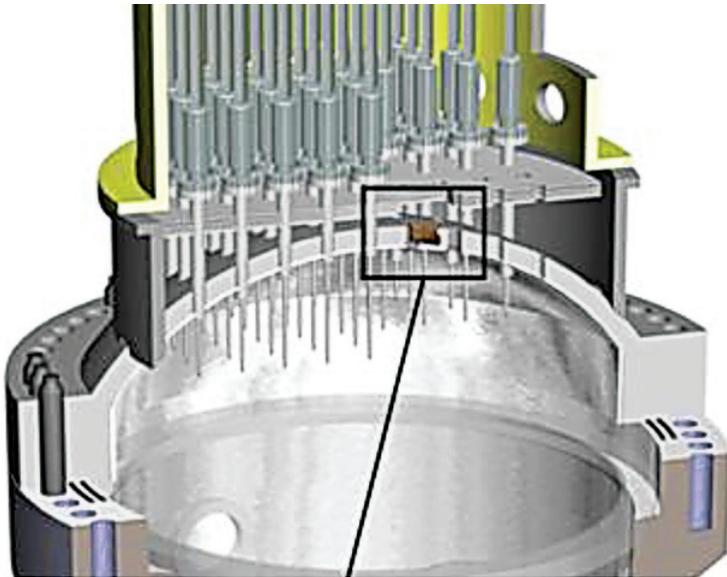
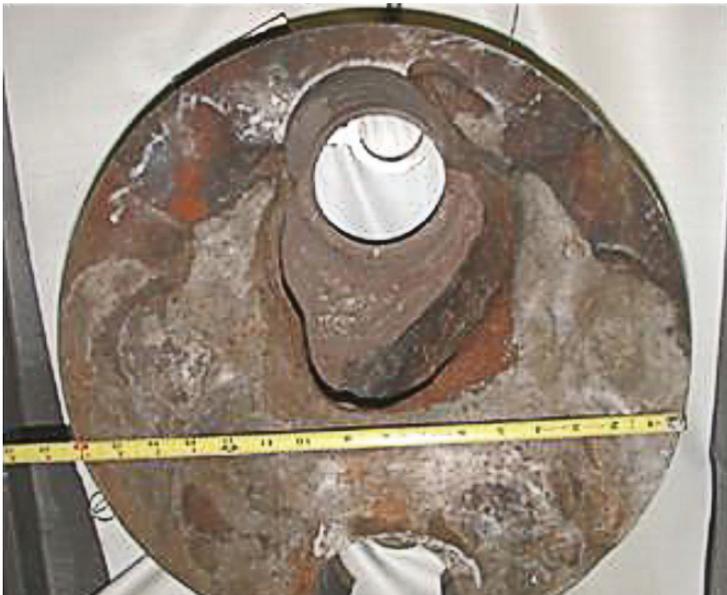
The licensee investigated the condition of the RPV head surrounding CRDM nozzle 3. The investigation included removing the CRDM nozzle and removing boric acid deposits from the top of the RPV head. Upon completing the boric acid removal on March 7, 2002, the licensee conducted a visual examination of the area and identified a large cavity in the RPV head on the downhill side of CRDM nozzle 3 (**Figure 2**). The corrosion was caused by borated water that leaked from the reactor coolant system onto the vessel head (**Figures 3 and 4**) through cracks in the nozzle and the weld that attached nozzle 3 to the RPV head (**Figures 5 and 6**). The remaining thickness of the RPV head in the wastage area was found to be approximately 3/8 inch. This thickness consisted of the thickness of the stainless steel cladding on the inside surface of the RPV head, which is nominally 3/8 inch thick. The stainless steel cladding is resistant to corrosion by boric acid, but it is not intended to provide structural integrity to the vessel. Failure of the stainless steel cladding would have resulted in a loss-of-coolant accident (LOCA). The LOCA would have resulted in actuation of the plant's emergency systems.

Figure 2. Region of the vessel head depicted by the model and photo of the cavity after it was removed from the vessel head

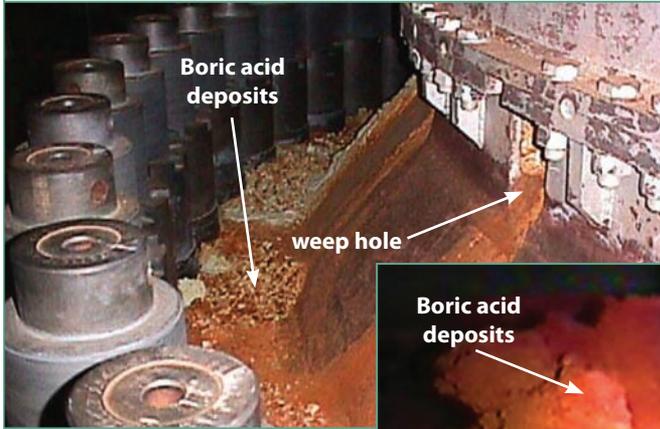
Figure 3a. RPV head flange area showing significant amounts of boric acid deposits (photo taken during the 2000 refueling outage at DBNPS)

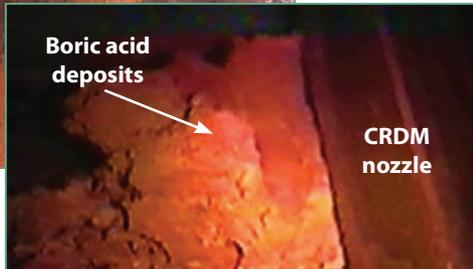
Figure 3b. Boric acid deposits accumulating near a CRDM nozzle (still photo of video taken during the 2000 refueling outage at DBNPS)

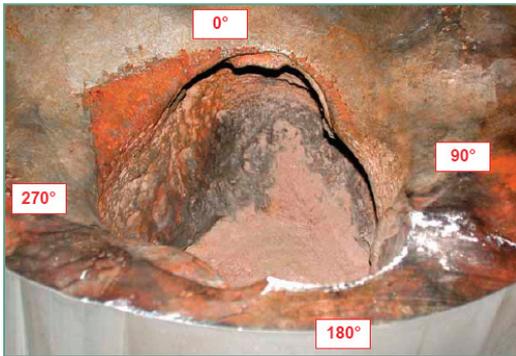
Figure 4a. Close-up view of the cavity

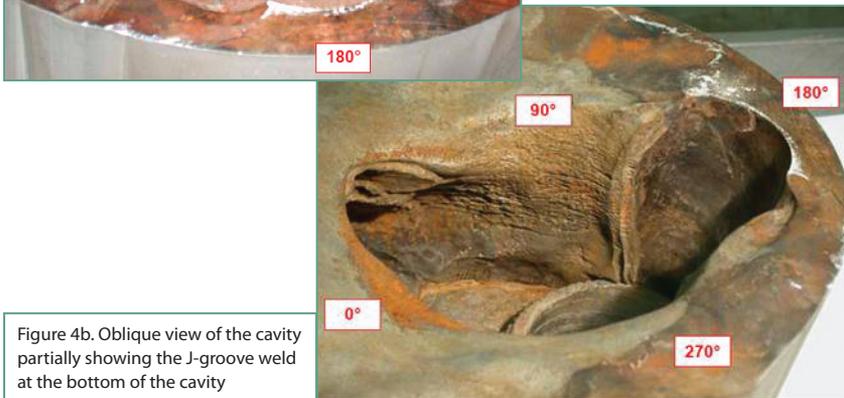
Figure 4b. Oblique view of the cavity partially showing the J-groove weld at the bottom of the cavity

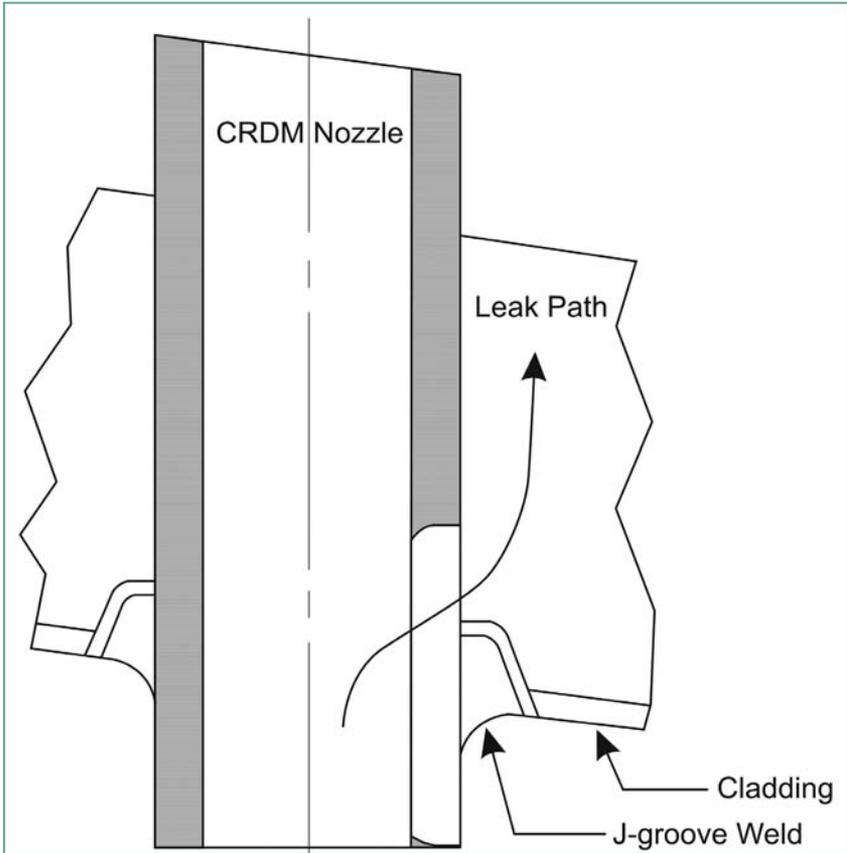
Figure 5. Schematic of the nozzle penetration cross section showing the leak path of the reactor coolant

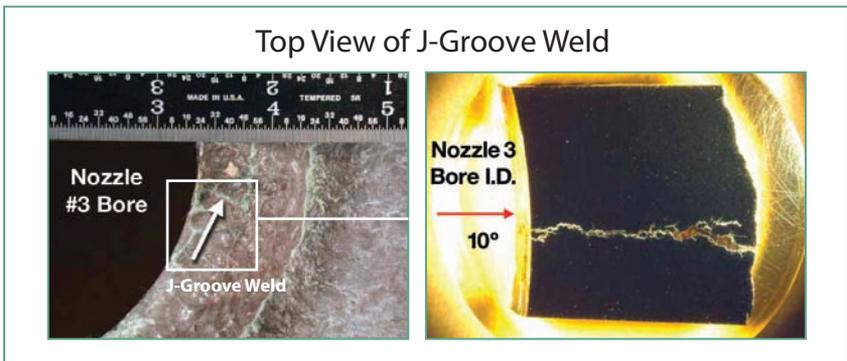
Figure 6. Top photo: Top view of the J-groove weld with an arrow pointing to a crack  
 Top-right photo: Polished cross section of the area shown in the top photo showing the through-wall crack in the J-groove weld
