SUBJECT: OYSTER CREEK GENERATING STATION - NRC INSPECTION REPORT
05000219/2009008 (UNDERGROUND PIPING LEAK)

IR 05000219/2009008; 04/15/09 - 08/14/2009; Oyster Creek Generating Station; NRC Inspection Report (Underground Piping Leak).

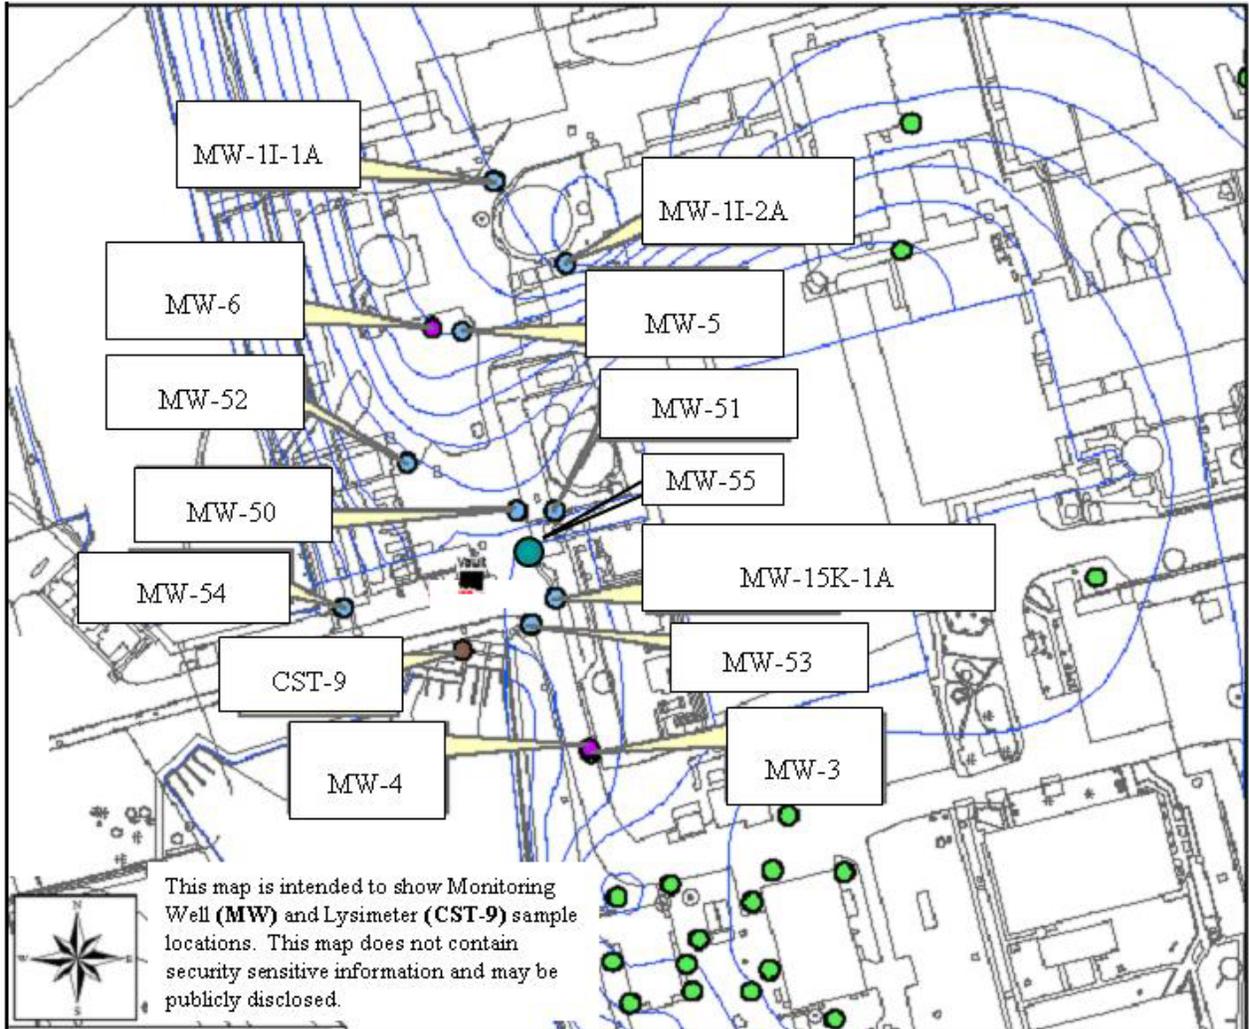
Figure 1

Oyster Creek Well Locations
Associated with Buried Pipe Leak
