SUBJECT: Power Shield Tap Block Solder Joints
10CFR Part 21 Report

NOTIFICATION BY: ABB Inc.
Allentown site
7036 Snowdrift Road
Allentown, PA 18106
Dennis Haring
Quality Assurance

Power Shield Tap Block Solder Joints
10CFR Part 21 Report
Attachment A
November 20, 2002

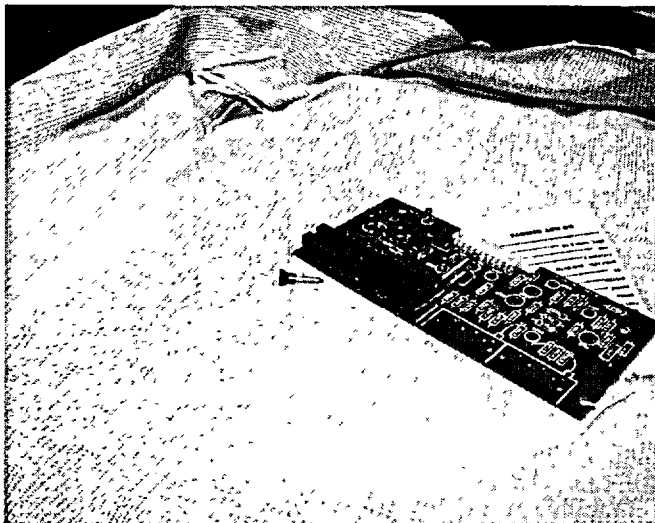
Photo #1 shows a Short Time board with the red tap blocks and a tap block pin removed.

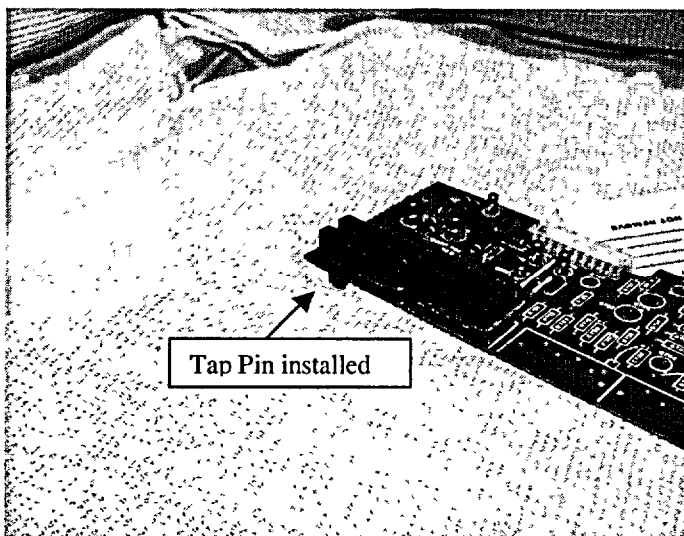
Photo #2 shows a Short Time board with red tap blocks and a tap block pin inserted.

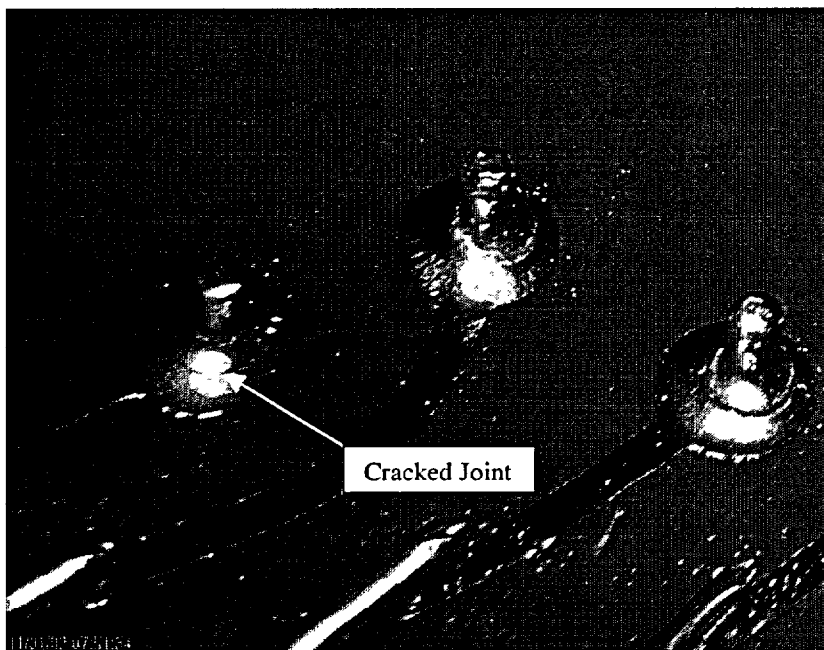
On June 25, 2002 the Virgil C. Summer Nuclear Station reported that they found broken solder joints (crack in solder joint) on some pins on the tap blocks of ABB Inc.'s Power Shield trip devices in the 30000 serial number range. Two Power Shield printed circuit assemblies were sent to ABB Inc. for review. The cracked solder connections look similar to the cracked solder connections found on the connectors reported via Part 21 on November 20th, 1995. The most likely cause of the cracked solder joints is from normal mechanical stress on the tap block pins.

Photo #3 shows cracked solder connections on three tap block pins (underneath tap block).

1. Inspect the solder connections on the tap block pins on the Short-Time / Ground And Long-Time / Inst printed circuit assemblies. Martin Marietta, IPC 610-A-610 Class 3 or the photographs provided by ABB should be used when inspecting these solder connections. All cracked or defective solder connections found, should be repaired by qualified personnel familiar with electronic circuit board repair. ABB Inc. recommends the following method be used:
 - 1a. The defective solder connection must be completely desoldered by using a good quality desoldering tool or solder wick. Care must be used when desoldering the joint as excessive heat will cause the printed circuit pad to

- 1b. All flux residue and poly spray must be removed from the connection area. ABB Inc. recommends that Micro Care MCC Pro Clean or a suitable substitute be used.
- 1c. A tap pin **must** be connected in to the associated tap block position when resoldering the connection. A 60/40 rosin core solder should be used. The soldering iron temperature should be 700 to 800 degrees Fahrenheit. Upon completion, the soldered connection should be cleaned of all flux residue. Personnel resoldering connections should have electronic repair and soldering skills and follow established ESD practices.

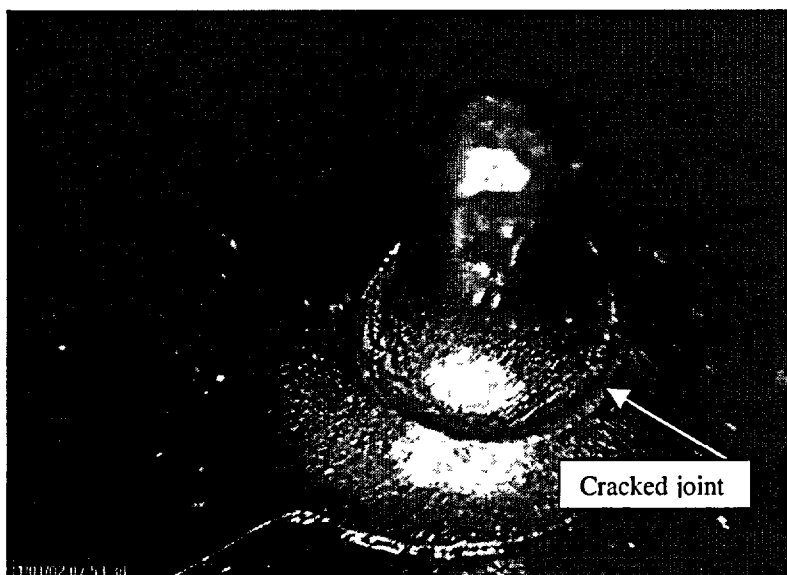
Photo #4 shows a tap block pin solder joint with a 360 degree crack.
