SUBJECT: Potential Manufacturing Problem With Certain Limit Switch Assemblies Used in ASCO General Controls Hydramotor[®] Actuators.

**POTENTIAL MANUFACTURING PROBLEMS WITH
LIMIT SWITCH ASSEMBLIES USED IN ASCO GENERAL CONTROLS
HYDRAMOTOR® ACTUATORS**

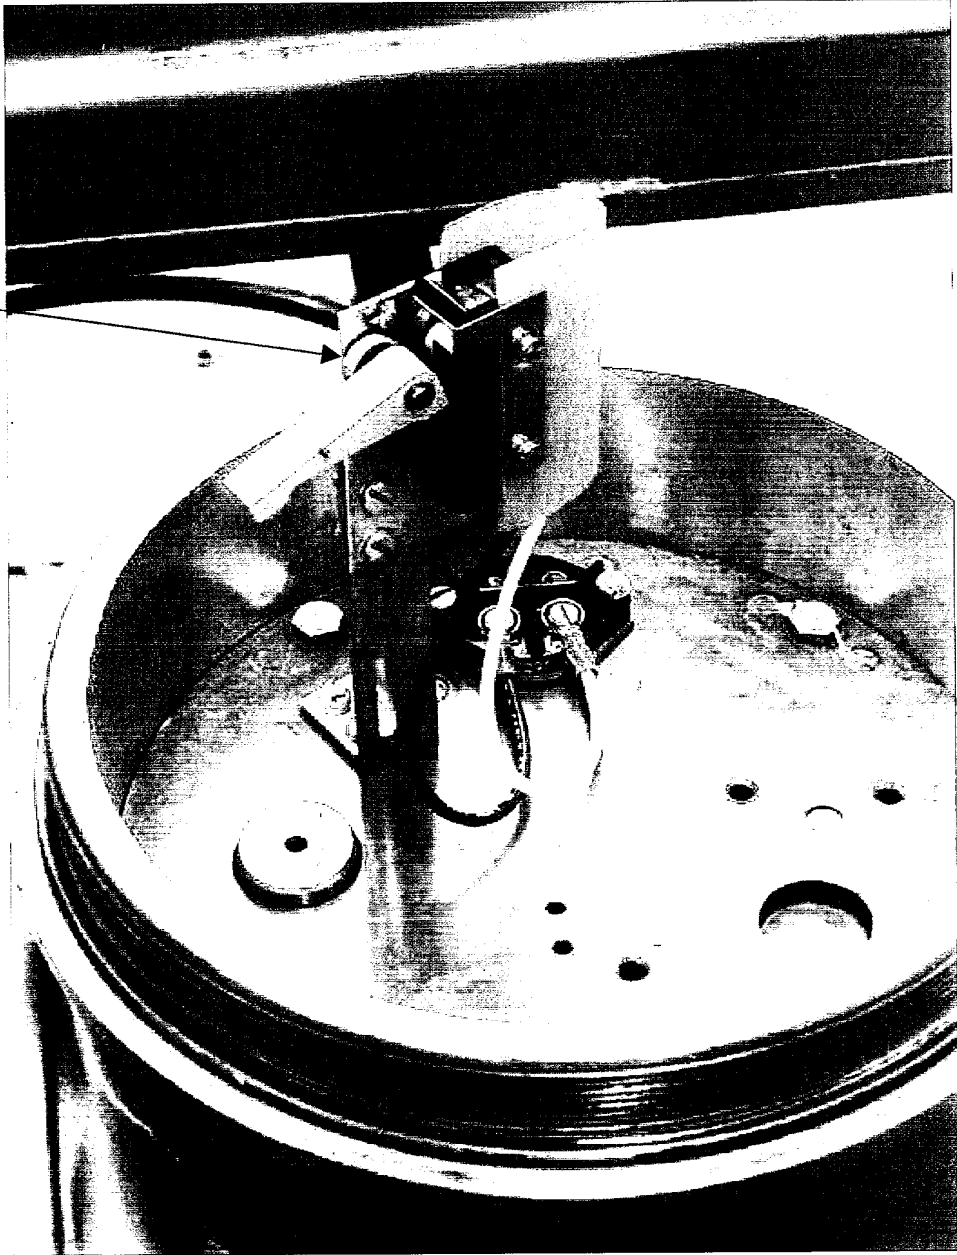
TYPICAL INSTALLATION
NH95 LIMIT SWITCH ASSEMBLY

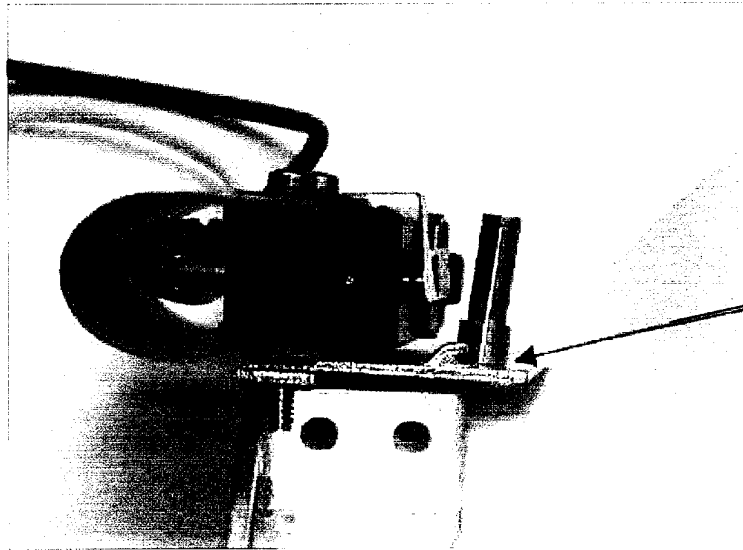
Analysis of the returned Limit Switch Assembly (see attachment 1) revealed that the shaft on which the position sensing lever operates was not secured tightly to the plate, causing wobble of the shaft. This wobble may result in the rotation of the lever past its actuation point, which would leave the switch contacts in the normally open (N.O.) position. This condition will result in the failure of the actuator piston to retract when the Hydramotor® is powered. The shaft is staked to the plate assembly. Manufacturing instructions for this assembly defines the maximum pressure to be applied for the staking press, but no minimum value. This led to variation of the staking process, which resulted in inconsistent and incomplete attachment of the shaft to the plate. (See attachment 2). In addition to the field return, Asco has found several limit switch assemblies in our inventory with this condition.

VIEW SHOWING ANGULATION CONDITION
OF FAILED SHAFT JOINT

ASCO will notify all purchasers of affected product of the potential problem. If the affected product is not in service, ASCO will offer to rework it at our factory at no charge. If the product is in service, ASCO will offer retrofit kits at no charge with complete instructions for installation of new limit switch assemblies. The method of forming this staked joint is being revised to ensure complete and consistent assembly of the shaft to the plate. In addition, the manufacturing instructions are being revised to fully define the parameters of this process as well as the testing necessary to confirm the reliability of the shaft-to-plate joining process.

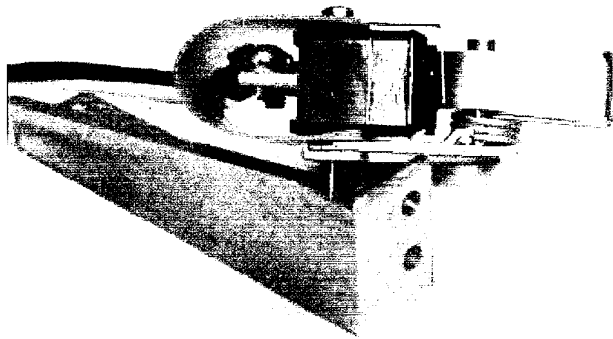
VIEW SHOWING LIMIT SWITCH ASSEMBLY
WITH PROPERLY SWAGED SHAFT
