To:		From:	Kevin Armstrong
Company:	Nuclear Regulatory Commission	Date & Time:	1-25-02
Fax Number:	301-816-5151	Pages:	10
Subject:	U02O3FBBR-**

The attached analysis indicates a potential 10 CFR Part 21 reportable problem with Automatic Valve part number U02FFBBR-**

AUTOMATIC VALVE TITLE: CORRECTIVE ACTION SUBJ: CORRECTIVE ACTION	NUMBER: D7174-003 LOCN: I:\WORD\DOCUMENT\07174003.DOC TYPE: FORM	PAGE 1 OF 9 DATE: 10-21-1999 REV: F-CN8020
--	--	--

10 CFR Part 21 Report Required: YES - for
U0203FBBR valves when inlet pressure is @ port 1

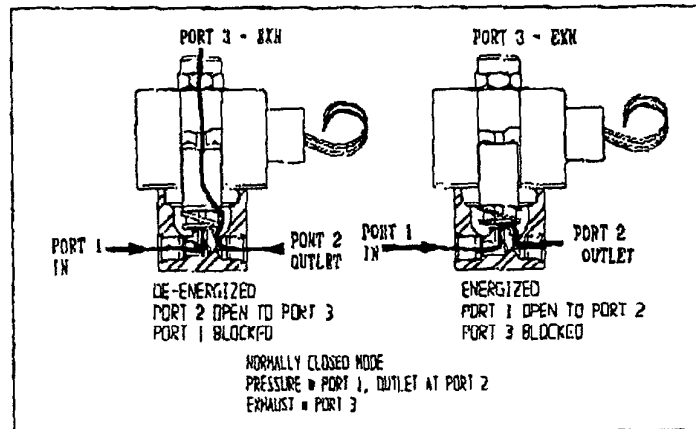
Figure 1A - Normally Closed Mode

1. A faulty valve will leak out of port 3 when the valve is used in its normally closed mode as shown in Figure 1A or leak out of port 1 when the valve is used in its normally open mode as shown in Figure 1B.

5. There is a concern that U0203FBBR-** valves used in the normally closed mode will not return to their de-actuated position if the valve has been in its de-energized position for a sufficient amount of time for the valve and the internal top seal to cool down. If the valve is energized then is de-energized, within a period of approximately 60 minutes with 125 psig at port 1, or 15 minutes with 80 psig at port 1 there is a high probability that the valve will not return to its de-energized condition.

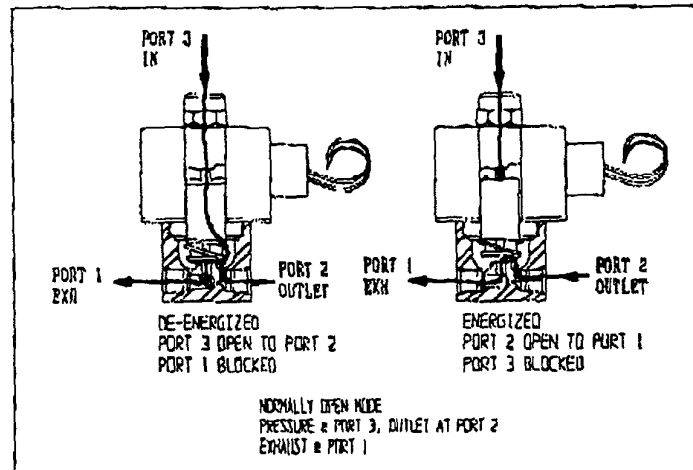
Figure 1B - Normally Open Mode

2. There is no concern that U0203FBBR-** valves used in the normally open mode (pressure at port 3) will return to their de-actuated position (port 3 open to port 2 and port 1 blocked) when the solenoid is de-energized. In this mode both the internal spring, the external spring, and inlet pressure at port 1 act to return the plunger to its normal de-actuated position.

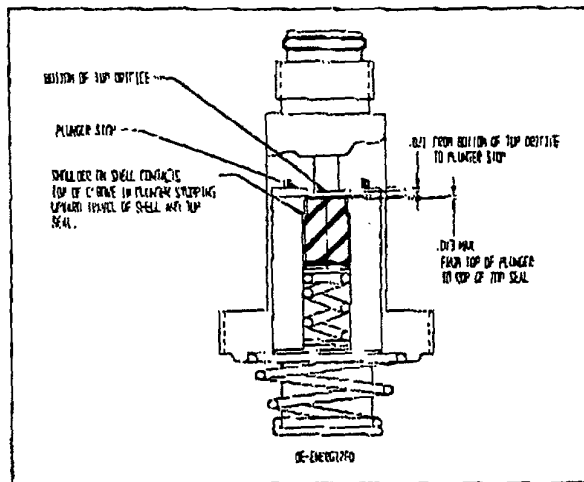
Figure 3A - Plunger in De-Energized Position

When the valve is in its de-energized state, upward travel of the top seal and its containment shell is stopped when the shoulder of the shell contacts the top of the counter-bore in the plunger as shown in Figure 3A. In this de-energized position, the top seal is within a maximum distance of .013" from the top surface of the plunger. When the valve is energized, the top of the top seal first contacts the bottom of the top orifice as shown in Figure 3B. At this point further upward motion of the top seal and shell stops. The plunger continues its upward travel until the top of the plunger contacts the plunger stop as shown in Figure 3C. Because upward motion of the top seal and shell stops when the top seal contacts the top orifice, the additional upward motion of the plunger compresses the internal spring by the distance the plunger travels after the seal contacts the orifice - approximately .008. (Refer to Figure 4 for a detailed view showing the shell and plunger in the energized position.)

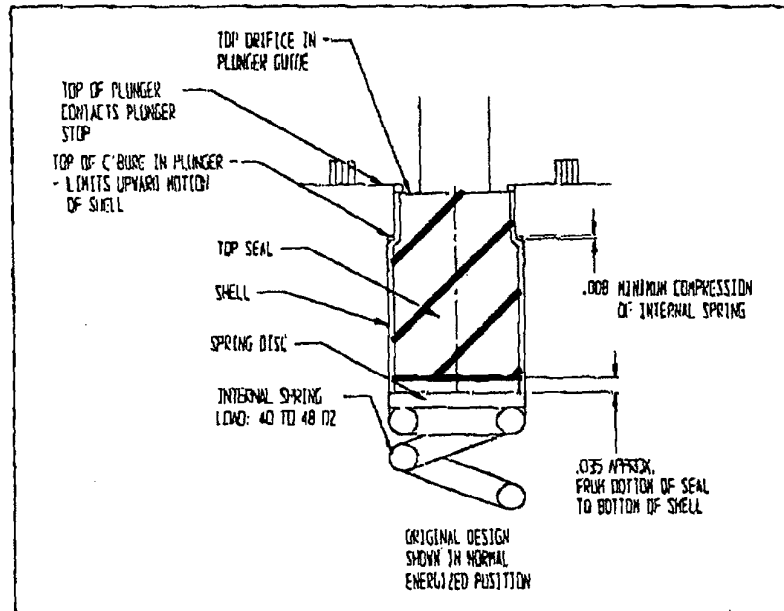
Figure 4 – Enlarged view of top seal and shell in the energized position.

1. The bottom of the containment shell is not flush with the bottom of the top seal as shown in Figure 4. Consequently, the spring force generated by the internal spring, and transmitted through the disk, acts only on the bottom of the shell. Because the top of the seal is in contact with the top orifice it cannot move further upwards. The force acting to counter the internal spring force exerted on the bottom of the shell to keep the shell in place relative to the top seal is the friction force between the shell and the seal as shown in Figure 6.

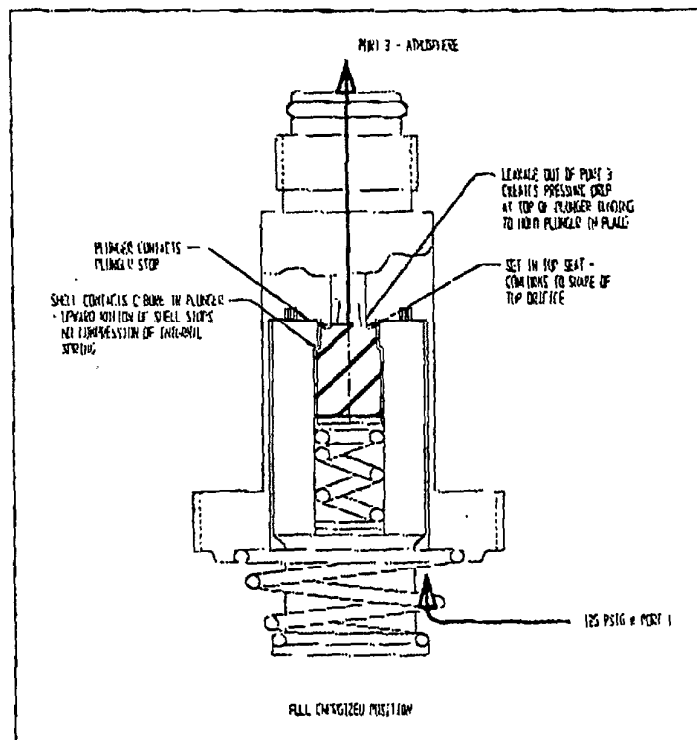
Figure 5 – Pressure Drop

When this happens, the top seal is touching the top orifice but is not compressing the internal spring sufficiently to create a good seal and leakage occurs out of port 3. As the leak intensifies, it creates a pressure drop at the top of the plunger as shown in Figure 5. The greater the leak, the greater the pressure drop. At leak rates less than 60 SCFH, all plungers returned.
