Report No. 10CFR21-0083
Rev. 0: July 31, 2002

10CFR21 REPORTING OF DEFECTS AND NON-COMPLIANCE

COMPONENT: Pistons used in EMD 645 series engines

SYSTEM: EMD diesel generators

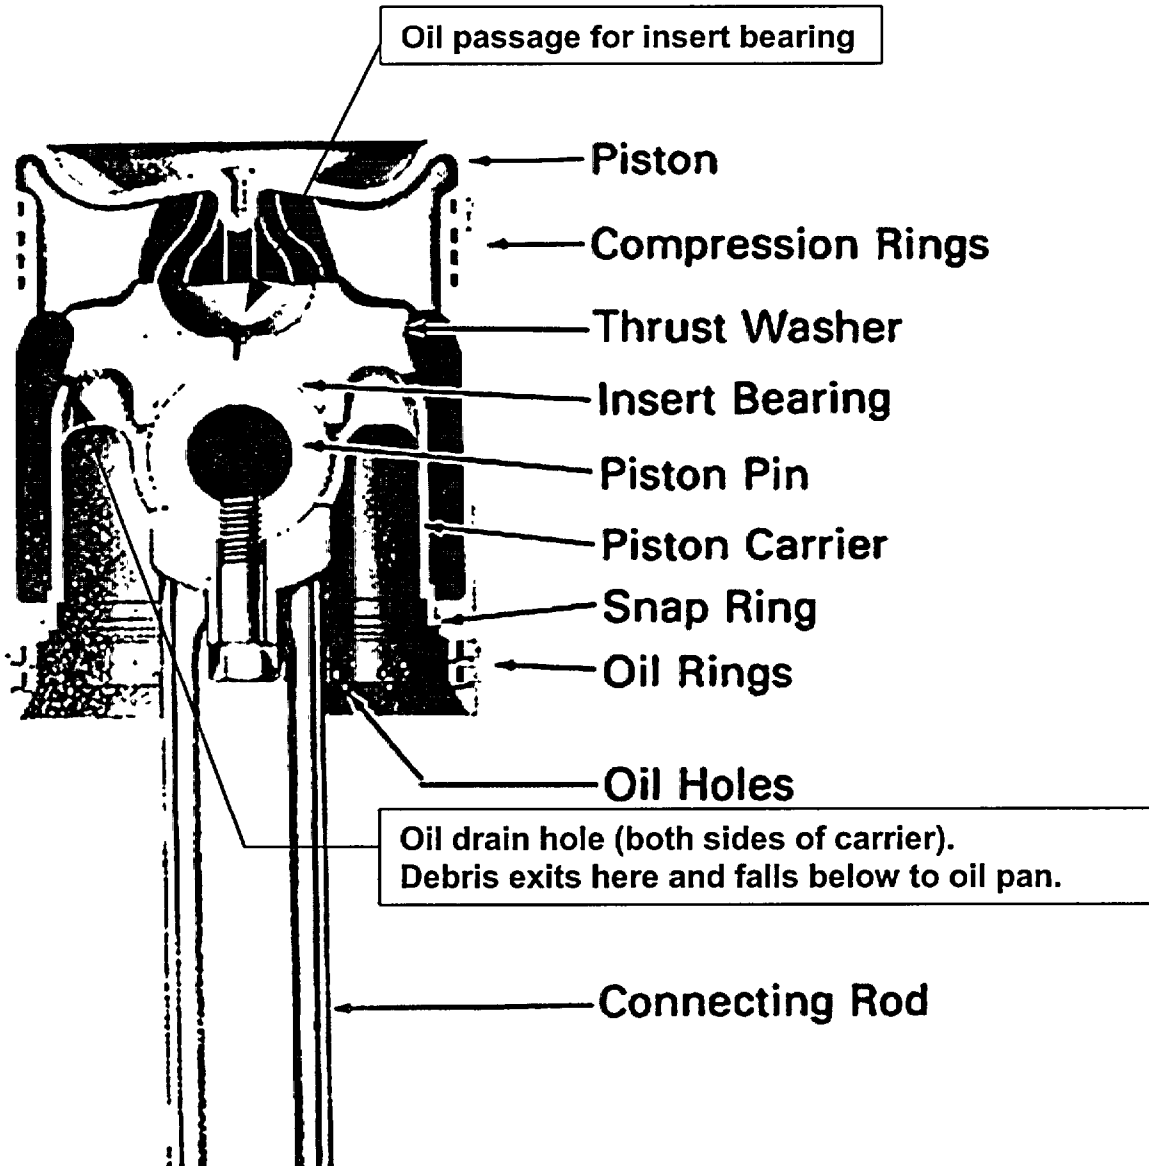
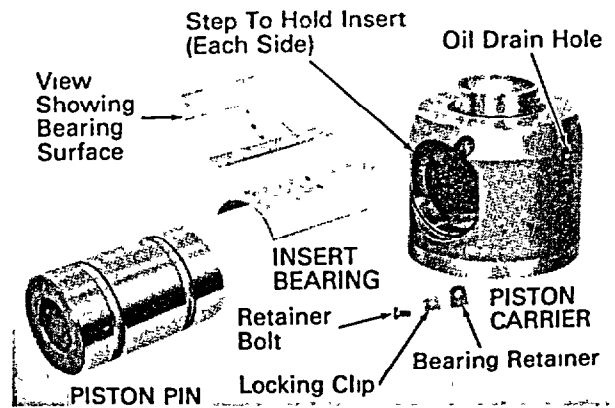
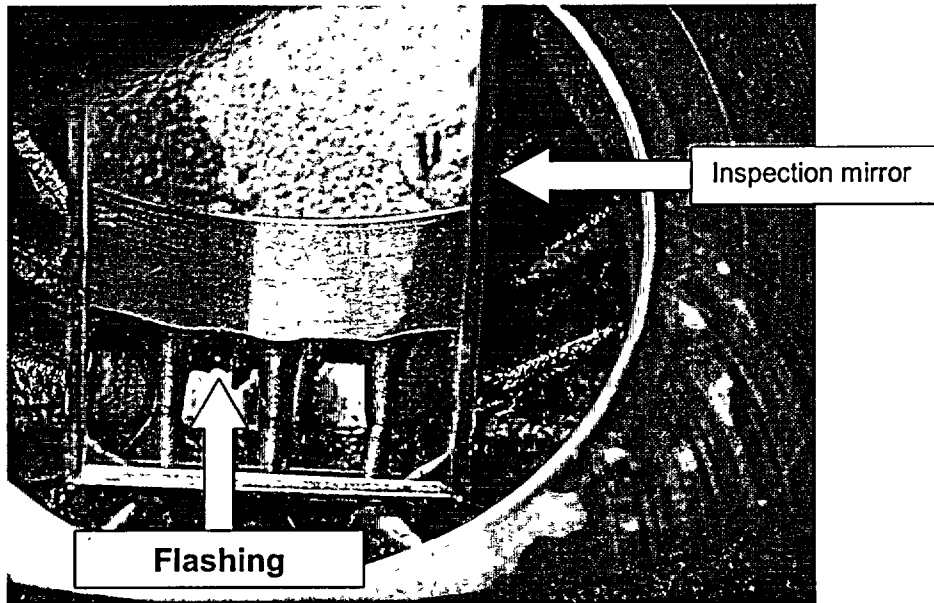
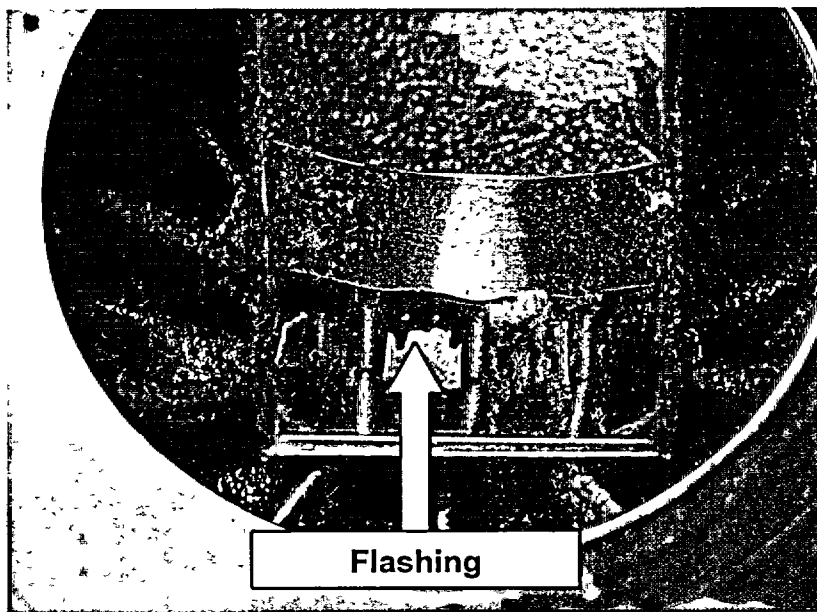
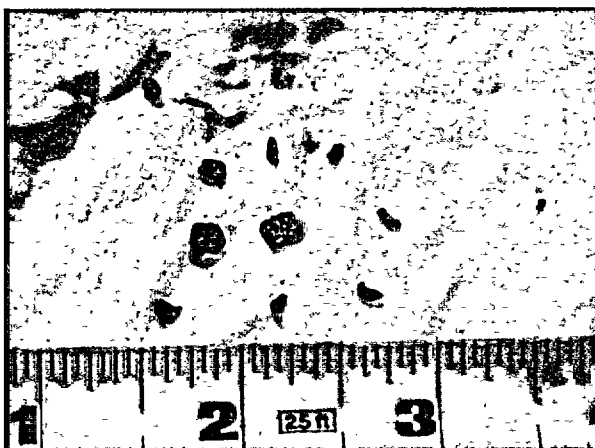
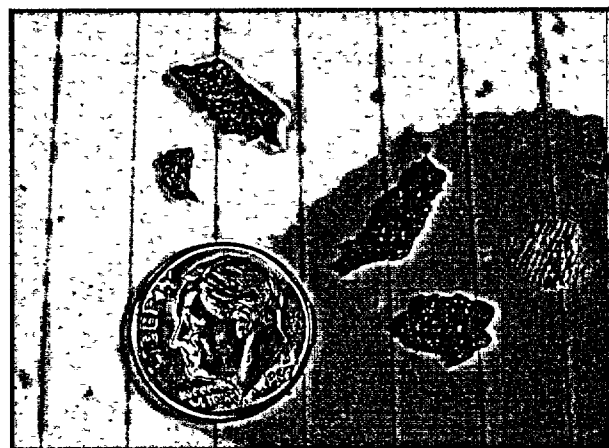
Engine Systems Inc. (ESI) has concluded our investigation of a condition reported with EMD pistons applicable to EMD 645 engines. The condition identifies casting flash material on the underside of the piston crown between the gussets (crown windows). The flash is a product of the piston manufacturing process when the piston cores are joined together. Internal parts of the piston are lubricated and cooled by the piston cooling oil. Cooling oil is directed through a drilled passage in the piston carrier and circulates about the underside of the piston crown area. Some of the oil lubricates the insert bearing and piston pin through an oil passage in the carrier and the remaining oil drains through two holes in the carrier located at the taper (refer to illustration on the next page). Any loose flash material that may become dislodged is carried by the oil through the piston carrier drain holes and settles at the bottom of the oil pan. The settled fragments are not of concern. There exists a concern, however, that a loose fragment could block the insert bearing oil passage and thus cause bearing damage. EMD has reported that no failures have been attributed to this condition (nuclear or commercial applications) to date.

- Point Beach nuclear plant originally reported such a condition in January 2002. During maintenance activity when engine lube oil was removed, small metallic fragments (1/4" to 1/2") were recovered from the oil pan. Some of the fragments were located directly below cylinders 9 & 19. Subsequent inspection of the cylinder 9 & 19 power assemblies revealed flashing on the piston underside area near the piston crown webbing that broke away when touched by hand. The remaining 18 power assemblies were then removed for evaluation. Insert bearing inspections revealed no abnormal conditions relating to the metallic fragments. The pistons were supplied in 1999 as part of 20 complete power assemblies. 14 of the 20 assemblies had some degree of flash material with 10 of those exhibiting loose pieces that could be flaked off using a small hand tool. All pistons were identified with 1999 serial numbers. The flash condition was thought to be limited to this batch of pistons.

- During inspection of an EMD cylinder power assembly for Surry Nuclear Station, piston flashing was again noted under the piston crown. The power assembly was sent to ESI for failure analysis because of a coolant leak. The piston flashing was not related to the coolant leak issue. The Surry failure analysis was completed in May 2002. The piston was identified with a 1999 serial number. Only a partial power assembly was supplied for analysis and therefore the insert bearing was not available for evaluation at ESI.

- Recently (July 2002), Nine Mile Point reported metallic fragments in the engine oil pan. The fragments were located below 6 cylinders and resemble those found in the Point Beach engine. The pistons are identified with 1997 and 1998 serial numbers.

Because the potential exists that lubrication of the insert bearing could be impacted by loose piston flashing material, all users of EMD 645 engines are being notified.

1. **Monitor lube oil for trend of increasing silver levels.** Review previous lube oil analyses and perform a lube oil analysis after each surveillance run. If silver concentration increases 0.2 ppm or greater between runs or if silver concentration is greater than 1.0 ppm, perform lead wire readings. Perform insert bearing inspections for any cylinders with unacceptable lead wire readings. Piston underside crown inspection (see below) shall be performed as soon as possible if any cylinder has insert bearing damage that is attributed to flash material.

2. **Check oil pan for metallic fragments at earliest convenience** (see note below).
 - a. **If metallic fragments are discovered**, perform the following:

- i. **Continue monitoring lube oil for any trend of increasing silver levels** (see above).
 - ii. **Perform piston crown inspections during next refuel outage.** Use an inspection mirror or boroscope to completely examine the underside of the piston crown. Flashing material that is tightly adhered and does not easily break off by exerting force from a finger or a hand held tool is considered acceptable.

- b. **If metallic fragments are not discovered**, perform the following:
 - i. **Continue monitoring lube oil for any trend of increasing silver levels** (see above).
