Subject: 10CFR21 Reporting of Defects and Non-Compliance -
Engine Systems, Inc. Report No. 10CFR21-0085, Rev. 0

EMD Engine-Driven Water Pump Assemblies

Report No. 10CFR21-0085
Rev. 0: October 04, 2002

COMPONENT: Engine Water Pumps
EMD P/N 40089540, 40089541, 40089881, 40089882

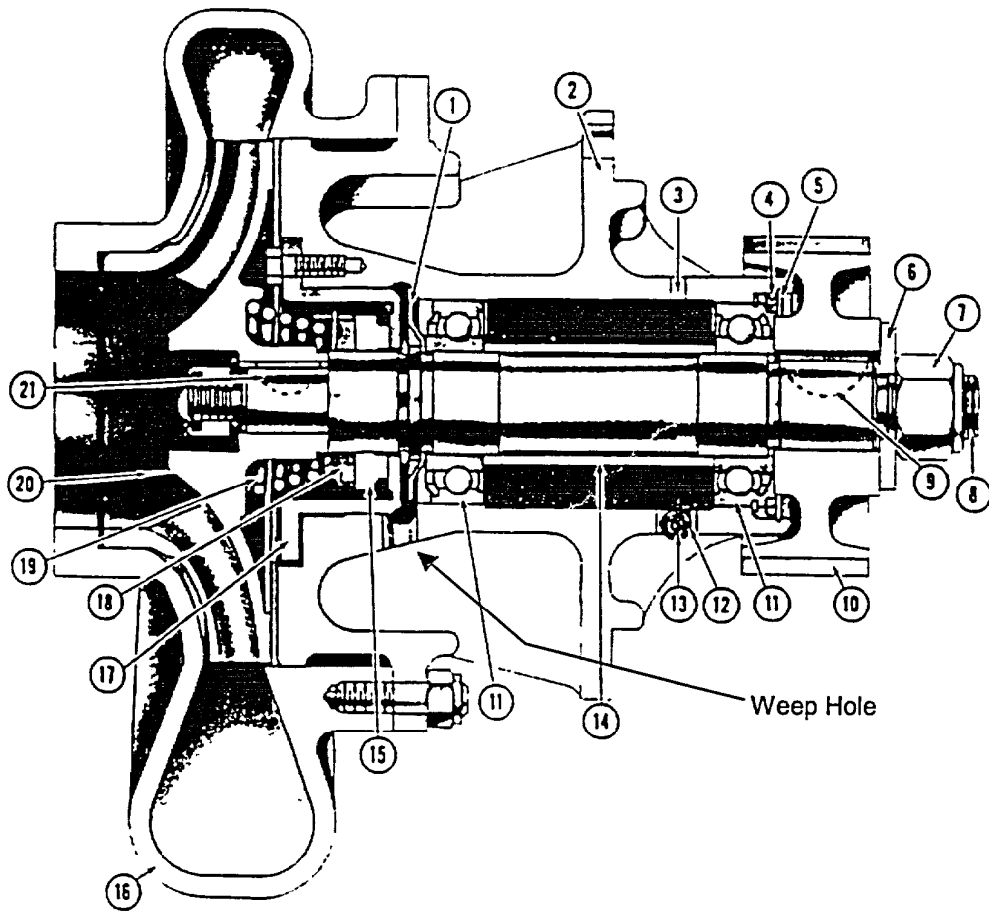
FIGURE 1
Water Pump Cross Section

A cross-sectional view of the EMD standard water pump is shown in Figure 1 of this report.

The water pump impeller and shaft assembly is supported in the housing by two roller bearing assemblies, item 11. The bearings are lubricated by splashed engine lube oil entering through the inlet hole, item 3, located in the top of the drive end of the support housing. Oil exits the bearing cavity through the oil outlet hole, item 12, located in the bottom of the drive end of the support housing. The cooling water is sealed through a mechanical seal assembly located at the impeller end of the shaft assembly, items 15, 17, 18 & 19. The cavity between the bearings and mechanical seal contains a drilled passage (weep hole) to provide an external visual indication of leakage of water from the mechanical seal as well as to prevent water from contaminating the bearings and engine oil system.

Through the locomotive and marine industry, EMD has found that the redesigned pumps are experiencing premature failures of the internal seals resulting in leakage via the weep hole. The primary leaking fluid is engine cooling water, however, leakage of lubricating oil from the bearing side is a possibility. The seals are failing as a result of an insufficient preload on the tapered roller bearings. Without adequate preload, there exists excessive clearance between the rollers and race. This clearance results in chattering of the rolling elements and relative movement of the shaft within the pump. The issue applies to the design of the pump assembly relating to establishing and maintaining adequate preload on the bearings during operation. The problem is not a result of incorrect assembly.

No method is available to indicate the condition of the seals within the water pump assembly. The service history of the pumps with tapered bearings has indicated the seal failures occur either immediately or prematurely after a low number of operating hours. It is for this reason that it is recommended to replace the tapered bearing pumps with the previous design units using standard roller bearings.

Replace the tapered roller bearing water pump assemblies with standard roller bearing water pumps as identified below. Use the leakage rate (if present) as an indicator of the urgency of pump replacement. If no leakage is present, continue with monthly leak inspections and replace the pumps at the next available opportunity.
