UNITED STATES
NUCLEAR REGULATORY COMMISSION
OFFICE OF NUCLEAR REACTOR REGULATION
WASHINGTON, DC 20555-0001

January 15, 2003

NRC INFORMATION NOTICE 2003-01: FAILURE OF A BOILING WATER REACTOR
TARGET ROCK MAIN STEAM SAFETY/RELIEF
VALVE

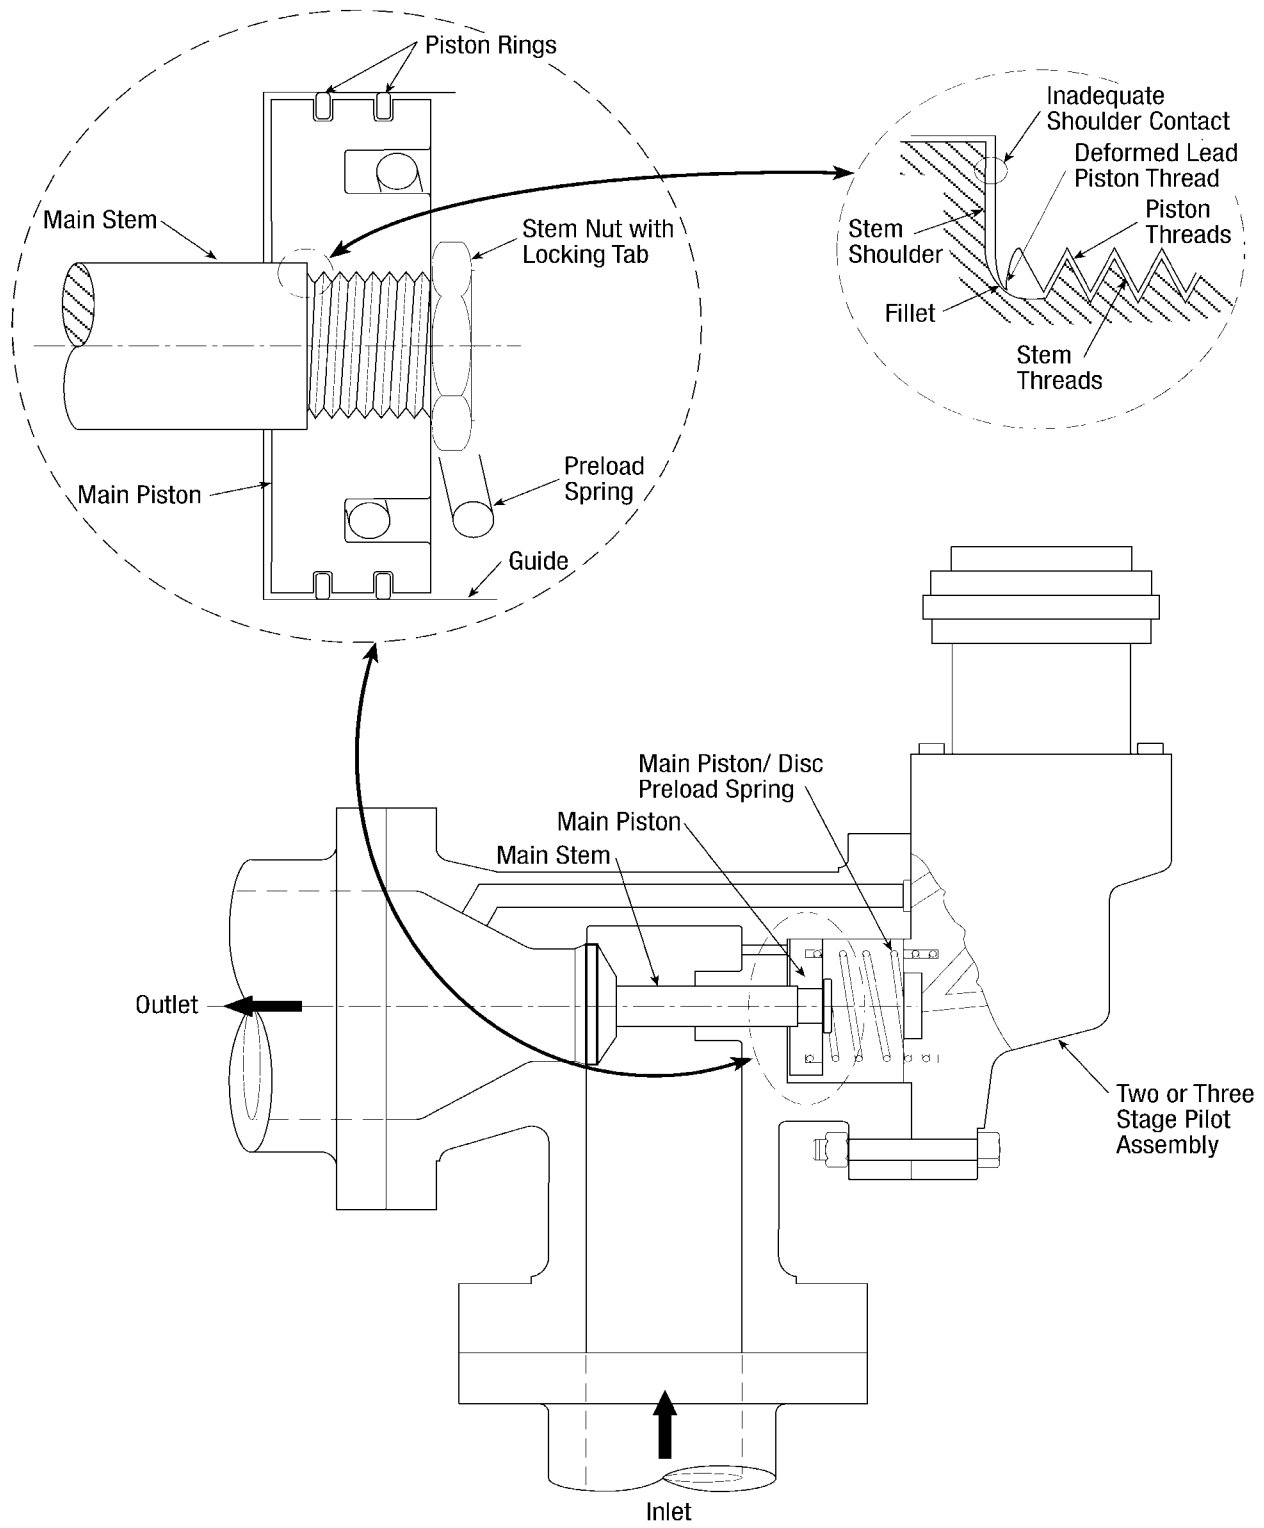
Figure 1 Target Rock Safety/Relief Valve

The S/RVs installed in Unit 1 are Target Rock two-stage S/RVs. The main stage valve internals (shown in attached Figure 1) are assembled by screwing the main piston onto the main stem so that the piston moves inside the guide, installing a locking tab washer, and installing the stem nut against the washer's locking tab. The piston is torqued to 100 ft-lbs, the stem nut is torqued to 50 ft-lbs, and the locking tab is bent to capture the stem nut. During the S/RV inspection after the April 2002 shutdown, the failed valve was found to have a .003-inch clearance between the main disc and its seat. When the valve was disassembled, the stem nut and the

piston were found to be loose. The stem nut was removed by hand and the piston was also unthreaded by hand from the stem. However, the threads on the stem were severely damaged. The piston was unthreaded by working it up to the good threads under the stem nut and threading it onto this portion of the stem. The inside of the guide was heavily grooved and was also worn by the piston edge wearing on the guide. The piston was visibly cocked on the valve stem.

Following the failure of the 1J S/RV, the licensee closely examined three valves which had been removed during the April 2002 refueling outage. The stem nuts and pistons of all three valves had lost torque, the stems of two of the valves showed significant wear on the valve threads, and one valve exhibited some thread wear. All three valves showed signs of damage on the stem shoulder, which is designed to contact the piston. In October 2002, the licensee removed three additional S/RVs from Unit 1 for testing, disassembly, and inspection. All three valves successfully stroked with steam pressure but when disassembled and inspected, were found to have lost torque on both the stem nut and the piston. Two valves had fairly good threads and the final valve (1F) had significant thread damage and a visibly cocked piston. All three valve stems showed varying degrees of damage in the shoulder area.

The licensee believes the loss of torque and damage of the valve internals can be attributed to the manufacturing tolerances of the valve stem and piston and to the lengthy service time without adequate inspection and maintenance. The valve is designed so the valve stem screws into the piston. The stem has a shoulder that seats against the piston shoulder. For the valves that show little to no thread damage, the stem apparently seats properly against the piston and most of the valve actuation force is carried by the stem and piston shoulders. For the valves with thread damage, the licensee believes that the end of the lead thread of the piston contacts the fillet that is machined into the shoulder of the valve stem. As shown in Figure 1, when this occurs, the shoulder of the stem does not properly seat against the shoulder of the piston. Thread damage starts with the first actuation on the test stand, resulting in a loss of torque. Over time, vibration from normal plant operations causes fretting and wear of the valve stem shoulder and threads. The piston rocks in the guide and wears grooves where the piston rings contact the guide. Eventually the piston could significantly cock on the stem and wedge in the guide during valve actuation, which would prevent proper opening or closing of the valve. The licensee has not been able to determine the time in operation required to damage a valve to the point of failure. The licensee believes the failed 1J valve and the damaged 1F valve were in service for approximately 20 years without maintenance. The licensee is currently removing several S/RVs during each plant outage to ensure that all installed S/RVs are inspected and maintained at least every 6 years. There are 11 S/RVs installed in each unit.

As the result of the 1J valve failure, the licensee performed a root cause analysis following the event and contracted an independent engineering firm to perform a separate root cause analysis. The licensee believes that the failure of the S/RV is related to the manufacturing tolerances of the valve stem and piston assembly and to the lengthy service time without adequate inspection and maintenance. The independent root cause analysis determined that the lead thread of the piston was contacting the fillet of the shoulder, preventing shoulder-to-shoulder contact. Since the piston was not adequately attached to the stem, operational vibration and valve actuation caused thread damage and eventual valve failure. The valve vendor (Curtiss Wright Flow Control Corporation) has developed changes to the inspection and refurbishment procedures to ensure proper shoulder-to-shoulder contact during valve assembly. The BWR vendor (GE Nuclear Energy) is issuing a Service Information Letter (SIL) to address the degradation found in the Hatch S/RVs.

The above-described circumstances emphasize the importance of periodic inspection of S/RV main stage components to identify deficiencies and necessary corrective actions. All Target Rock two-stage and three-stage S/RVs have similarly designed main stage components. Currently 11 BWR plants in the U.S. have two-stage S/RVs, and 11 BWR plants have three-stage S/RVs.
