UNITED STATES  
NUCLEAR REGULATORY COMMISSION  
OFFICE OF NUCLEAR REACTOR REGULATION  
WASHINGTON, D.C. 20555

NRC INFORMATION NOTICE 2004-11: CRACKING IN PRESSURIZER SAFETY AND RELIEF NOZZLES AND IN SURGE LINE NOZZLE

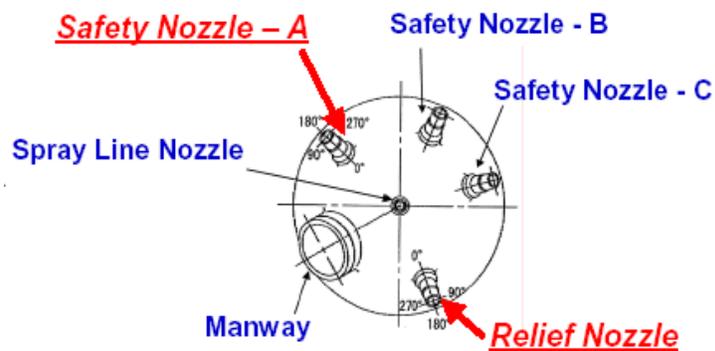
Figure 1. Top View of Reactor Pressurizer (Courtesy of Japan Atomic Power)

Tsuruga 2 was in its 13<sup>th</sup> annual inspection, which started in September of 2003. During a visual inspection of the pressurizer safety and relief nozzles with insulation removed, boric acid deposits were found on the pressurizer relief nozzle. Subsequent ultrasonic testing performed on the pressurizer safety and relief nozzles revealed linear indications in the nozzle-to-safe-end weld metal on the relief nozzle and on safety nozzle A, one of the three safety nozzles (Figure 1).

All of the flaws found were axially oriented and located in the welds, that is, the flaws did not extend into the base metal. The 0° location of each nozzle is the point of the nozzle closest to the centerline axis of the pressurizer cylinder, marked by the spray line nozzle in Figure 1. On safety nozzle A, two indications with a maximum length of 24 mm (0.9 inches) were found at the 35° - 45° location. On the relief nozzle, two indications with a maximum length of 35 mm (1.4 inches) were found at the 90° location, and one indication with a maximum length of 34 mm (1.3 inches) was found at the 315° location.

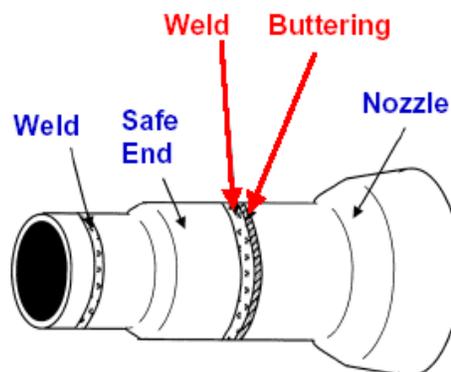
Figure 2. Nozzle Configuration (Courtesy of Japan Atomic Power)

Each nozzle consists of a safe end made of Type 316 stainless steel and a nozzle end made of a low-alloy steel, similar to Type 508 ferritic steel typically used in the same nozzles for U. S. plants (Figures 2 and 3). The safety and relief nozzles are the same size, about 190 mm (7.5 inches) outside diameter and about 130 mm (5.1 inches) inside diameter. Weld butter with Alloy 132 (which has properties similar to Alloy 182) was initially applied to each of the nozzles. The component was stress-relieved. Then a safe end was welded to each nozzle with Alloy 132. The weld is approximately 40 mm (1.6 inches) in width.
