UNITED STATES
NUCLEAR REGULATORY COMMISSION
OFFICE OF NUCLEAR REACTOR REGULATION
WASHINGTON, D.C. 20555-0001

NRC INFORMATION NOTICE 2005-01: HALON FIRE-EXTINGUISHING SYSTEM PIPING
INCORRECTLY CONNECTED

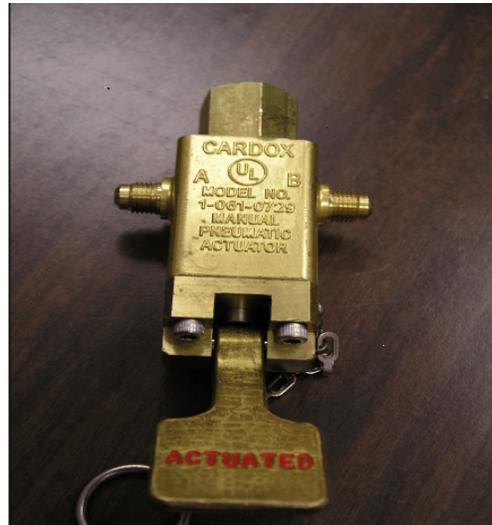
Figure 1 - Manual-Pneumatic Actuator

Typically, each of the manual-pneumatic actuators have ports marked A and B, (see Figure 1). The ports have specific requirements for connection to the pilot manifold (from port A) and to the solenoid pilot valve assembly (from port B). In the improper configurations recently identified, the actuation piping to ports A and B was reversed. Figure 2 is a diagram of a correctly configured actuator.

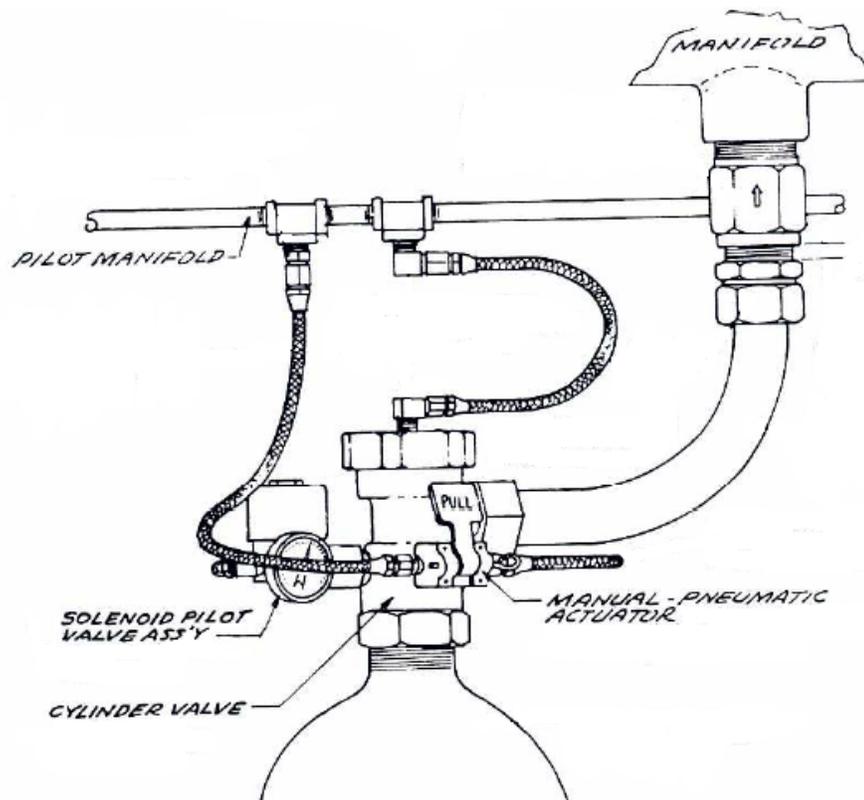
Figure 2 - Diagram of Actuator Setup

Improper configurations of the halon fire-extinguishing system could have adverse effects on the system. The Callaway and Wolf Creek licensees contacted the vendor (Chemetron) to assist in the assessment of the halon system with the piping to the actuator reversed. On January 26, 2005, an NRC fire protection specialist observed the vendor perform a series of tests with the actuator piped in both the correct and reversed configuration. With the piping to the actuator reversed and based on the internal non-symmetric construction of the actuator, there was an approximate 2-second delay in the opening of the cylinder valve. This would result in a 2-second delay in the delivery of halon gas to the affected equipment.

Based on the above discussion, both carbon dioxide and halon fire-extinguishing systems that are not properly configured have the potential to impact the extinguishing capability of the system. Thorough inspection of the systems and adequate postmaintenance testing procedures can help to ensure that the systems are properly configured.
