UNITED STATES  
NUCLEAR REGULATORY COMMISSION  
OFFICE OF NUCLEAR REACTOR REGULATION  
WASHINGTON, D.C. 20555

April 7, 2005

NRC INFORMATION NOTICE 2005-09: INDICATIONS IN THERMALLY TREATED ALLOY  
600 STEAM GENERATOR TUBES AND TUBE-  
TO-TUBESHEET WELDS

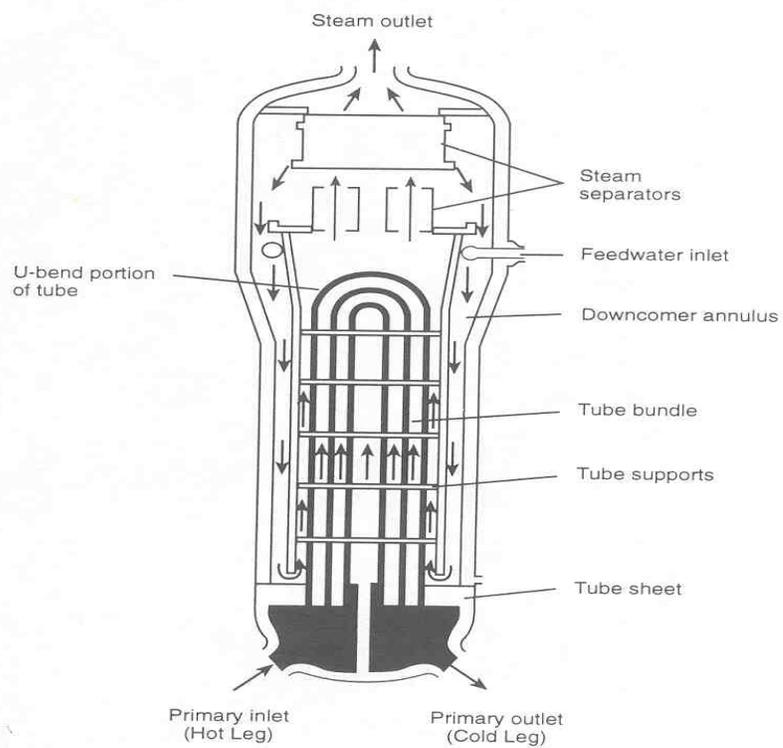
Figure 1

Catawba Nuclear Station, Unit 2, has four Westinghouse Model D5 recirculating steam generators. Each steam generator has approximately 4,600 tubes fabricated from thermally treated Alloy 600 (Figure 1). During fabrication of the steam generators, a portion of the U-shaped tubes are inserted into a thick plate called a tubesheet. The tubesheet is approximately 21 inches thick and has two holes for each tube (one hole on the hot-leg side of the steam generator and one hole on the cold-leg side). The lower end of the tubes were tack-expanded into the tubesheet for approximately 0.70 inch (Figure 2). This tack expansion is performed to facilitate welding of the tube to the primary side of the tubesheet. In the case of Catawba Unit 2, this region is frequently referred to as the tack roll region since the tack expansion was accomplished by mechanically rolling the tube into the tubesheet. The tack expansion forms a temporary expansion transition (i.e., a roll transition in the case of Catawba). Following welding, the tubes were hydraulically expanded for the full depth of the tubesheet. The transition from the expanded portion of tube within the tubesheet to the unexpanded portion of the tube at the top of the tubesheet is referred to as the expansion transition region of the tube.

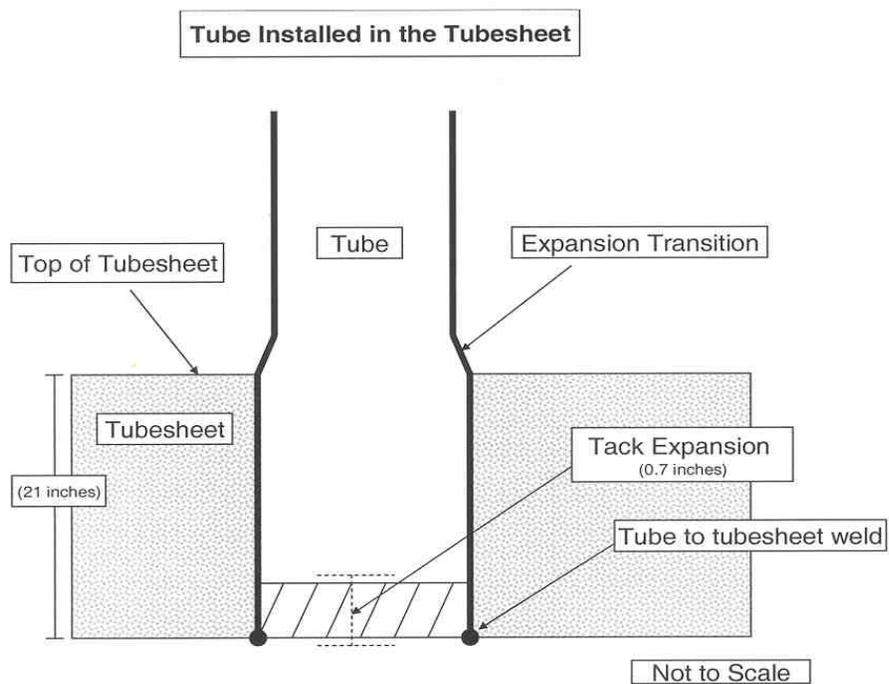
**Figure 2**

During these additional rotating probe examinations, no additional indications were found in the overexpanded (bulged) regions; however, several indications were found at the tube ends (tube-to-tubesheet weld) and one indication was found in the tack expansion region. At the tube ends, the licensee identified approximately 12 indications in steam generators A, B, and D. These indications were in the tube-to-tubesheet weld and were not visible during visual inspections of the weld. The indication in the tack expansion (the region of the tube expanded into the tubesheet to facilitate welding) was approximately 0.70 inch above the tube-to-tubesheet weld and was circumferentially oriented. It was estimated to be 330 degrees in circumferential extent and 100 percent through-wall.

In steam generator B, 9 tubes were found to have indications in the tack roll region. These indications were circumferentially oriented and consisted of either single or multiple cracks. No indications were found in the tack roll region in steam generators A, C, or D. In the tube-to-tubesheet weld region, 188 tubes in steam generator B, 1 tube in steam generator A, and 7 tubes in steam generator D contained indications in the tube-to-tubesheet weld. No indications were found in the tube-to-tubesheet weld region in steam generator C. Six tubes in steam generator B were identified with tube end (i.e., tube-to-tubesheet weld) indications that extended into the tube material. The indications in these tubes were axially and circumferentially oriented and consisted of either single or multiple cracks.

The licensee plugged the tube with the circumferential indications in the overexpanded region and the tubes with indications in the tack roll region. In addition, the licensee plugged the six tubes with indications in the weld region that extended into the tube material.
