The applicator involved in the five medical events was a Mick Radio-Nuclear Instruments, Inc. Wang Front-Loading Vaginal Applicator, Model 8524 (applicator), intended for use with cesium-137 sources, to treat patients. See the attached diagram of the Wang applicator. The instructions provided with the applicator specified the use of sources manufactured by the 3M Company (3M), and the applicator was marked with the appropriate source dimensions.

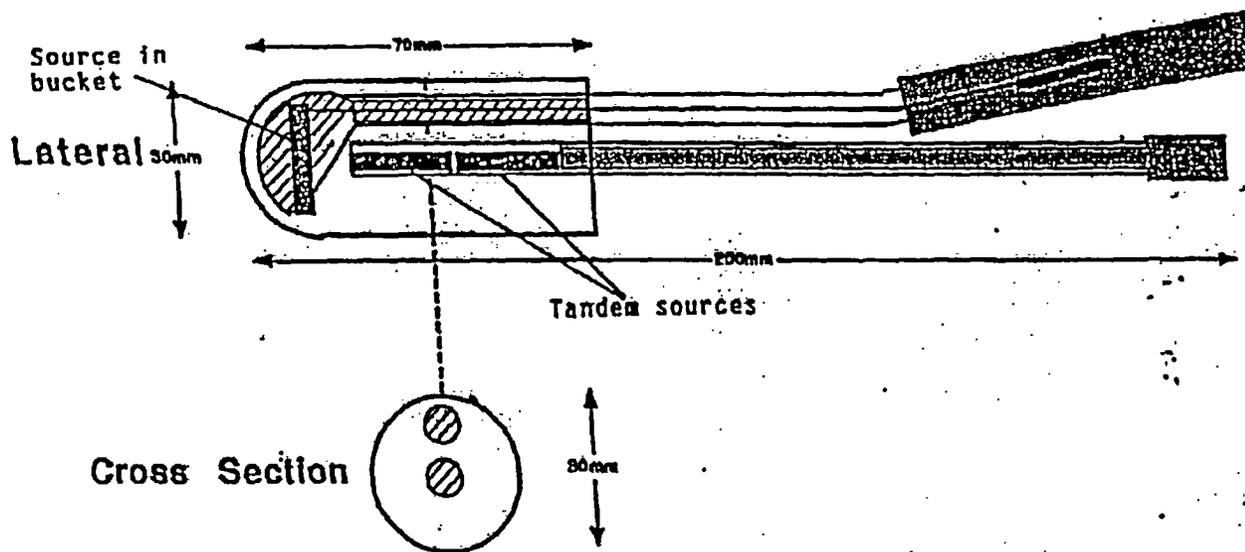
Attachments: 1. Diagram of Wang Applicator
2. List of Recently Issued NMSS Generic Communications

During each of the first five brachytherapy treatments performed by the licensee with the Wang applicator, that resulted in medical events, licensee staff selected G.E. Healthcare (formerly known as Amersham; hereafter referred to as Amersham) sources for use in the tandem portion of the applicator. The Amersham sources were different in a critical dimension from the 3M sources specified in the instructions - they were too small in diameter, being 2.6 millimeter (mm) (0.10 inch) in diameter, when 3.1 mm (0.12 inch) diameter sources were specified. As a result, the tandem sources slid down to the opposite end of the applicator's flexible carrier tube whenever the applicator was tilted more than 20 degrees off-level (i.e., the tandem sources moved out of their intended position whenever a patient moved more than 20 degrees off-level (e.g., sat up) during treatment), resulting in irradiation of the skin on the patient's thighs. The Amersham sources moved through the center of the applicator's carrier tube spring because the diameter of the sources was smaller than the inner diameter of the coil spring.

- Instructions did not clearly alert the user to proper action that must be taken if the spring in the tandem portion of the applicator required shortening. The distal end of the applicator coil spring was designed with an inward bend, to prevent source movement down the center of the spring. The instructions stated that the applicator spring could be shortened. This would be necessary if more than two sources were used in the tandem portion of the applicator. The instructions did not provide a warning to the user not to cut the distal end of the spring with the inward bend, if shortening of the spring was necessary. Such an action could result in source movement down the center of the spring.

The licensee had not used more than two sources in the tandem portion of the applicator for any of the five similar brachytherapy treatments completed. Therefore, the licensee did not cut the applicator spring. However, the spring supplied with the licensee's applicator did not include the inward bend at the distal end, which increased the potential for source movement under certain circumstances. The Amersham sources could, and did, for the five patients involved in

medical events, move down the center of the spring to the opposite end of the tandem portion of the applicator when the patients undergoing treatment raised up from horizontal positions.

licensee modified the applicator by using different hardware to keep the radioactive sources in proper position during brachytherapy treatments. The licensee's modification of the applicator was effective.¹ However, the licensee misinterpreted the medical event reporting requirements in 10 CFR 35.3045(a)(3) and failed to promptly identify, in April 2004, that multiple medical events had occurred. Reporting of medical events (2) to NRC was delayed until March 2005, when, following patient reexaminations, the licensee determined that treatment side effects for two patients were more severe than previously observed.

The medical events involved errors in selection of ancillary equipment--sealed radioactive sources--required for use of the afterloader applicator employed in the treatments, resulting in failure of the sealed sources to remain in their intended positions throughout the specified treatment times. Licensees performing LDR manual brachytherapy procedures are expected to review this IN and:

- Assure that radioactive sources and any other ancillary devices to be used with an LDR manual brachytherapy applicator for a therapeutic procedure are designed for use with, or are known to be compatible with, the LDR applicator to be used during the procedure;
