UNITED STATES  
NUCLEAR REGULATORY COMMISSION  
OFFICE OF NUCLEAR REACTOR REGULATION  
WASHINGTON, D.C. 20555-0001

NRC INFORMATION NOTICE 2006-01: TORUS CRACKING IN A BWR MARK I  
CONTAINMENT

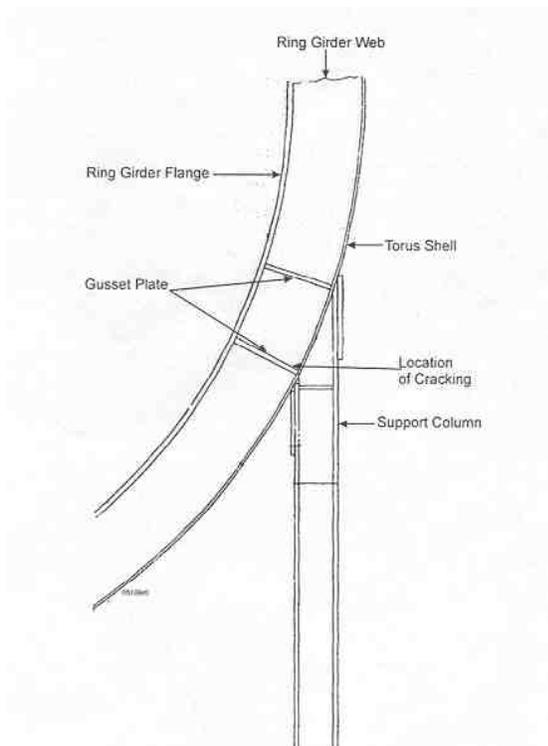
The leak was characterized as a slight seepage with streaking and a small puddle below the leak. Subsequent nondestructive examination determined that the leakage was from a small through-wall torus crack which was x-shaped with an approximate 4.6 inch maximum length. The licensee determined that operability of the primary containment was not assured and declared an Unusual Event and subsequently shut down the reactor (see Event Notification 41815, Reference 1).

The FitzPatrick licensee performed a root cause investigation of the event, and after eliminating a number of possible causes (thermal fatigue, clearing load phenomena, metallurgical discontinuity, weld defects, corrosion, flow-induced phenomena, flow-accelerated corrosion, cavitation, and direct jet impingement), the licensee concluded that the most likely cause for the initiation and propagation of the crack was the hydrodynamic loads of the turbine exhaust pipe during HPCI operation coupled with the highly restrained condition of the torus shell at the torus column support (see Figure 2). The cracking occurred in the heat-affected zone of the lower gusset plate of the ring girder at the torus column support (Figure 3 shows the HPCI turbine exhaust pipe entering the torus and the approximate location of the crack). The licensee concluded that the crack was initiated by cyclic loading due to condensation oscillation during HPCI operation.

These condensation oscillations induced on the torus shell may have been excessive due to a lack of an HPCI turbine exhaust pipe sparger that many licensees have installed. The licensee could not pinpoint exactly when the crack started. Subsequent HPCI system operation helped propagation of the crack. The licensee indicated that no detrimental torus condition was noted during the general visual examination performed (per the 1998 edition of Subsection IWE

Figure 2  
A cutaway side view of the torus shell and support showing the location of the cracking.

To correct this condition, the licensee installed an approximately 13 inch outer diameter torus repair plate with a full-penetration weld joint. Pressure testing and inspection of the torus and drywell were completed after the repairs were completed. An NRC special inspection team

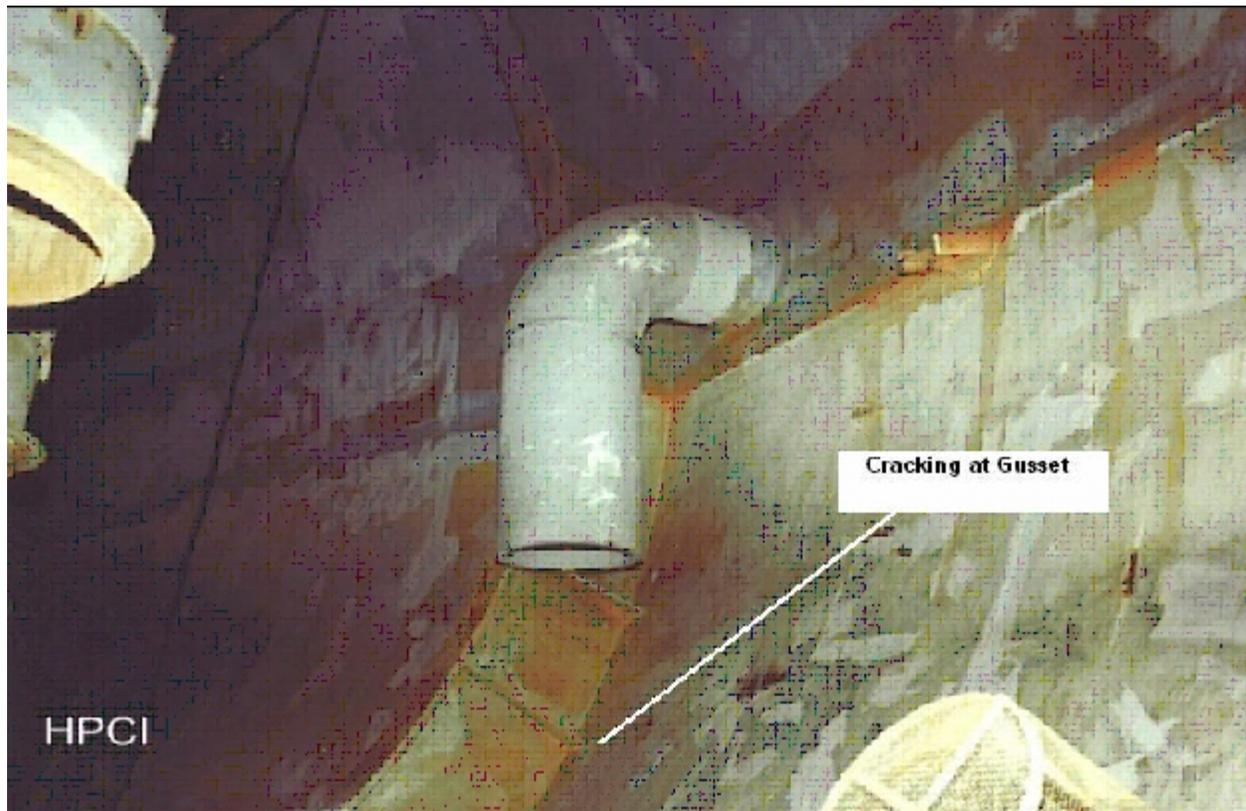
Figure 3

Figure 3: Photograph from inside the torus of HPCI turbine exhaust pipe, with the approximate location of the crack at the gusset. This view is from inside the torus. The HPCI turbine exhaust pipe (in the center of the photo) is approximately 24 inches in diameter.

- Many licensees have installed HPCI turbine exhaust pipe condensing spargers as one possible way to adequately distribute the operational type hydrodynamic loads and ensure that the stresses developed by these loads are within the acceptable limits.
