NUREG/CR-7019
PNNL-18713, Rev. 1

Results of the Program for the Inspection of Nickel Alloy Components

Manuscript Completed: April 2010

Pacific Northwest National Laboratory

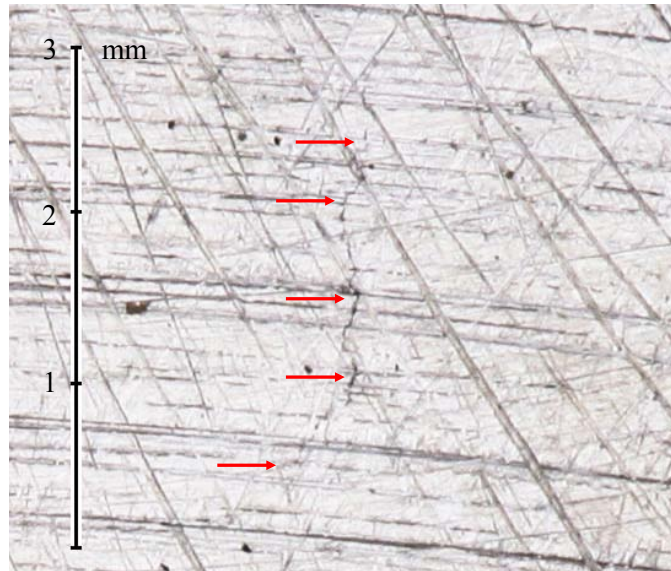
Figure 2.53 Weld Solidification Crack in Test Block 5.6 at 45 Degrees

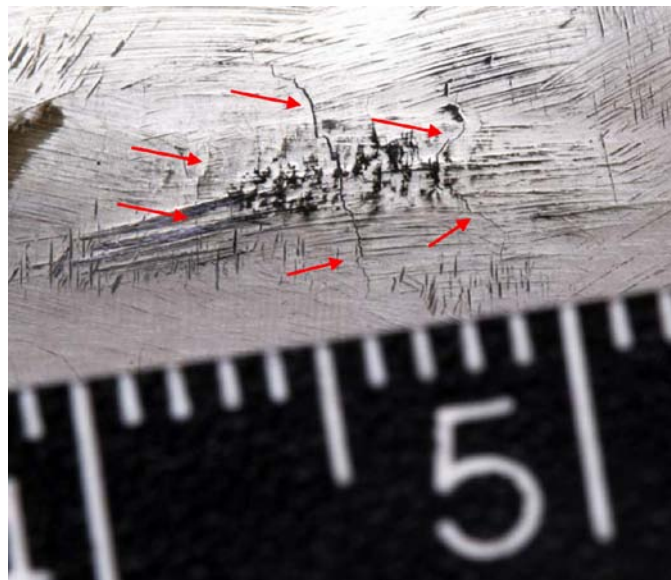
The flaws in test block 5.7 were fabricated using an in situ thermal fatigue process. This process is able to introduce flaws into the material without the weld fabrication problems associated with the coupon insertion or weld-solidification cracking. It is also possible to control crack properties such as crack opening displacement (COD) and crack depth with a high level of precision. The thermal fatigue cracks are very expensive, however, so only two such flaws were ordered. Because of an accident during the fabrication of one of the flaws, three flaws are present in test block 5.7. Only two have the proper pedigree involving length and depth, however. All three flaws in test block 5.7 were confirmed as surface-breaking using visual examination. Photography of the flaws showed that the flaws at 15 degrees and 300 degrees consisted of multiple small cracks spaced closely together. The flaw at 15 degrees is shown in Figure 2.54.

Figure 2.54 Thermal Fatigue Cracks in Test Block 5.7

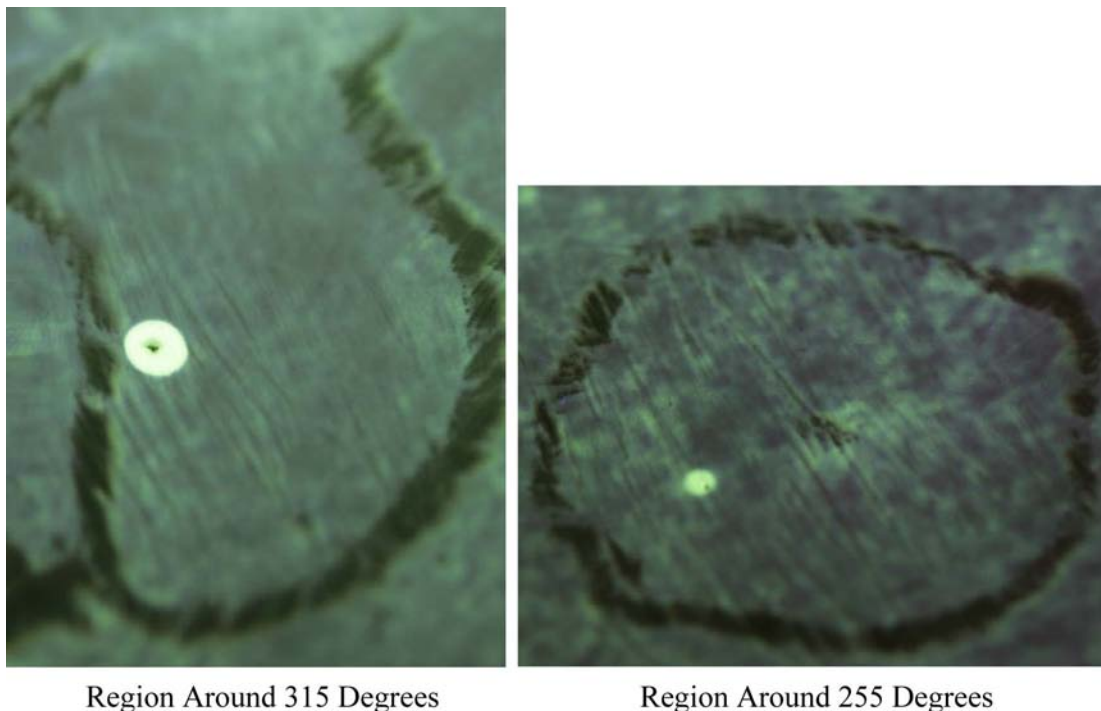
A careful visual examination using high-resolution macro photography found no evidence of surface-breaking flaws in test blocks 5.9 or 5.10. This is in contrast to the weld solidification flaws in test block 5.6, where flaws were visible on the surface. Test blocks 5.9 and 5.10 were then examined using fluorescent dye penetrant testing. The penetrant testing of test block 5.9 showed no indications of any surface-breaking flaws. The penetrant testing of test block 5.10 found no linear indications, but two small spots of penetrant appeared at locations consistent with the crack implantation regions of 255 and 315 degrees. During the destructive examination of sample 5.10 the crack was revealed to have a limited surface-breaking component, and it is now believed that the PT indication near 315 degrees may have come from a welding defect such as porosity. The results of the penetrant testing are shown in Figure 2.55.

Figure 2.55 Penetrant Testing Results for Test Block 5.10

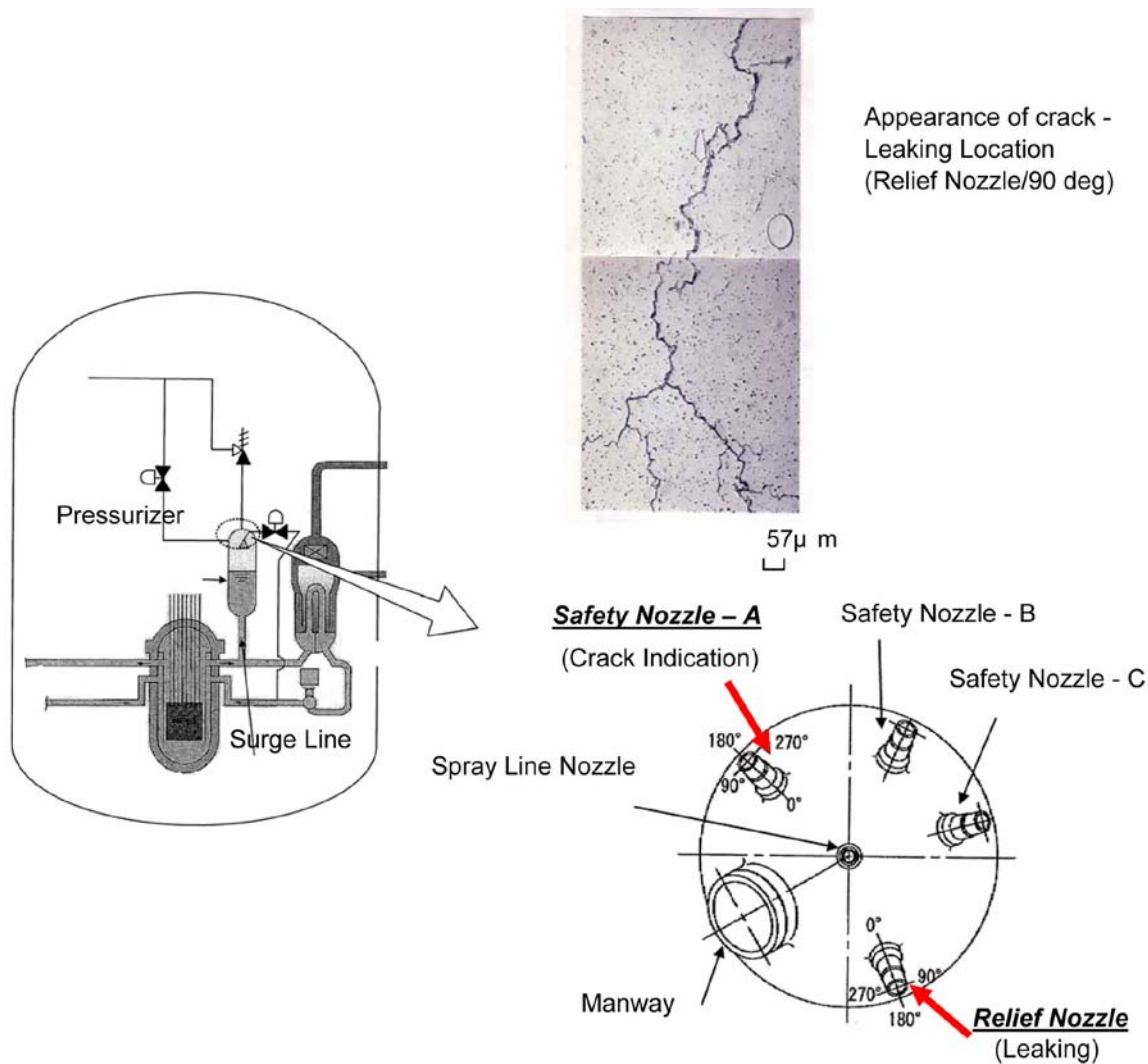
Figure 6.1 DMW Failures of Pressurizer Nozzles in Tsuruga 2

Affected nozzles were finally repaired by welding with replacement safe-end spool pieces and alloy 690 weld metal.

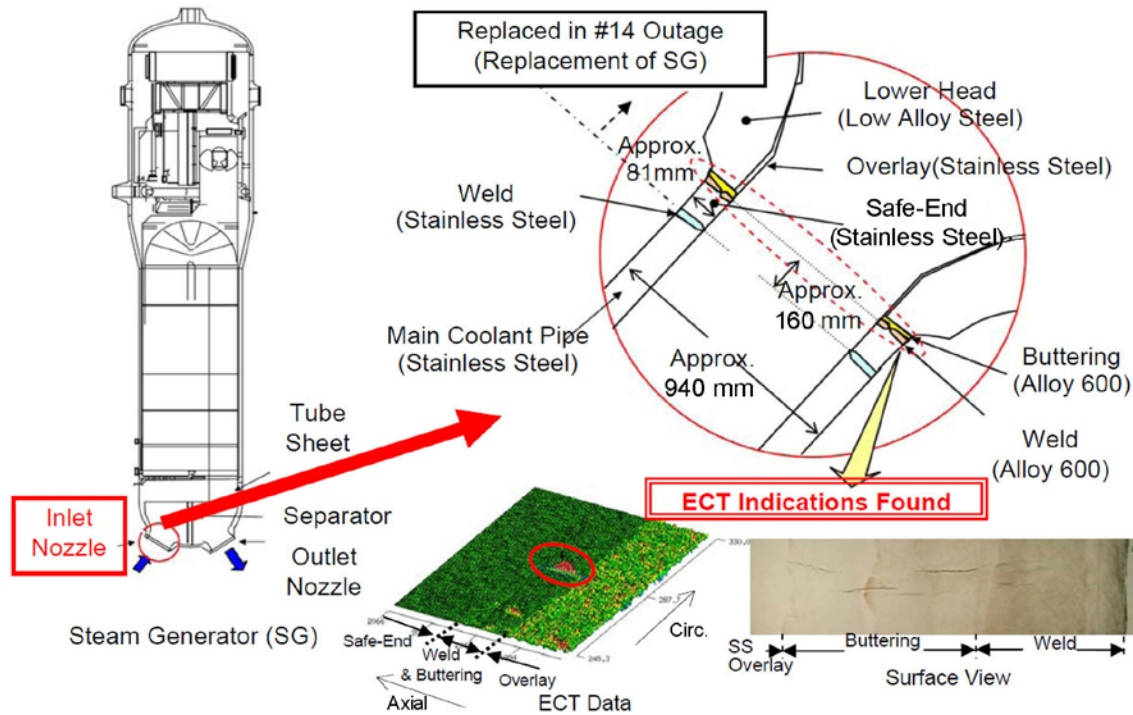
Similar ECT indications have been found in several other plants during their USP efforts that followed operation at Mihama 2. Alloy 600 DMWs of SG nozzles have been inspected as listed in Table 6.4.

Figure 6.2 DMW Failure of Steam Generator Nozzle in Mihama 2

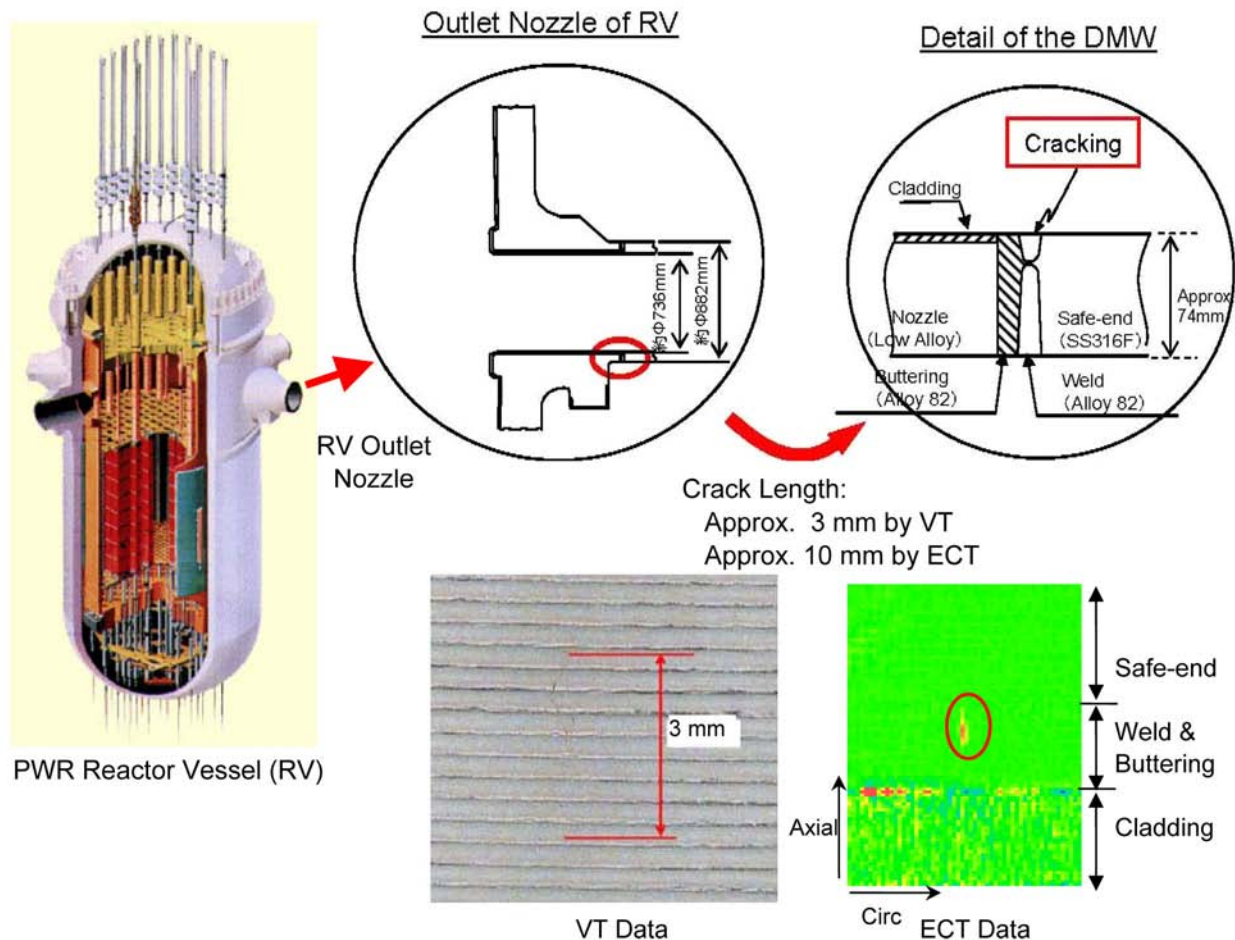
Figure 6.3 DMW Failure of Reactor Vessel Outlet Nozzle in Ohi 3

The plant resumed operation in November 2008.

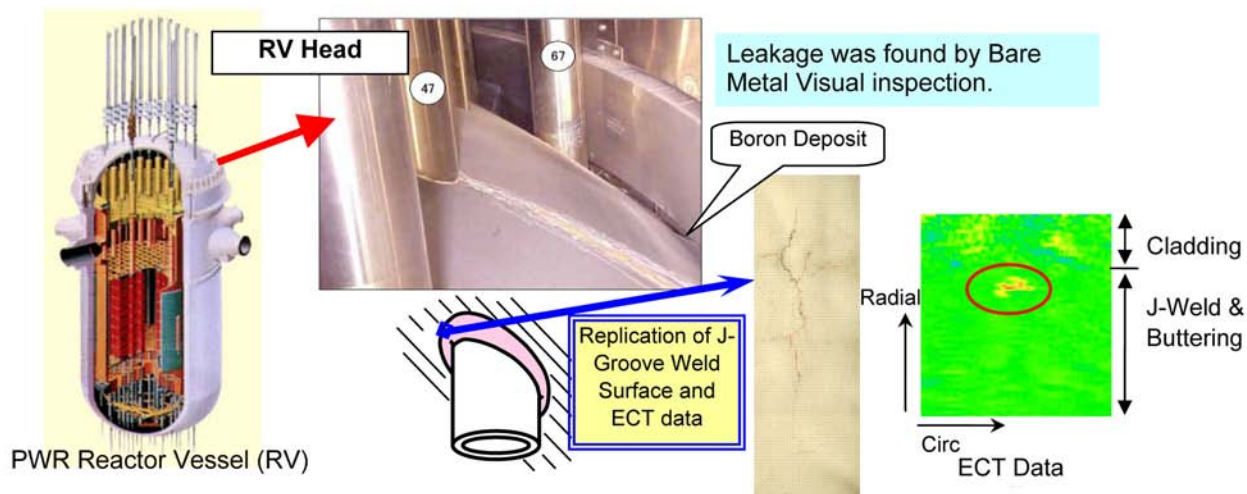
Figure 6.4 Failure of CRDM J-Groove Weld in Ohi 3

In order to maintain the integrity for the RCS pressure boundary and protect PWSCC propagation, weld repair had been performed to the affected weld by using alloy 690 weld material before restart of the plant. This vessel head was replaced during the 12th annual inspection outage of Ohi 3.

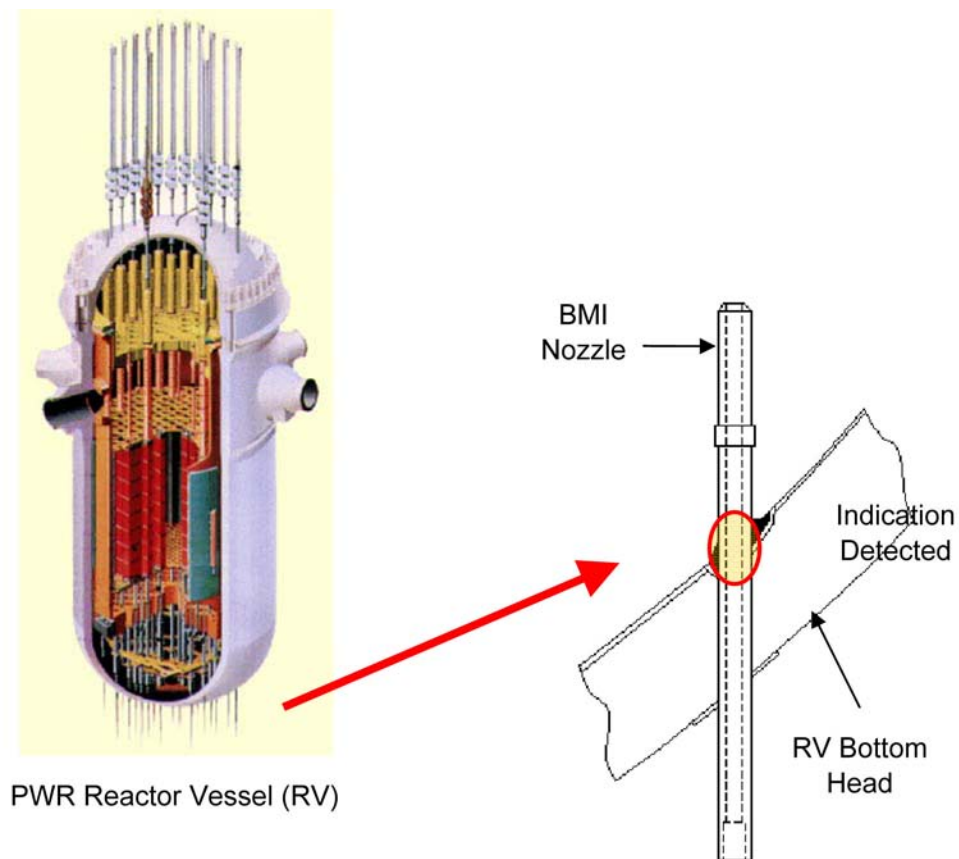
Figure 6.5 Spurious ECT Indication Found in BMI of Takahama

Eventually, the area concerned was ground in case in the next outage. Retesting with ECT after grinding verified that the indication had been completely eliminated.

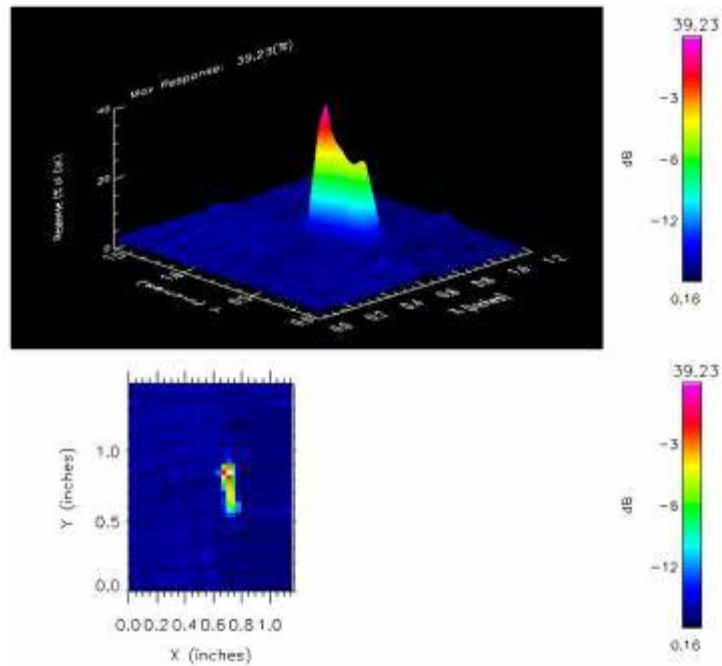
Figure 7.7 shows the eddy current response from a WSC in Alloy 182 weld metal. The indication is 39% of the calibration EDM notch. The length of the indication is 12 mm using loss of signal. Figure 7.8 provides a signal-to-noise analysis of eddy current response from the weld solidification crack. The noise level is set to 3.5% of the calibration EDM notch, giving the indication a signal-to-noise ratio of 11.2.

Figure 7.7 Eddy Current Response from Weld Solidification Crack in Alloy 182 Weld Metal

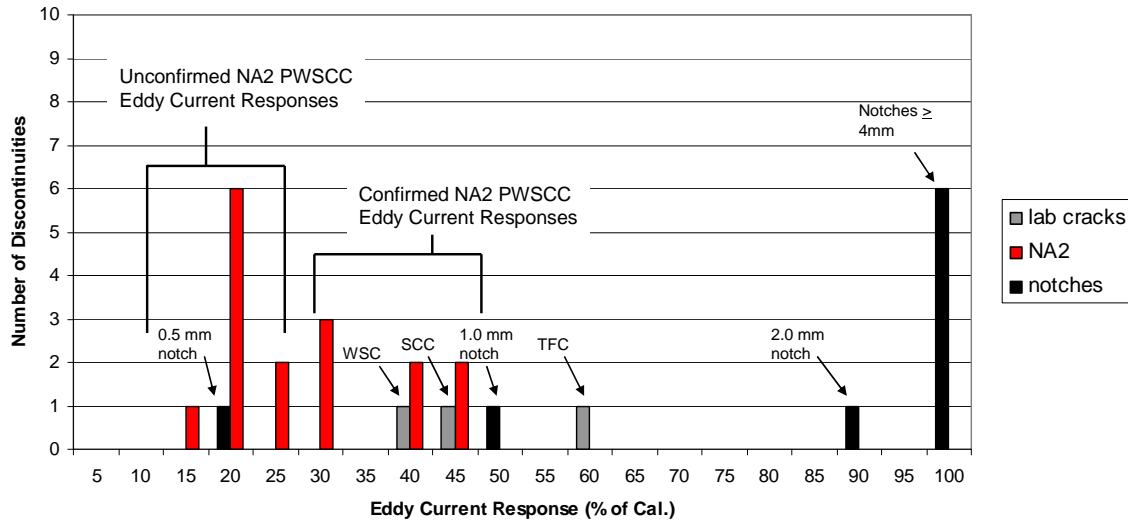
Figure 7.9 provides a summary of the eddy current response distributions for 13 crack indications in the North Anna 2 nozzle 31, 3 manufactured cracks, and 9 EDM notches. The 0.5-mm EDM notch and 1.0-mm EDM notch approximately bracket the crack indication distribution. The responses from manufactured cracks are representative of PWSCC crack indications producing the largest NDE responses.

Figure 7.9 Eddy Current Response Distributions for 13 Crack Indications in North Anna 2 Nozzle 31, 3 Manufactured Cracks, and 9 Electro-Discharge Machined Notches
