UNITED STATES OF AMERICA  
NUCLEAR REGULATORY COMMISSION  
OFFICE OF NUCLEAR REACTOR REGULATION

In the Matter of	)	
	)	
SOUTHERN CALIFORNIA EDISON COMPANY	)	Docket Nos. 50-361
	)	and 50-362
(San Onofre Nuclear Generating	)	10 CFR § 2.206
Station, Units 2 and 3	)

DIRECTOR'S DECISION UNDER 10 CFR § 2.206

UNITED STATES NUCLEAR REGULATORY COMMISSION  
DOCKET NOS. 50-361 AND 50-362  
SOUTHERN CALIFORNIA EDISON COMPANY, ET AL.  
SAN ONOFRE NUCLEAR GENERATING STATION, UNITS 2 AND 3  
ISSUANCE OF DIRECTOR'S DECISION UNDER 10 CFR 2.206

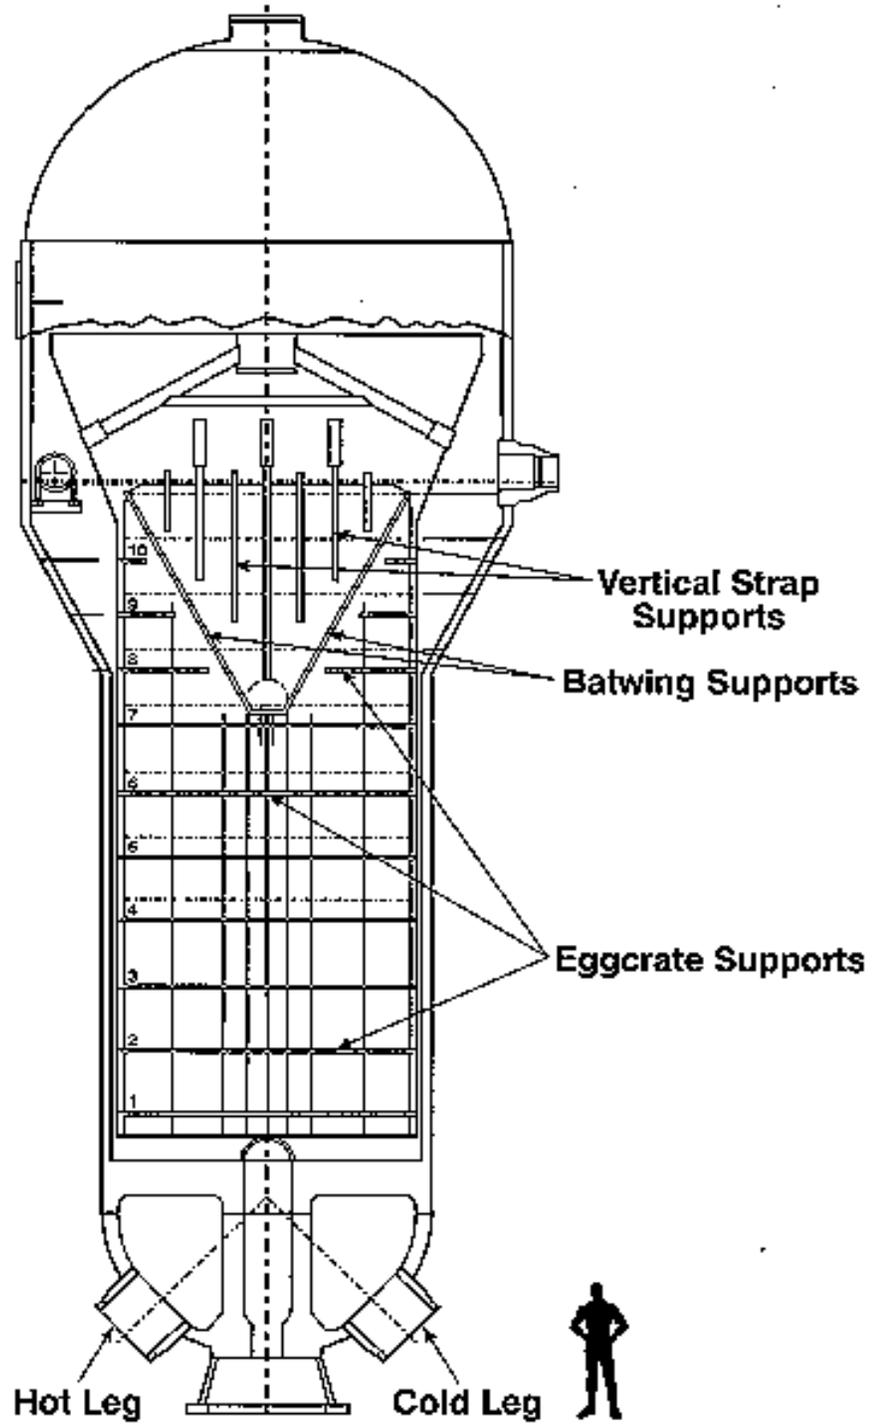
Figure 1

For the individual steam generator tube analysis, the licensee calculated the maximum loads that could occur assuming that adequate support was not available at two consecutive eggcrate levels (see Figure 1). The staff finds this assumption conservative and acceptable because the licensee has removed from service all tubes where two consecutive eggcrate levels were found degraded to the point where adequate support could not be assured.

Steam Generator  
Eggcrate Locations

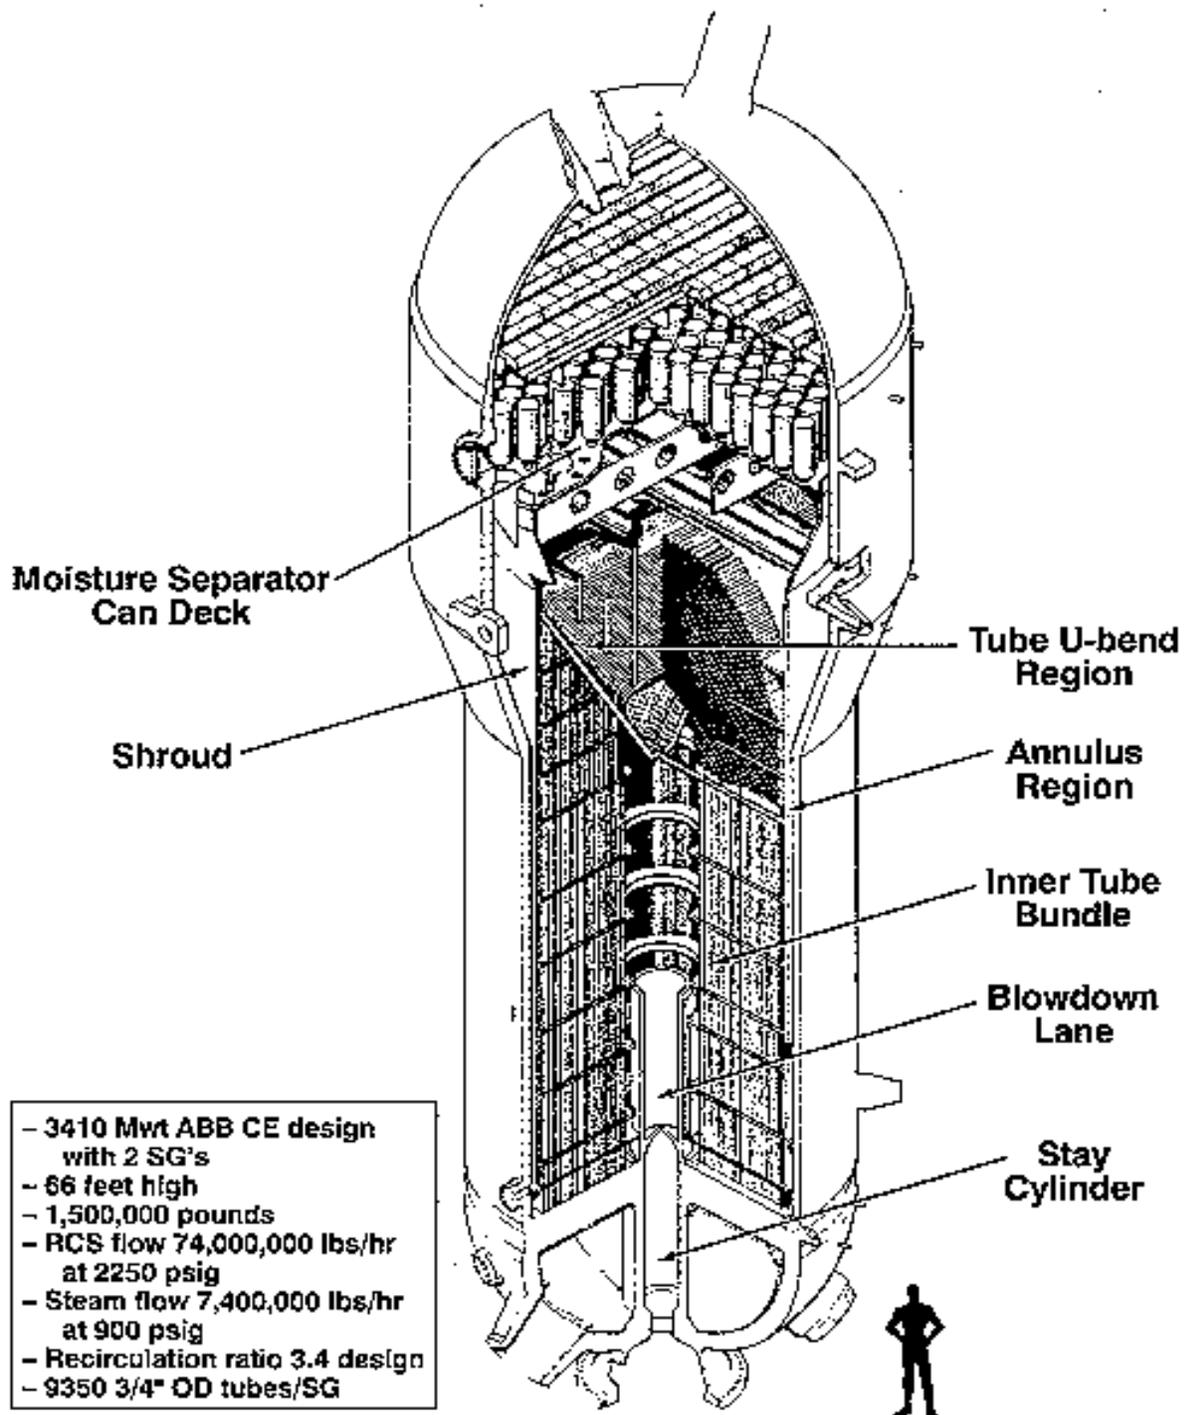
The SONGS units utilize Combustion Engineering Model 3410 recirculating steam generators. This model of steam generator contains 9,350 Inconel 600 (ASME Material Specification SB-163) U-tubes with a nominal diameter and wall thickness of 0.75 and 0.048 inch, respectively. Secondary side tube support structures consist of seven horizontal full eggcrate supports, three horizontal partial eggcrate supports, and upper bundle supports (i.e., two batwing diagonal supports and seven vertical supports). The materials used for fabrication of the steam generator vessels and internals (including tube supports) are low-alloy and carbon steels, respectively. Figure 1 is a simplified cross-sectional diagram of the SONGS steam generators that clearly displays the 10 eggcrate support levels, and Figure 2 is a three-dimensional representation of the steam generators that gives additional structural detail.

Typical CE Steam Generator

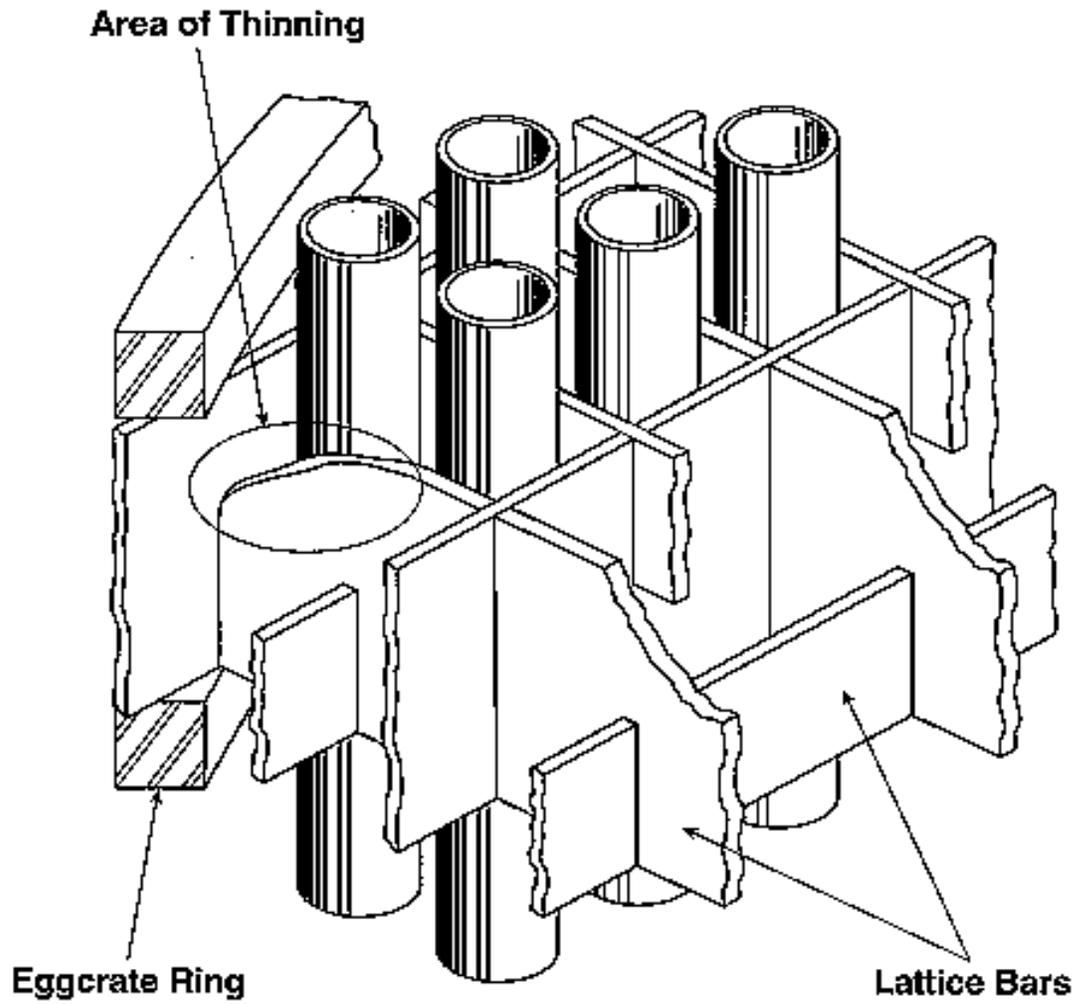
Figure 3

The eggcrate supports consist of 1- and 2-inch carbon steel strips interlocked perpendicular to each other as shown in Figure 3. The eggcrate supports limit lateral motion of the tubes and, at the same time, allow free flow of fluid around the tubes.

Eggcrate Arrangement
