NUREG/CR-0596  
SAND78-2238  
RP

A PRELIMINARY REPORT ON  
FIRE PROTECTION RESEARCH PROGRAM\*  
FIRE BARRIERS AND SUPPRESSION  
(September 15, 1978 Test)

Leo J. Klamerus

Sandia Laboratories  
Albuquerque, NM 87185  
operated by  
Sandia Corporation  
for the  
U.S. Department of Energy

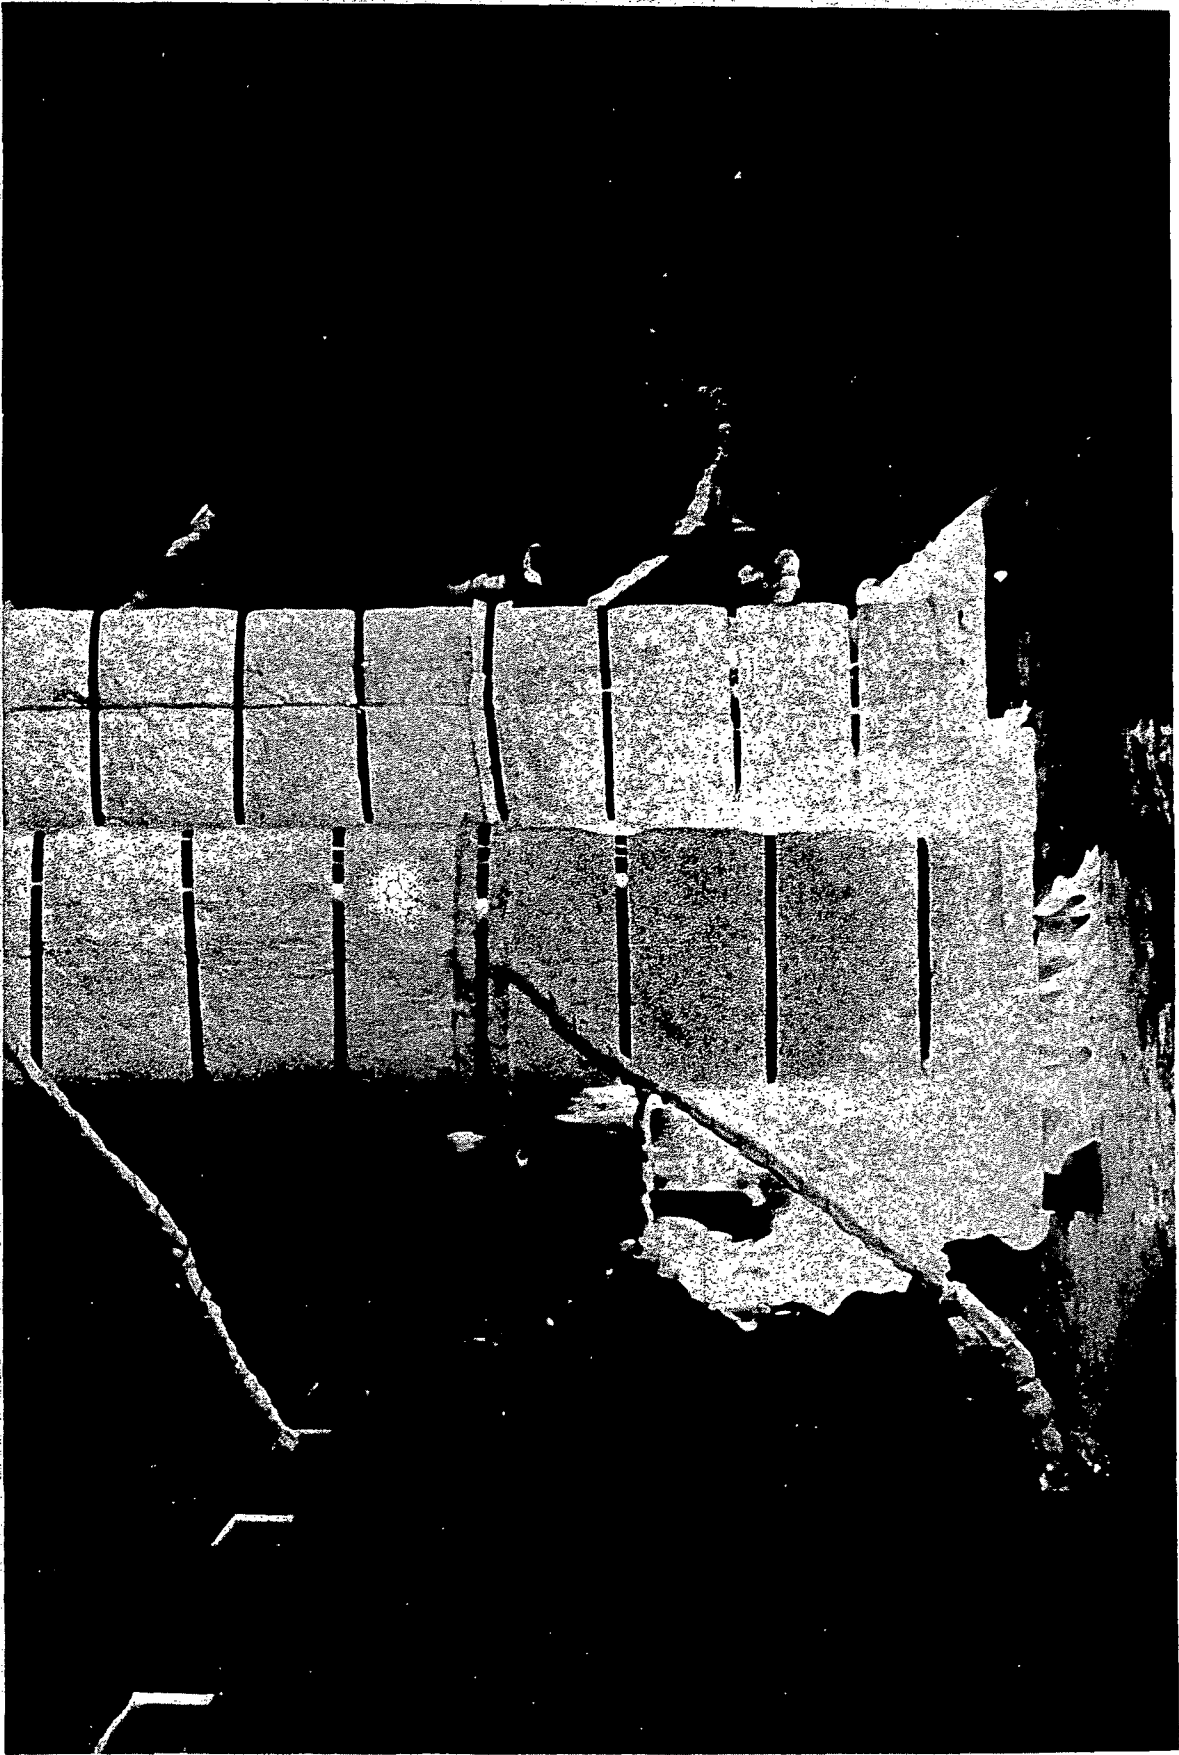
Figure 6. Test Assembly at Ten Seconds

<u>Time (Min:Sec)</u>	<u>Description</u>
0:10	Flaming appeared uniform over the entire pan area with a maximum flame height of 4 feet (1.2 m). Appearance of test assembly is shown in Figure 6.

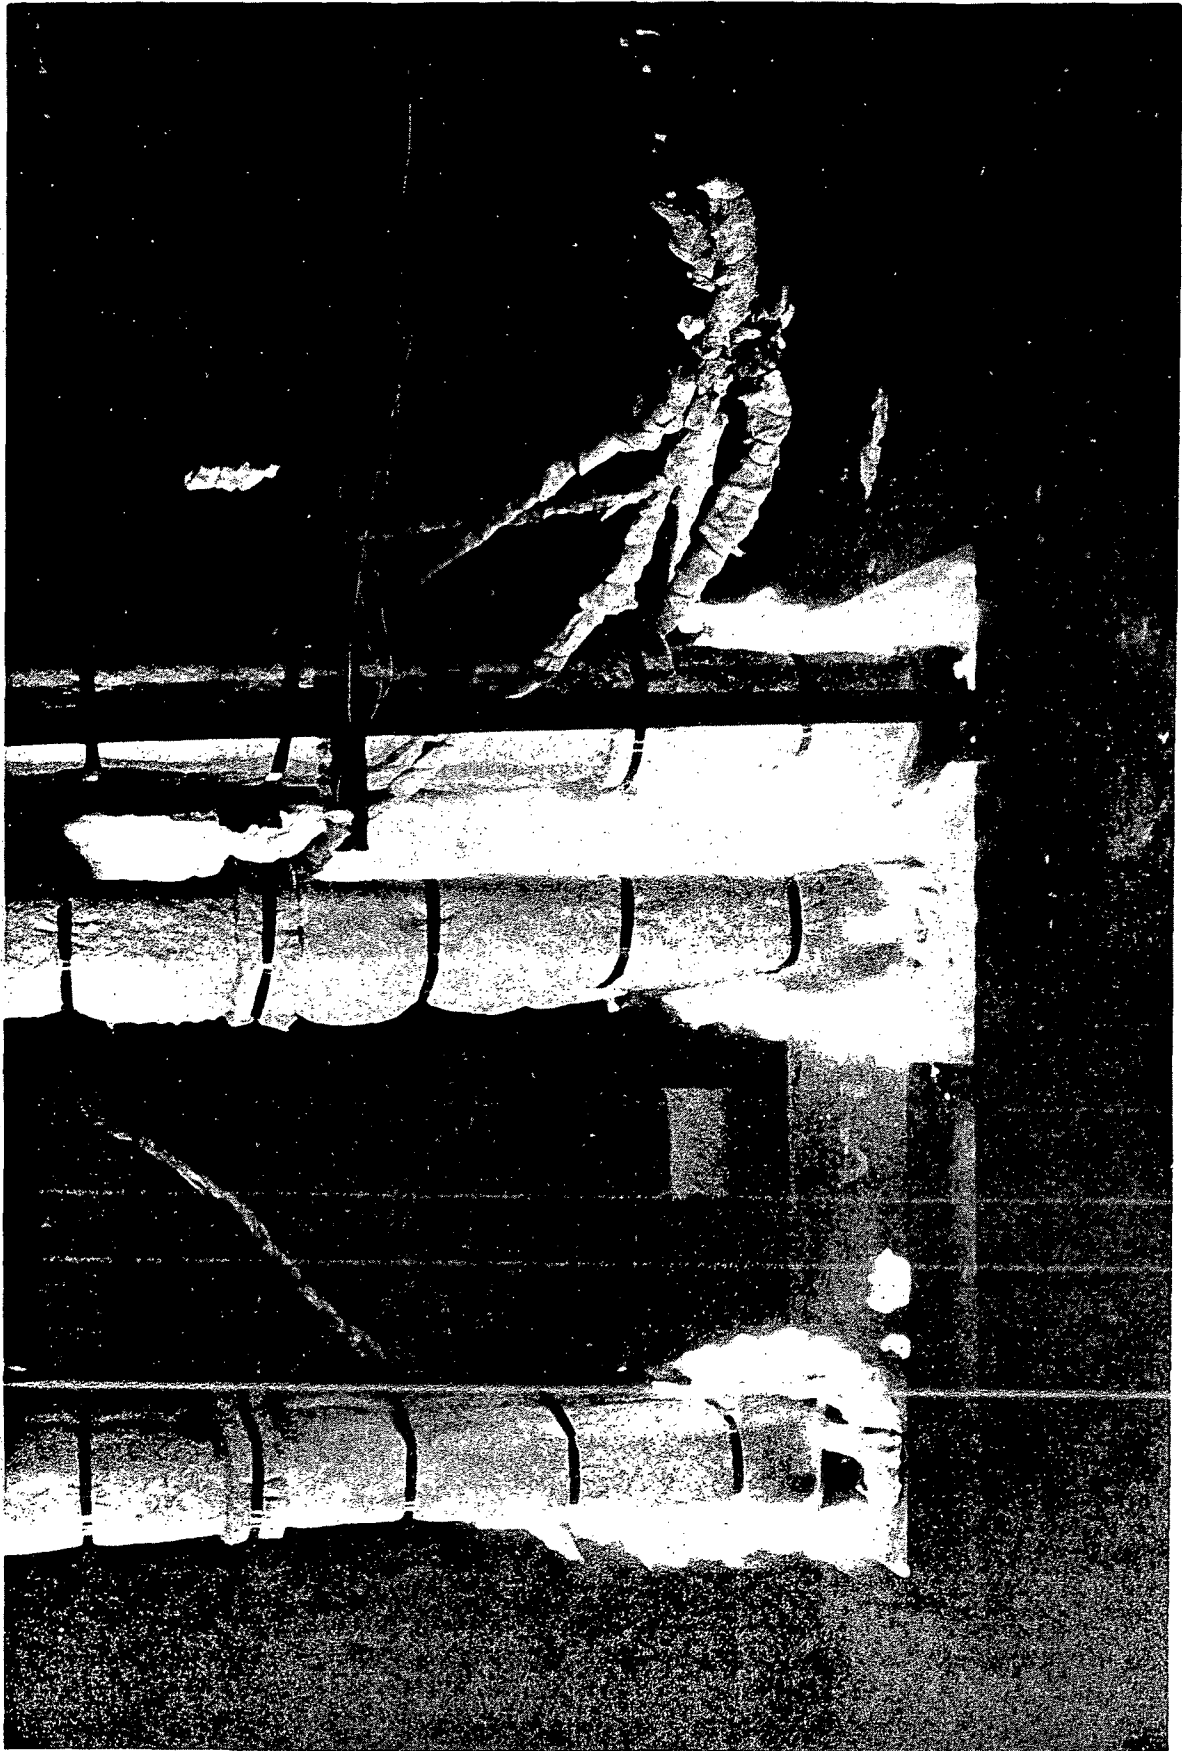
Figure 7. Test Assembly at Ninety Seconds

1:30	All flames now issued from the base of ceramic wool on each cable tray. (It appeared the heptane had been soaked up by the wool, and was burning slowly in wick fashion.) Maximum flame height was about 3 feet (0.9 m) except between trays 1 and 3. Maximum flame height between these two trays was 6 feet (1.8 m) Appearance of test assembly is shown in Figure 7.

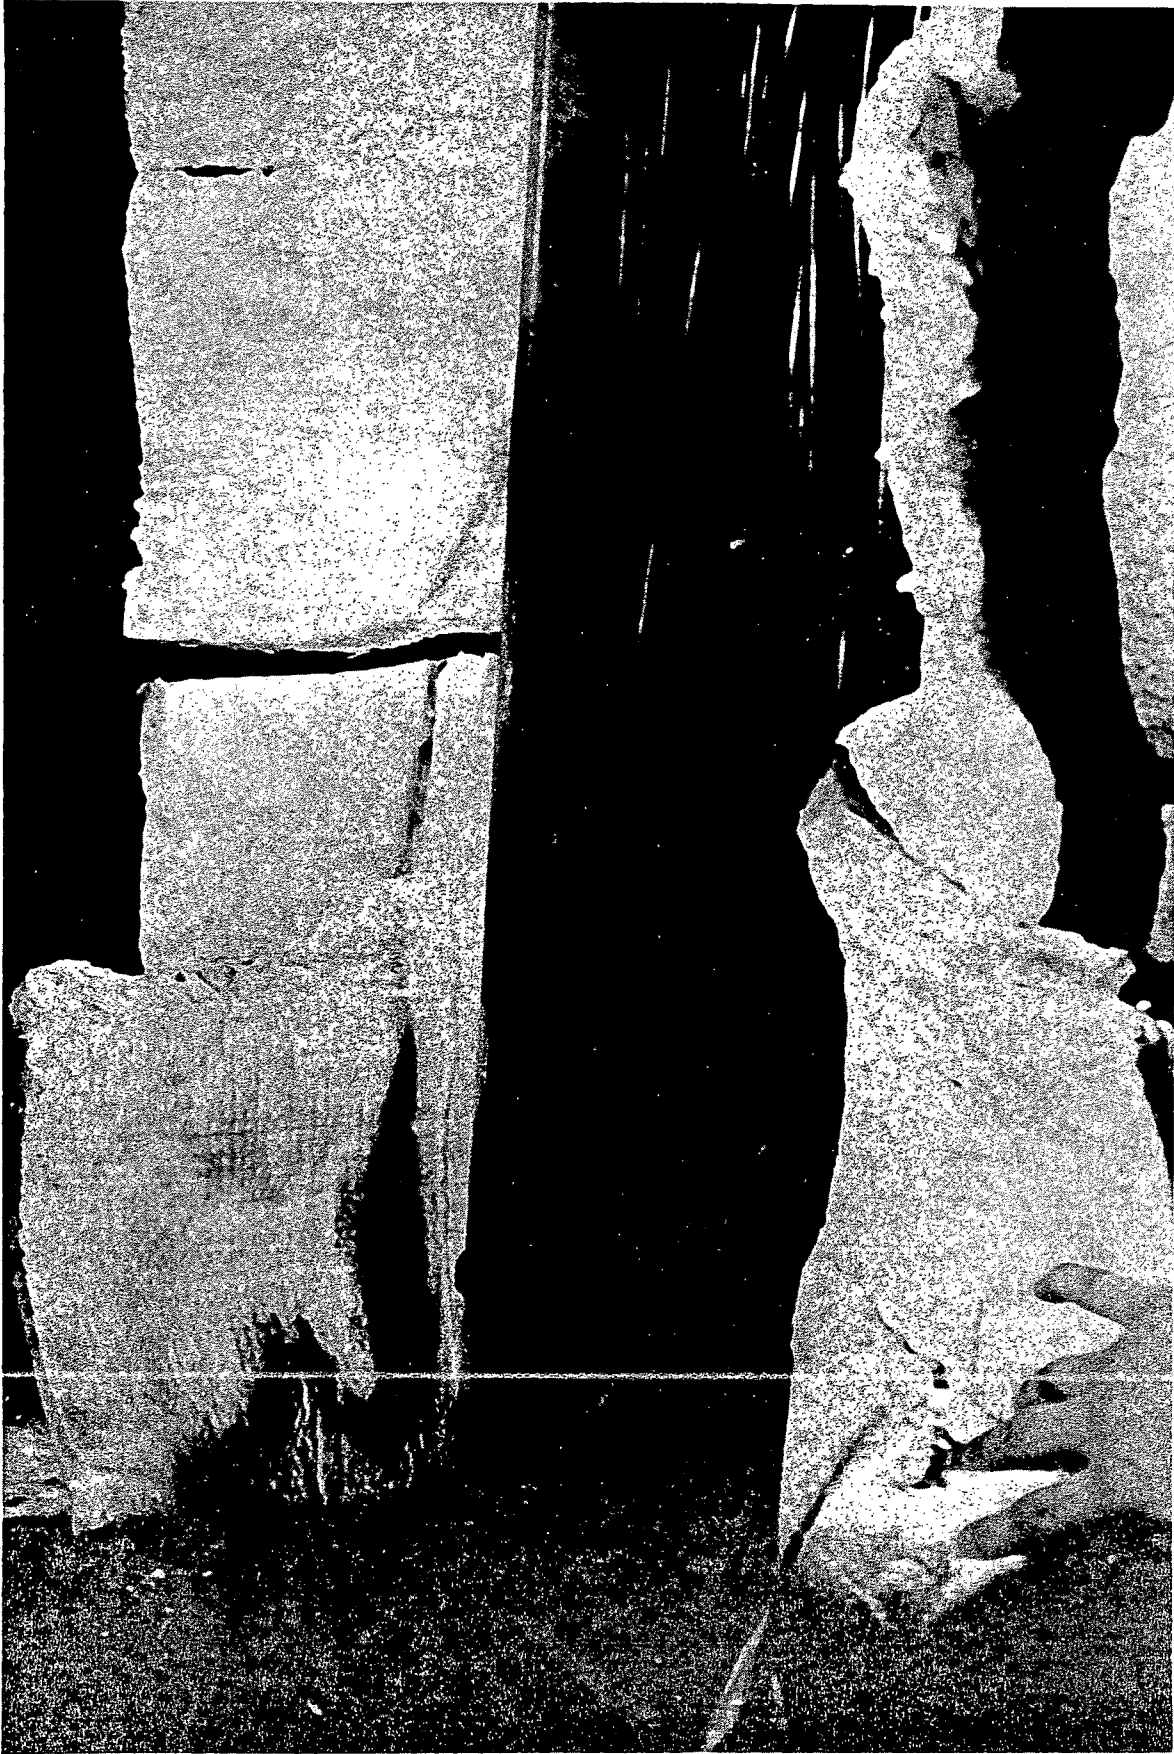
Figure 11. Tray 3 After Test

above the floor. The interior surface of the wool appeared unchanged, except for small areas of light brown near the base in trays 1, 2, 3 and 4, as shown in Figure 11.

In all cable trays except tray 5, thermal damage of cables was observed near the base (3 to 6 inches above the fire pan). A summary of damage is shown in Table 12. Cable damage in tray 3 is shown in Figures 11 and 12. Cable damage in tray 2 is shown in Figure 13.

<u>Tray No.</u>	<u>Description</u>
1	Cable material at bottom of bundle loop melted and charred.
2	Cable material of all cables in contact with bottom tray rung melted.
3	Cable material at bottom of bundle loop and along tray side channels melted and charred. Greatest amount of cable damage occurred in tray 3.
4	Cable material at bottom of bundle loop melted and charred.
5	No cable damage observed.

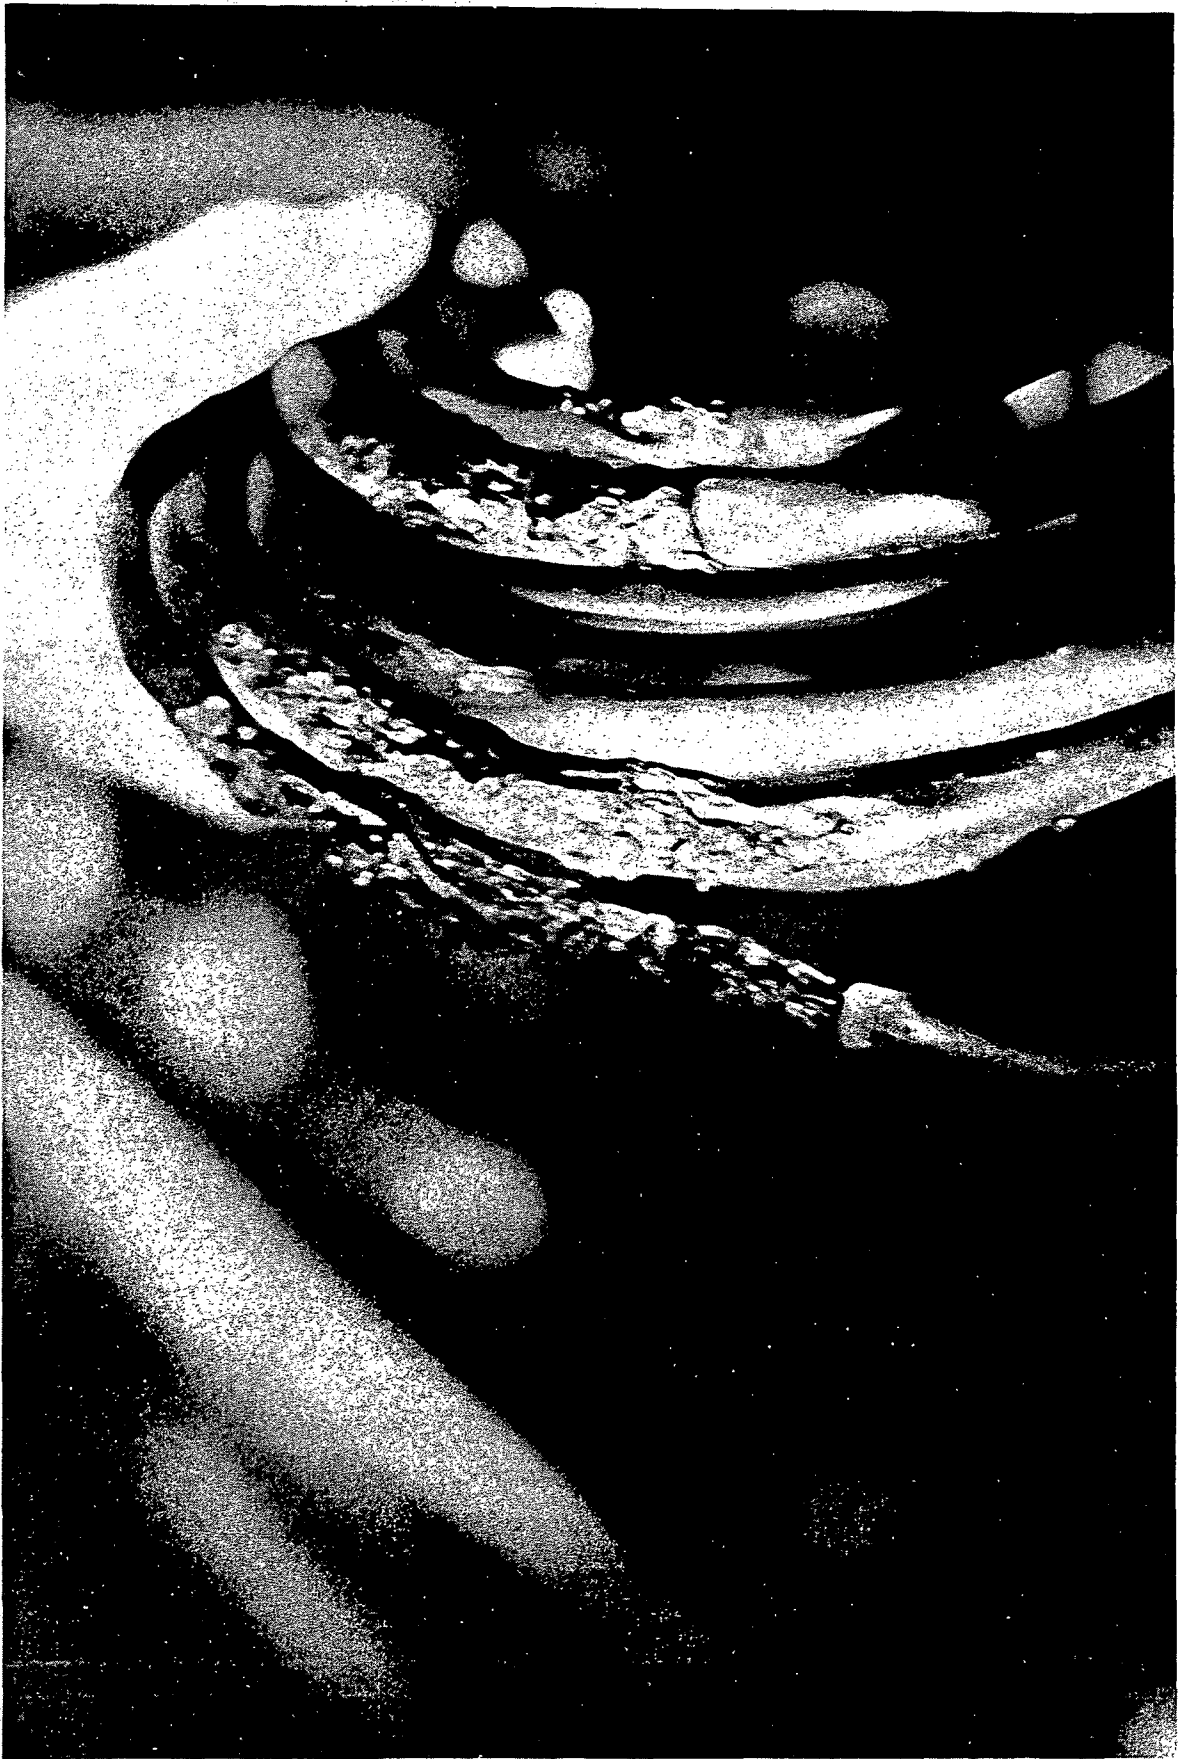
Figure 12. Tray 3 After Test

4:00	Flame height between trays 1 and 3 decreased to 3 feet (0.9 m).
5:00-23:00	Flaming continued but intensity and height gradually diminished.
23:35	A loud report was heard and a burst of flame issued from the base of tray 3. Wool wrapping on tray 3 between 6 and 10 feet (1.8 and 3.0 m) above the floor appeared to have slipped from its fasteners causing openings in the vertical and horizontal joints.
