# **Ultrasonic Phased Array Assessment of the Interference Fit and Leak Path of the North Anna Unit 2 Control Rod Drive Mechanism Nozzle 63 with Destructive Validation**

## AVAILABILITY OF REFERENCE MATERIALS IN NRC PUBLICATIONS

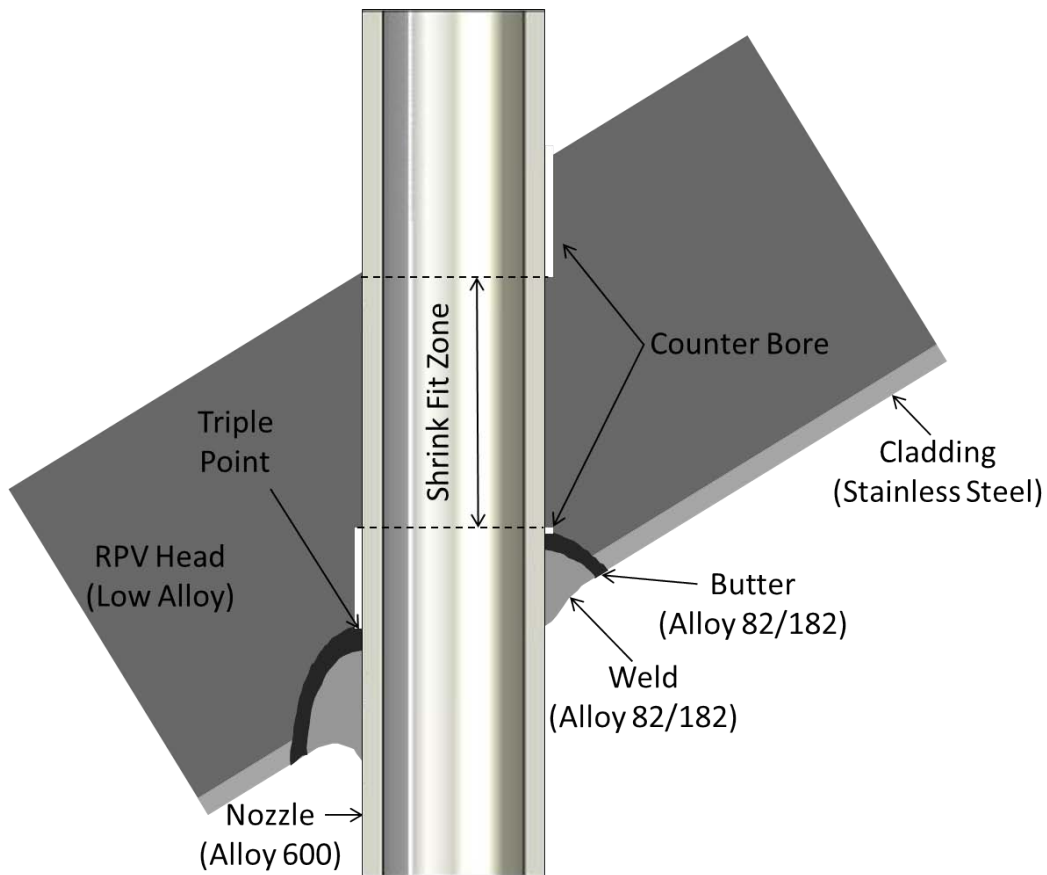
**Figure 1.1 CRDM J-groove Weld Schematic**

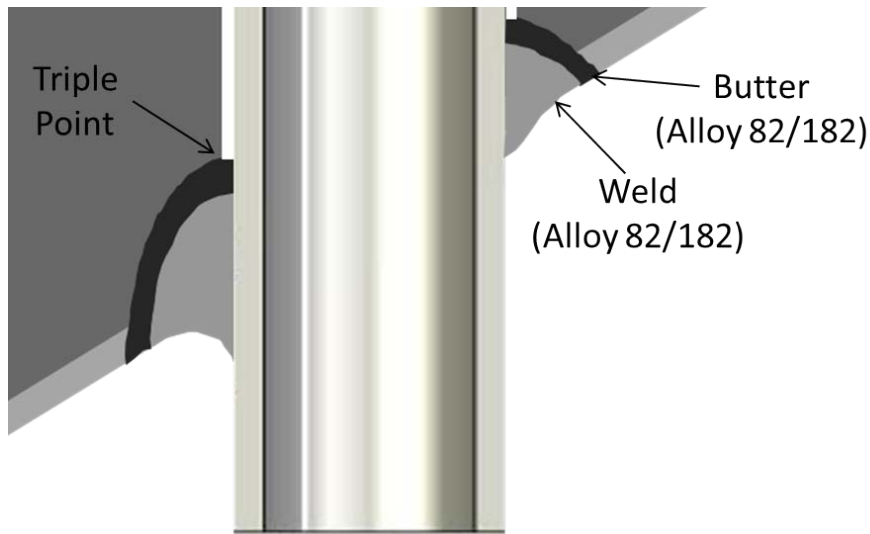
**Figure 1.2 The Triple Point in the Assembly Where the Alloy 600 Nozzle, RPV Head, and Weld Buttering Material Meet**

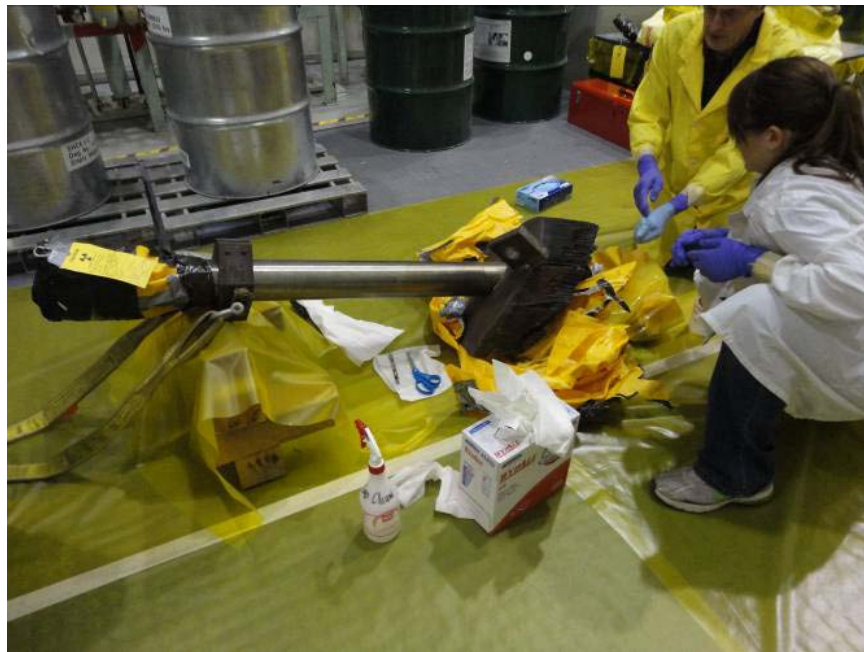
Figure 2.1 As-Received Condition of Nozzle 63

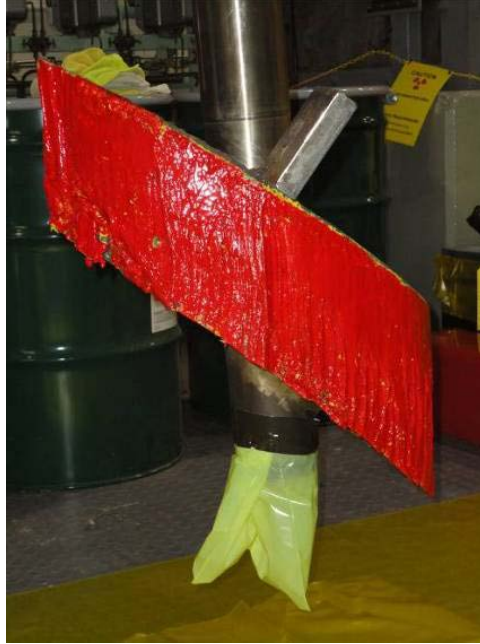
**Figure 2.2 Nozzle 63 with Painted Edges**

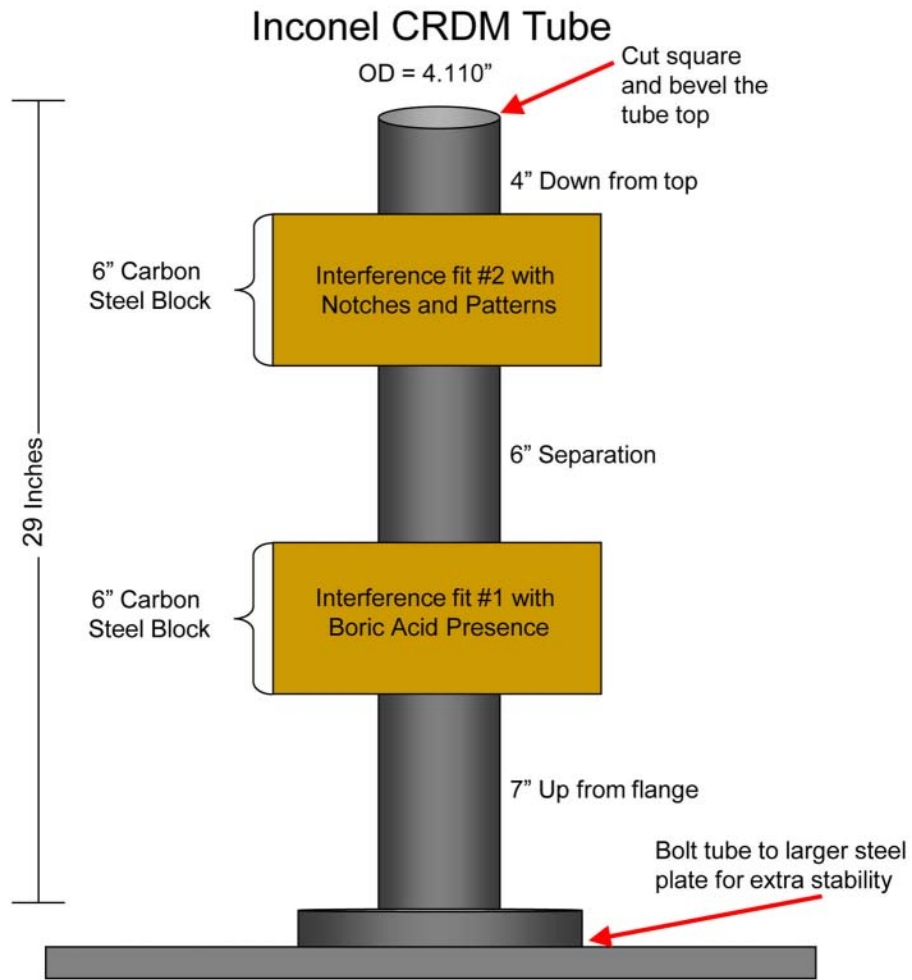
**Figure 4.1 Assembled CRDM Interference Fit Mockup Specimen**

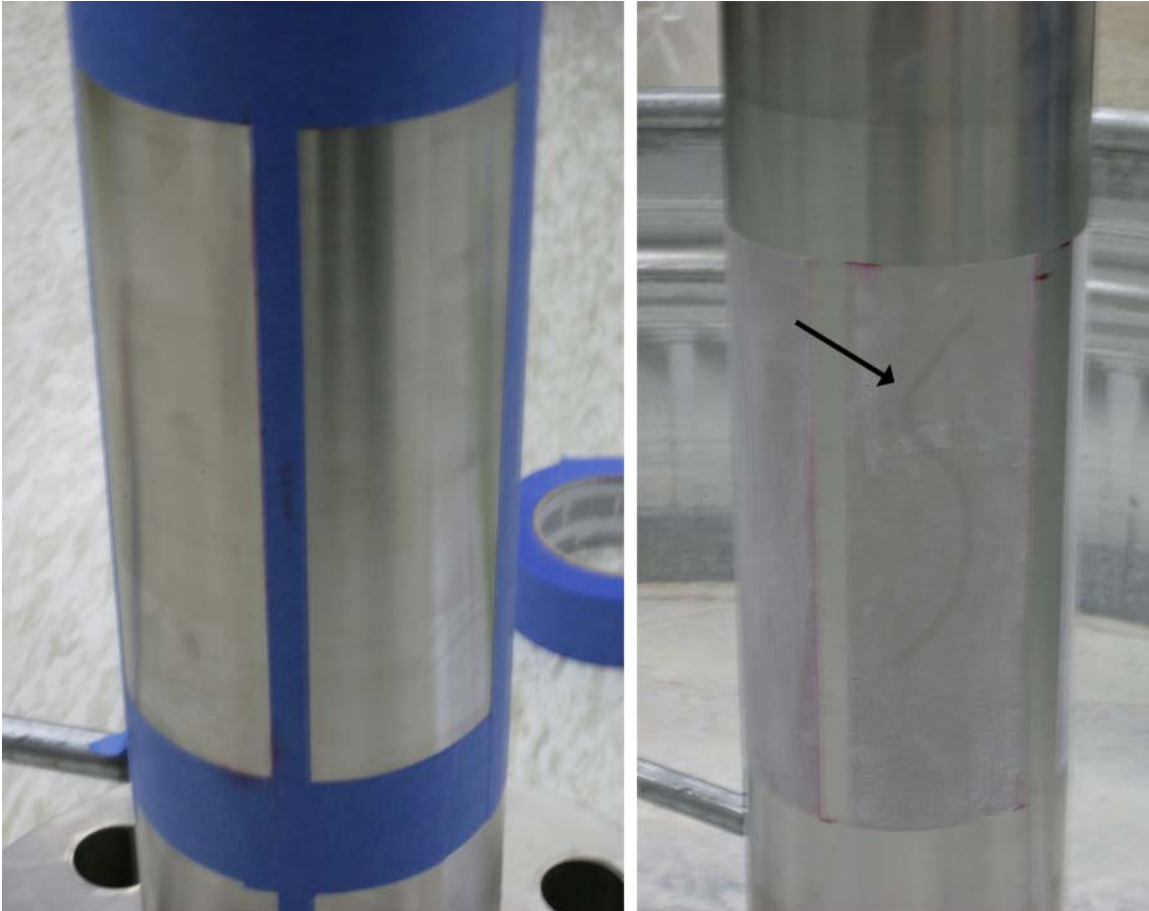
**Figure 4.3 Boric Acid Application.** Left: Blue painter's tape was used to preserve the bare metal surface of the Alloy 600 tube. Right: The arrow indicates the path where boric acid was scraped off.

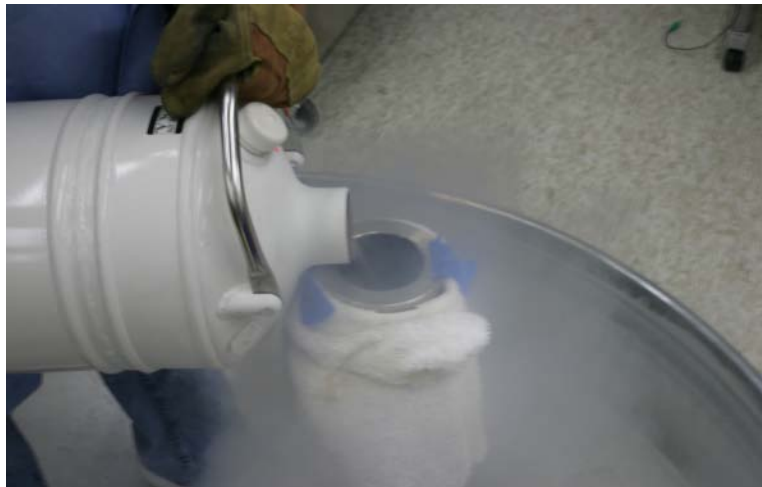
**Figure 4.7 Filling Alloy 600 Tube with Liquid Nitrogen**

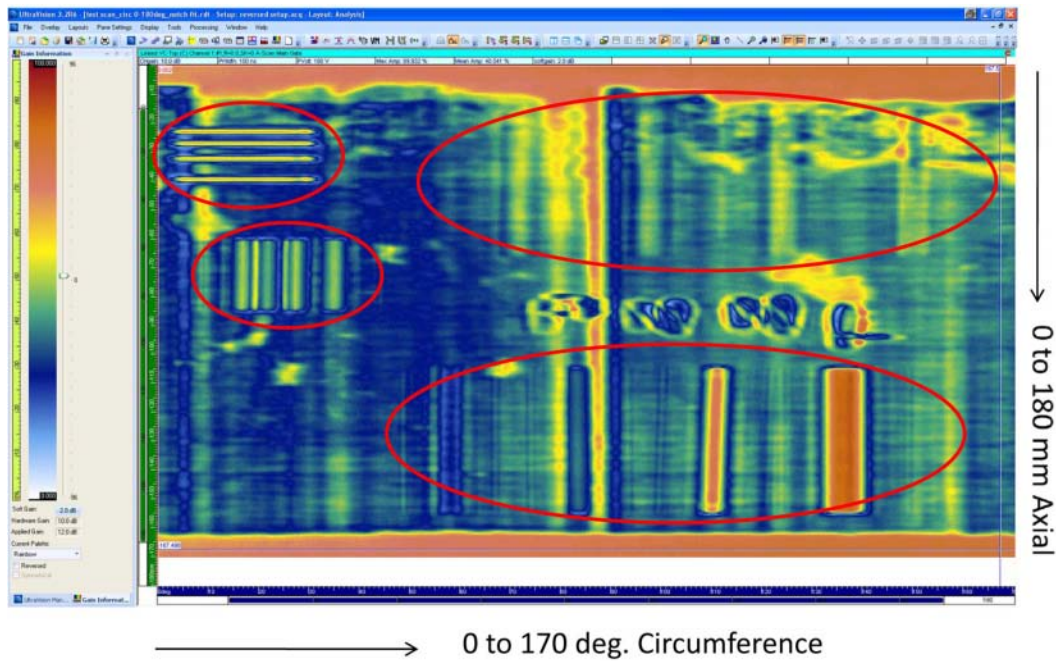
**Figure 4.10 Top View, Plan View, or C-scan Ultrasonic Image of the Upper Interference Fit Region Containing Calibration Notches in the Alloy 600 Tube. Calibration notches are circled.**

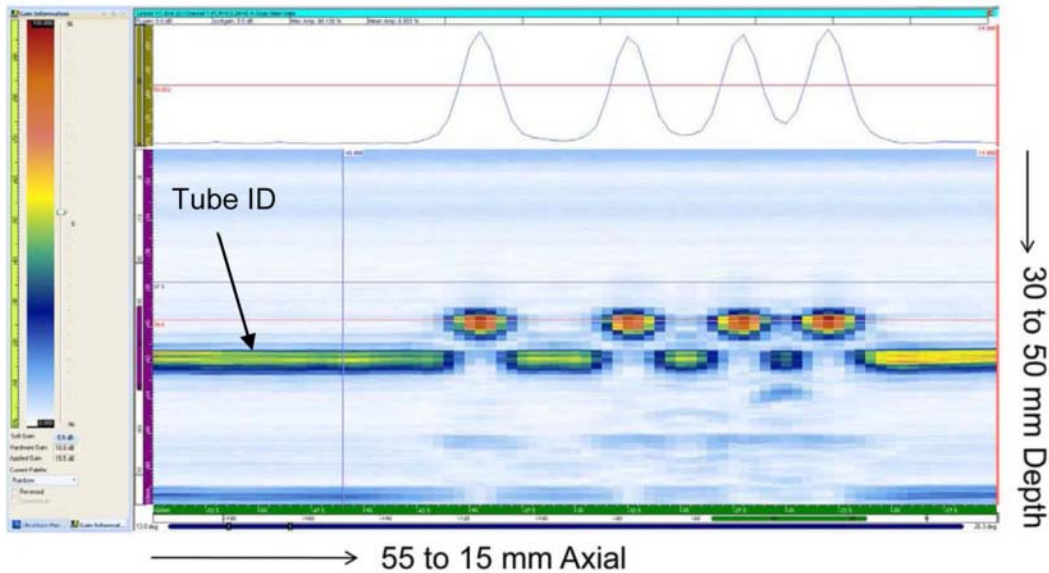
**Figure 4.11 D-scan End View of the Axial Resolution Notches in the Alloy 600 Tube**

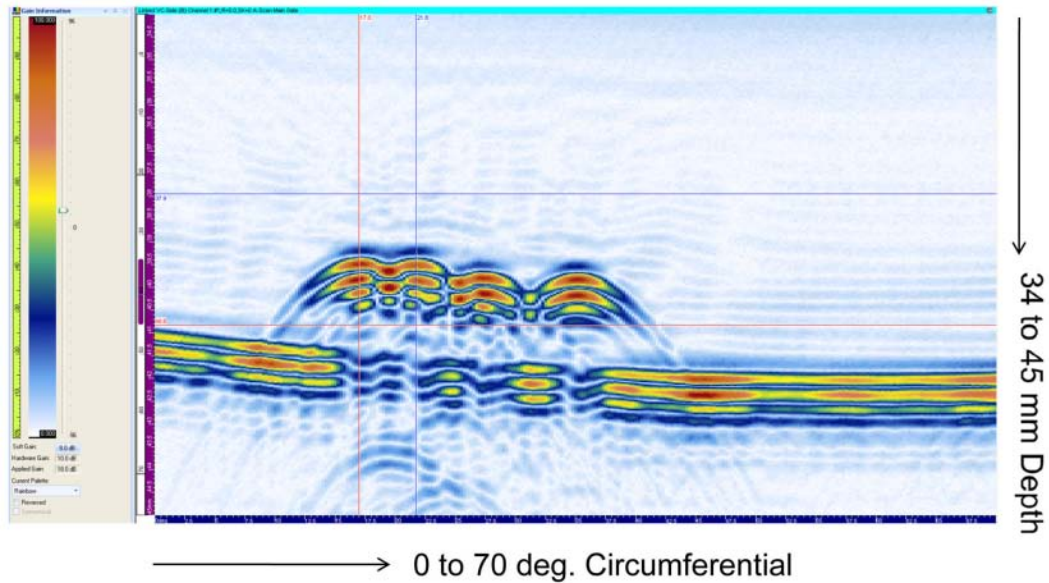
**Figure 4.12 B-scan Side View of the Circumferential Resolution Notches in the Alloy 600 Tube**

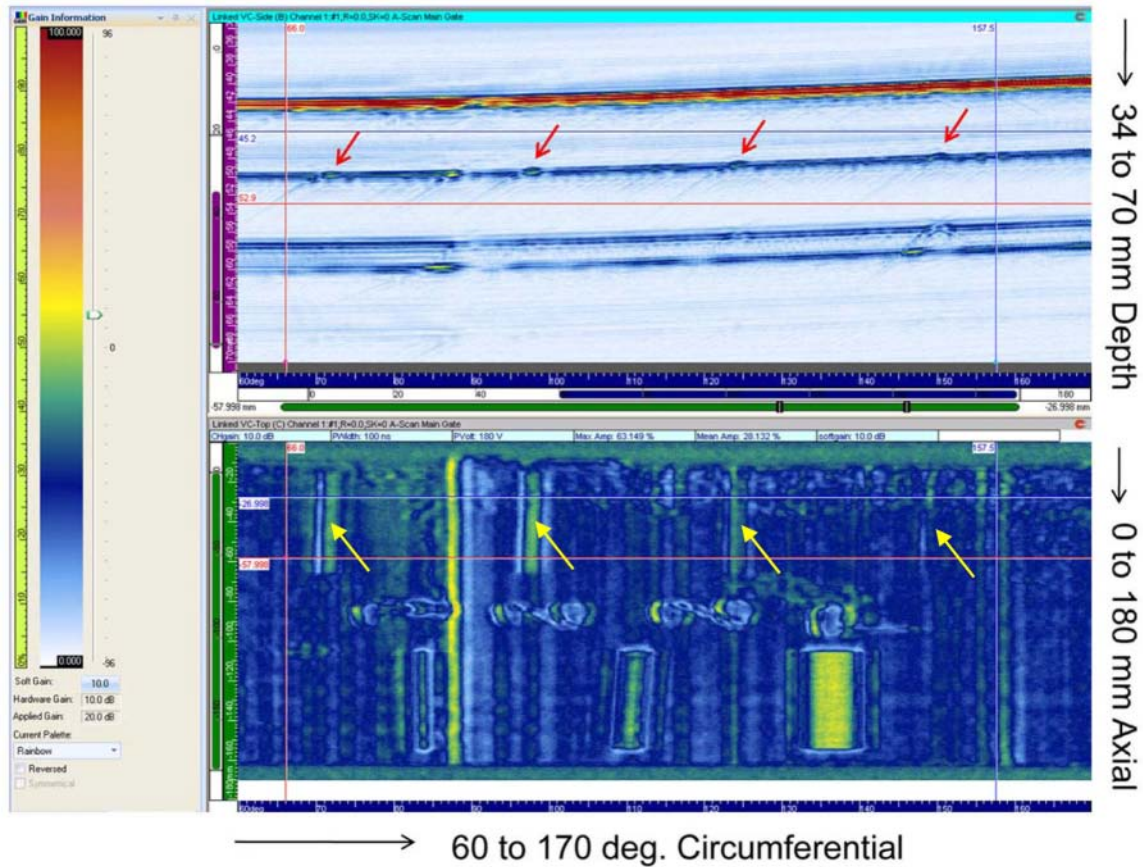
**Figure 4.13** The Second Echo is Gated in the Side View Image in the Top of Figure with the Horizontal Lines. The corresponding C-scan top view is displayed in the bottom image. This second echo captures a disturbance in the back-wall echo showing some depth information, noted by the red arrows at top. The yellow arrows note the depth-varying notches.

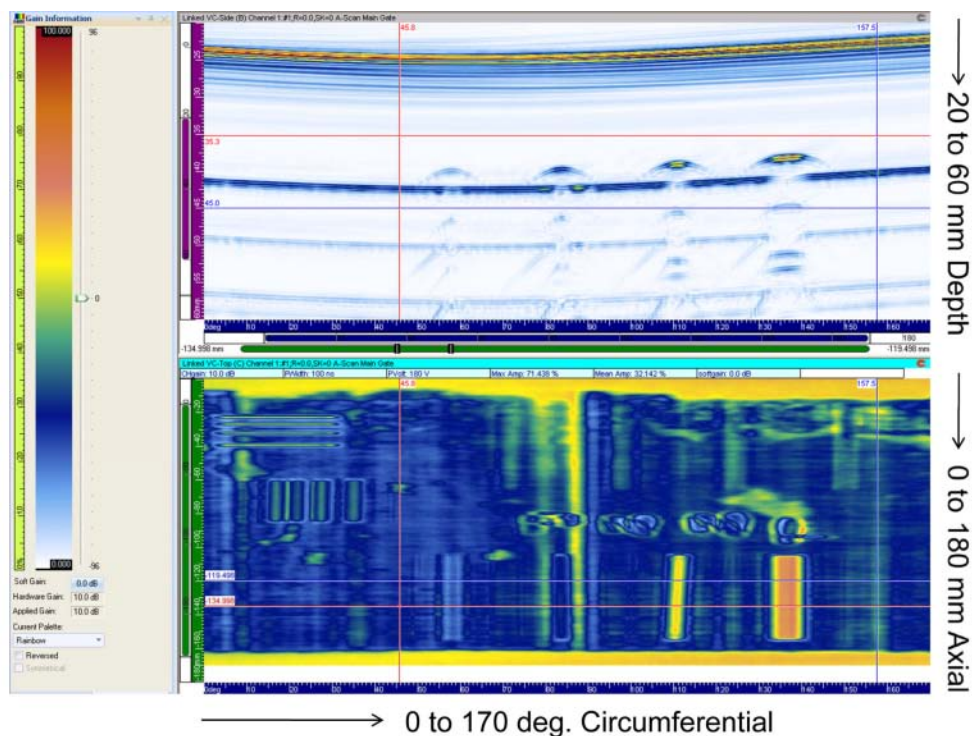
**Figure 4.14 B-scan Side View on Top and C-scan Plan View on Bottom of the Width Varying Notches in the Inconel Tube**

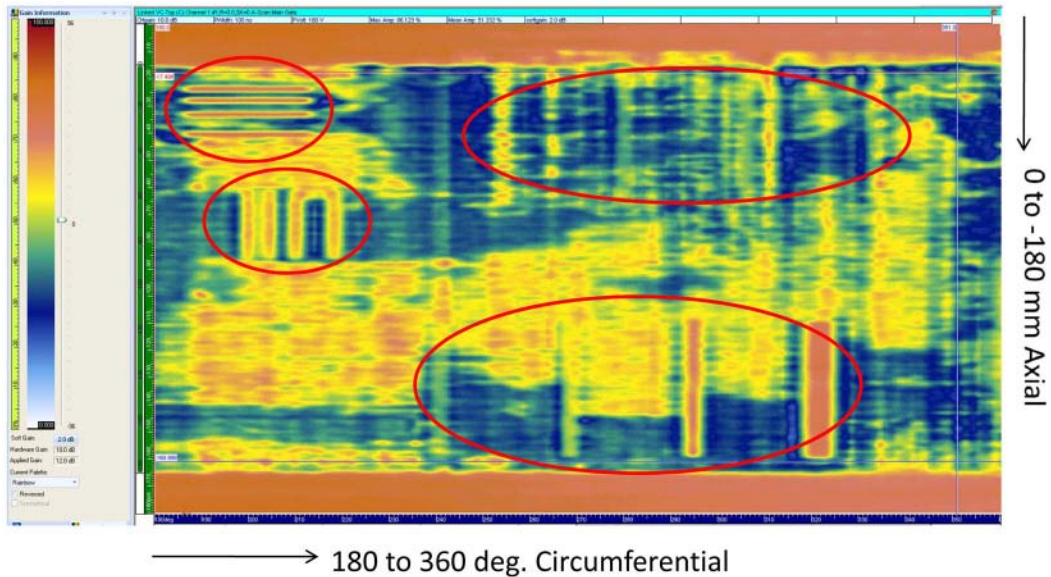
**Figure 4.15 C-scan Plan View of the Notches in the Low-Alloy Steel from the First Ultrasonic Echo. The calibration notches are circled.**

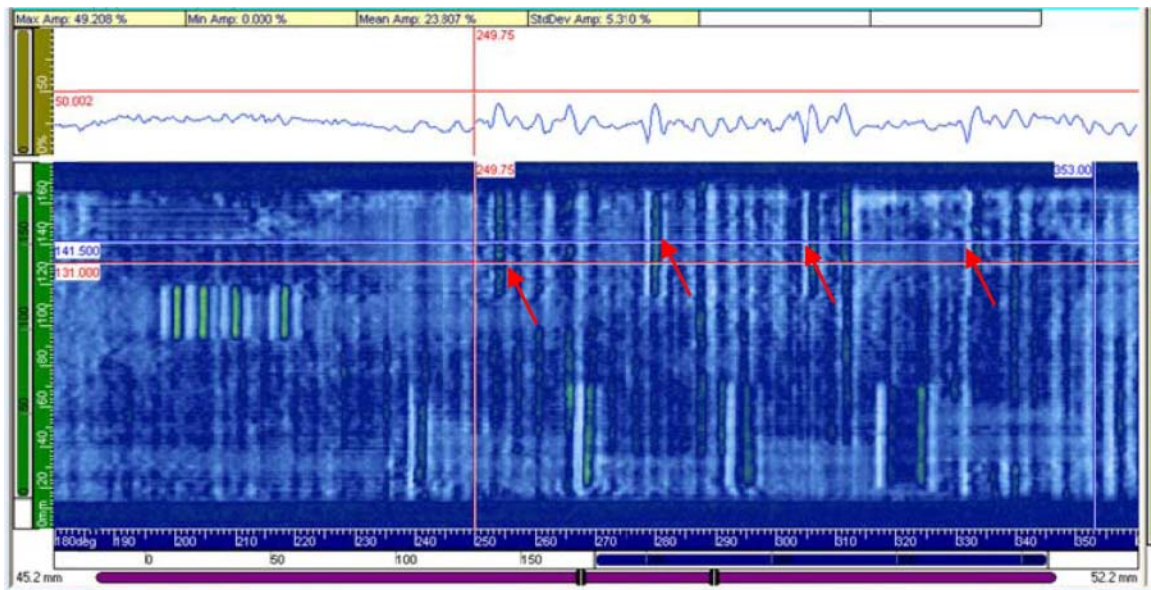
**Figure 4.17 C-scan Plan View of the Depth Notches in Low-Alloy Steel, Noted by Red Arrows on the Upper Right. This image was acquired from the second ultrasonic echo.**

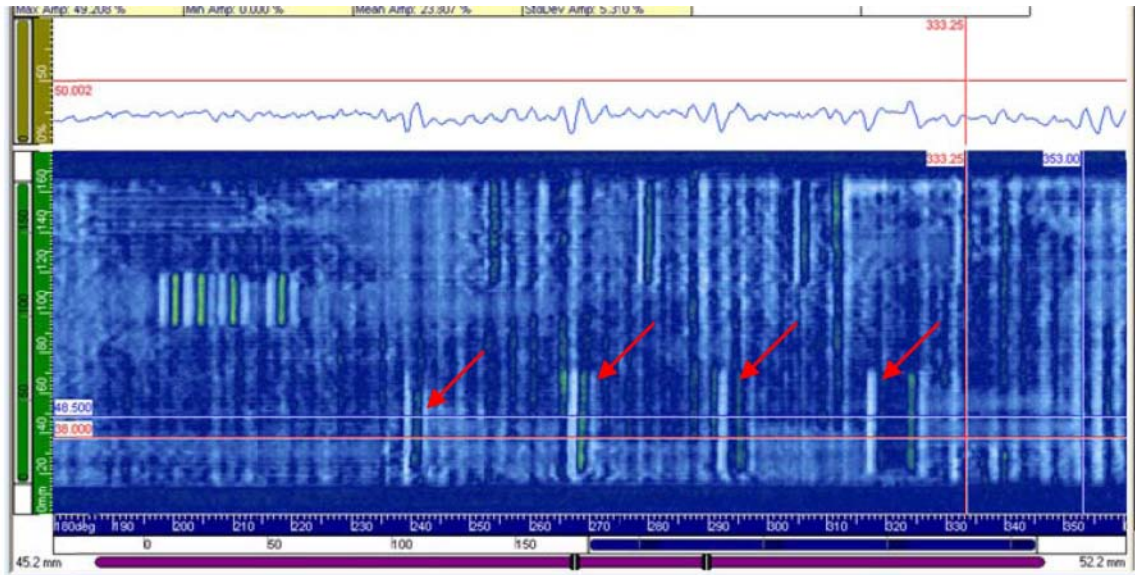
**Figure 4.18 C-scan Plan View of the Width Notches in Low-Alloy Steel, Noted by Red Arrows on the Bottom. This image was acquired from the second ultrasonic echo.**

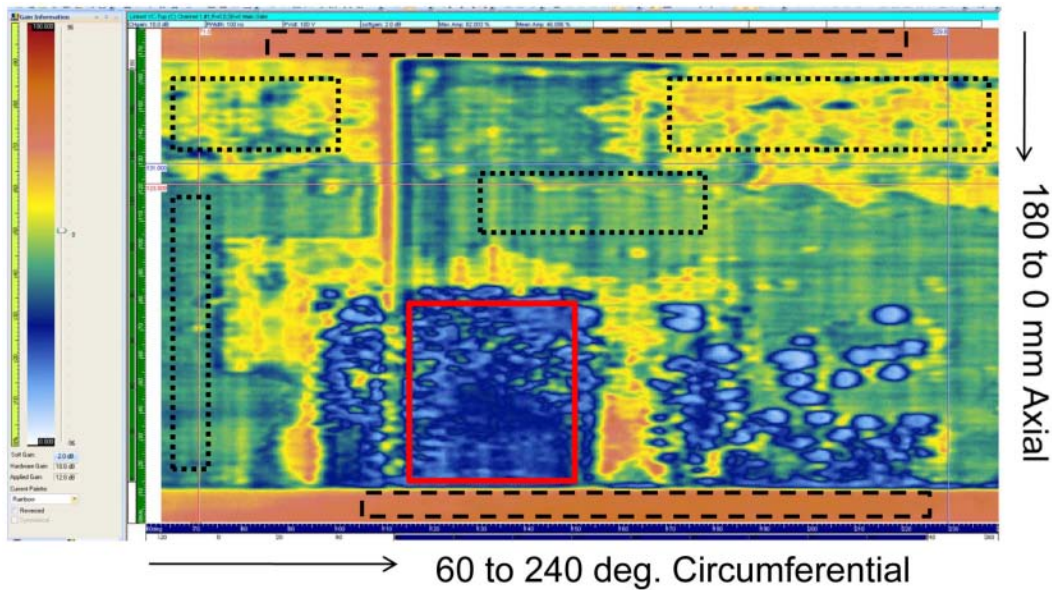
**Figure 4.21 The Interference Fit Region Containing Boric Acid is Subdivided into Three Regions. The red box represents the presence of boric acid in the interference fit region, the black dashed boxes represent the tube-to-air interface region, and the black dotted boxes represent the nominal interference fit region.**

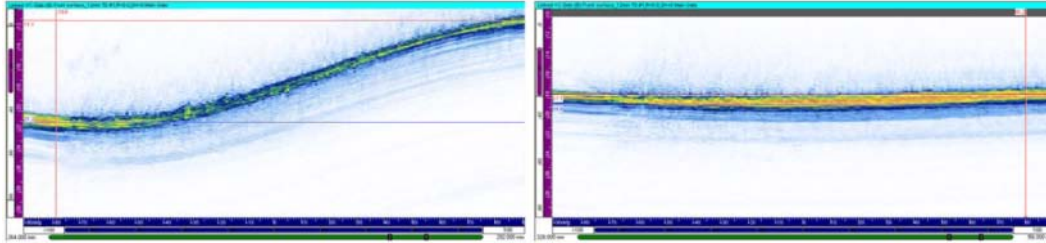
**Figure 5.1 Alloy 600 Tube ID Response Before (left) and After (right) Centering the Scanner on the Nozzle. The horizontal axis represents approximately 180 degree and the vertical axis 20 mm (0.79 in.).**

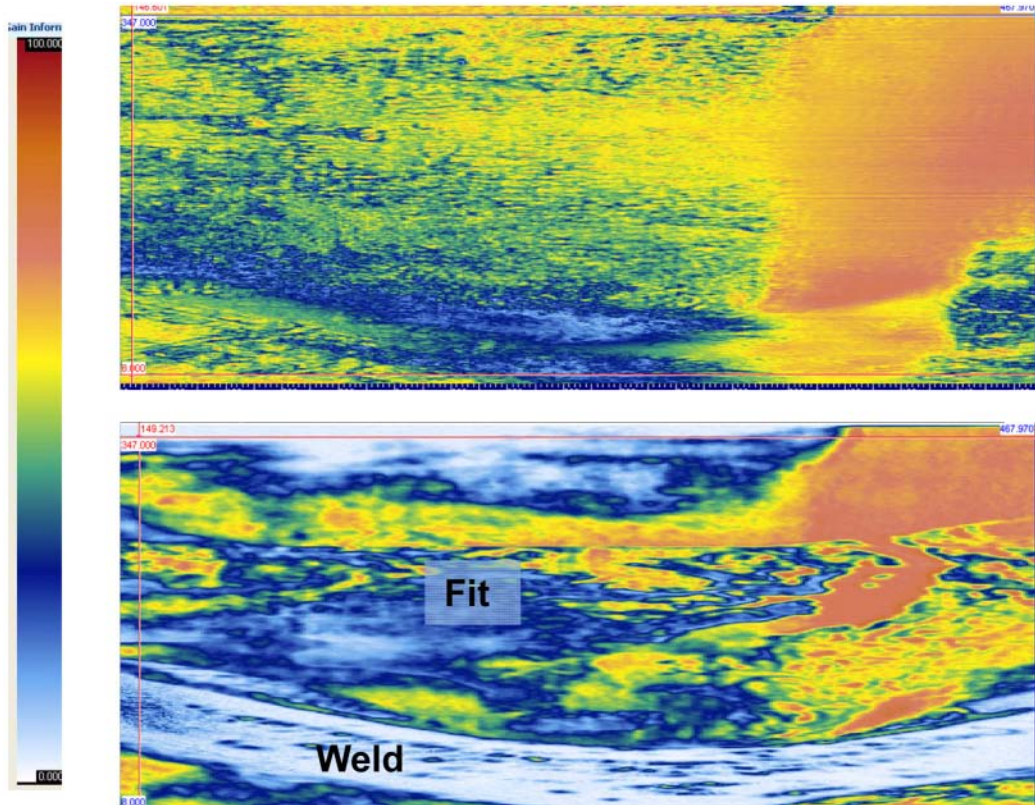
**Figure 5.2 First PA Ultrasonic Data from Nozzle 63. The front surface or nozzle ID echo is on the top and the interference fit echo on the bottom. The horizontal axis represents the 86 to 274 degree area and the vertical axis represents 360 mm (14.17 in.). The color scale is represented on the far left.**

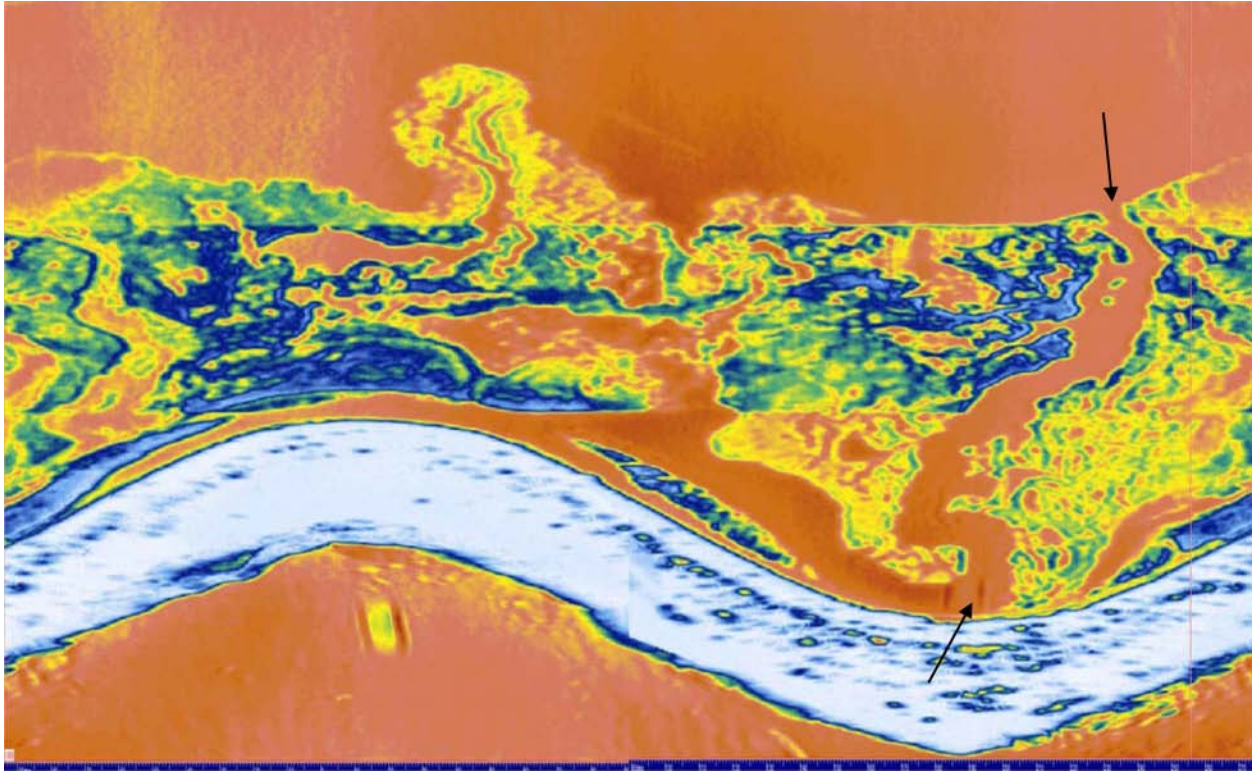
**Figure 5.3 PA Ultrasonic Data from the Interference Fit in Nozzle 63 Acquired After the Second Brushing of the Nozzle ID. The horizontal axis represents the full 360-degree area and the vertical axis represents 360 mm (14.17 in.). Black arrows indicate primary leak path. The left edge marks the -90 degree location and the right edge the 270 degree location.**

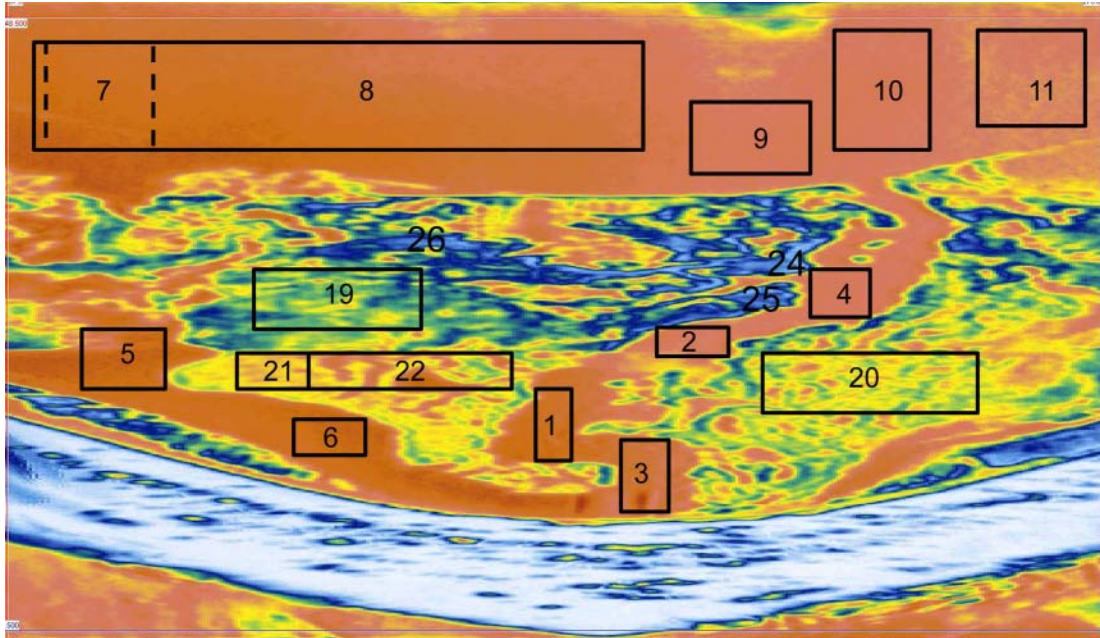
**Figure 5.4 Interference Fit Data Image After First Brushing. The horizontal axis represents approximately 90 to 270 degrees. The vertical axis represents 360 mm (14.17 in.). Boxed regions were used in an amplitude analysis.**

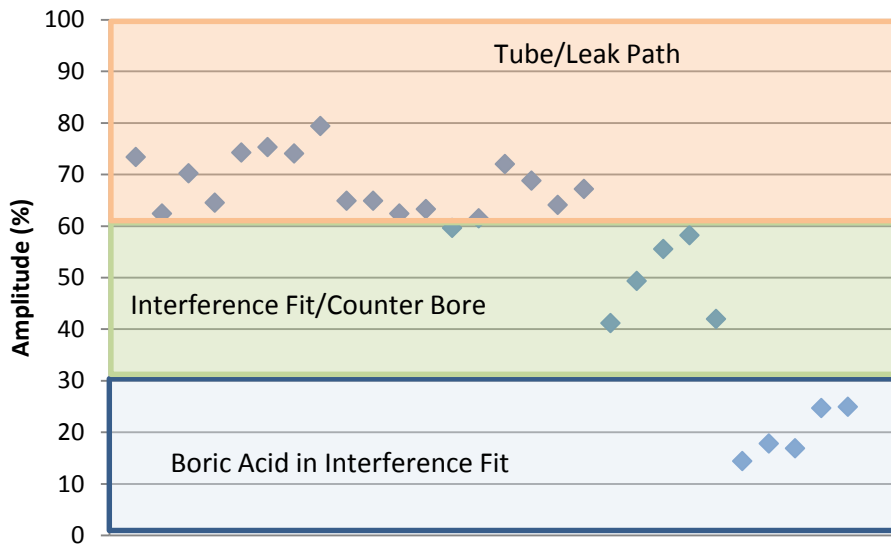
**Figure 5.6 Mean Amplitude Response from the Regions Indicated in Figures 5.4 and 5.5**

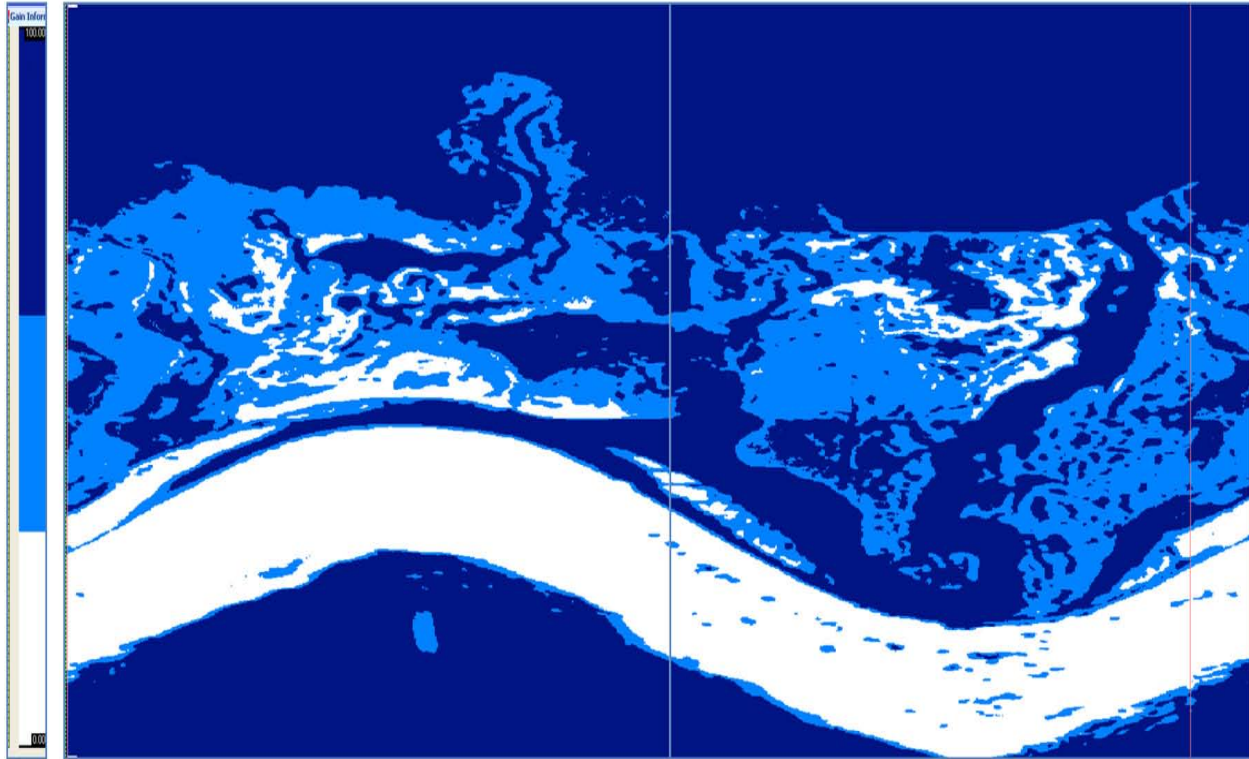
**Figure 5.7 A Tri-Color Representation of the Interference Fit Data. The dark blue represents a leak path or tube-to-air interface, the light blue represents the nominal interference fit and counter bore regions and the white represents the weld and suspected boric acid presence in the interference fit.**

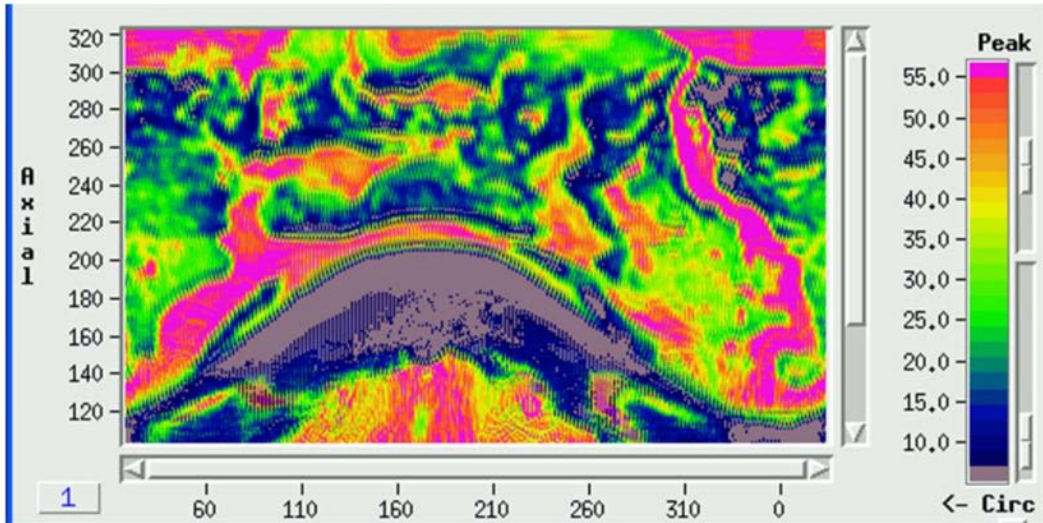
**Figure 5.8** Ultrasonic Data from Nozzle 63 as Obtained by WesDyne International. The image was acquired with a 5-MHz probe. The horizontal axis represents the nozzle circumference in units of degrees. The vertical axis represents the nozzle axis in units of millimeters.

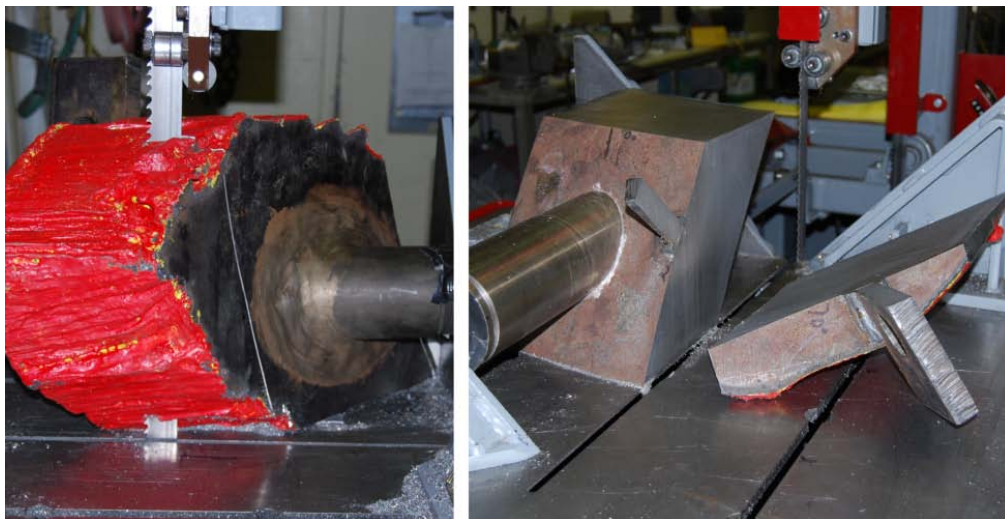
**Figure 6.1 Size Reduction Cutting Activity**

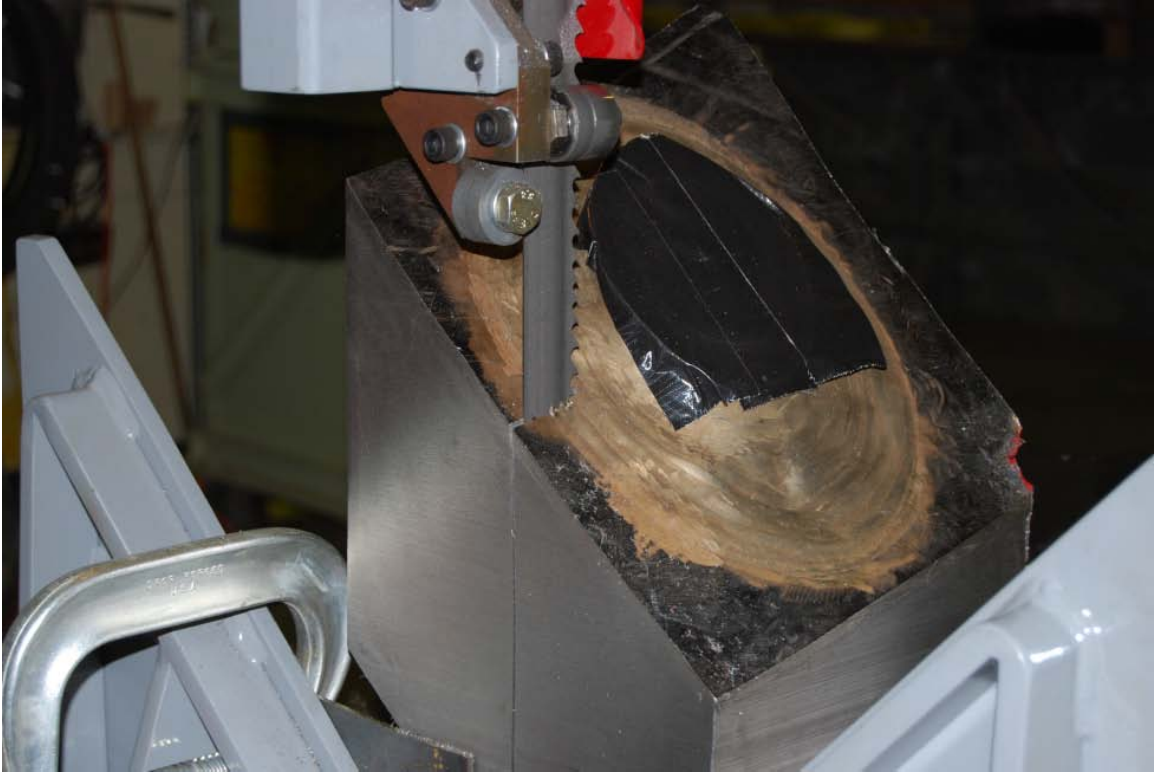
**Figure 6.2 Start of the Dissection Cut**

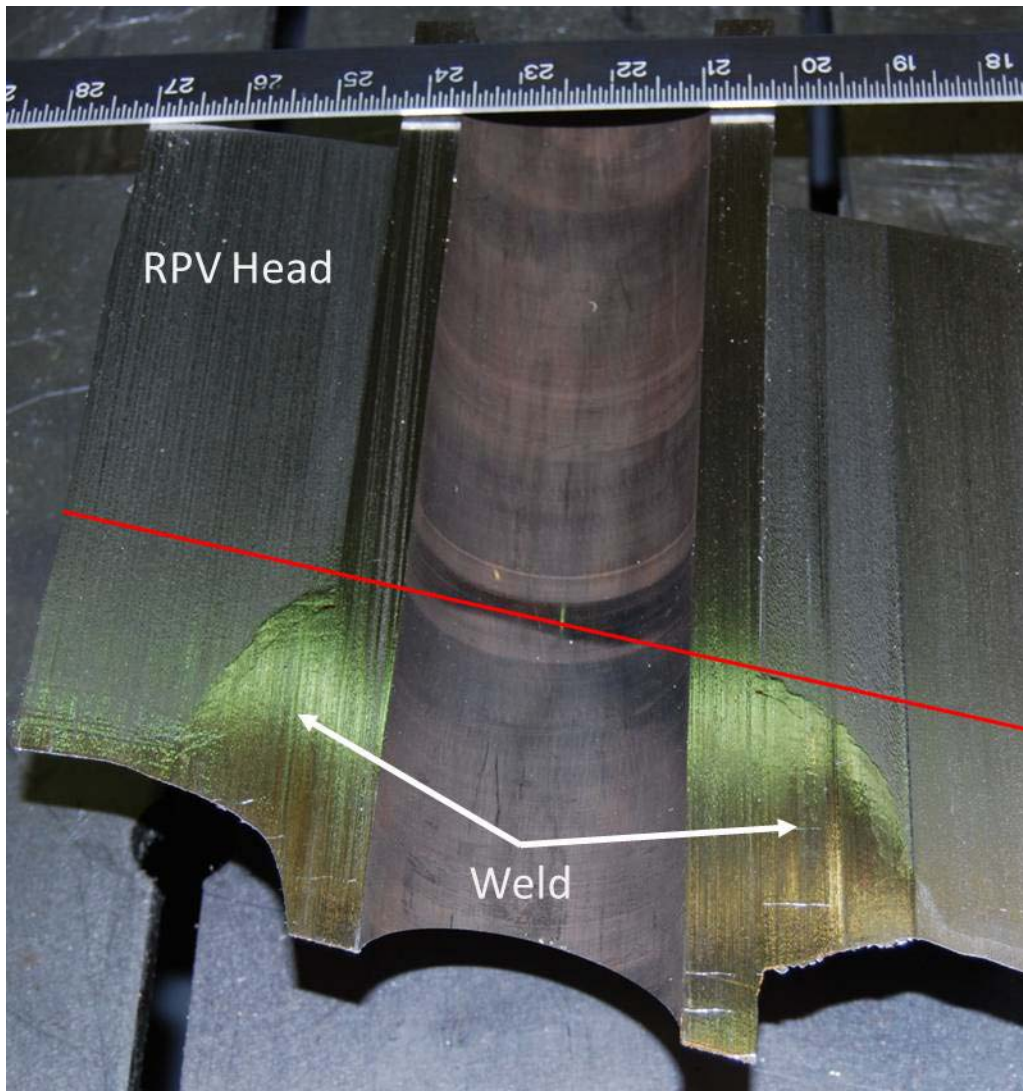
**Figure 6.3 Nozzle 63 Assembly Cut in Half by Dissection Cut. The red line indicates where the weld removal cut was made.**

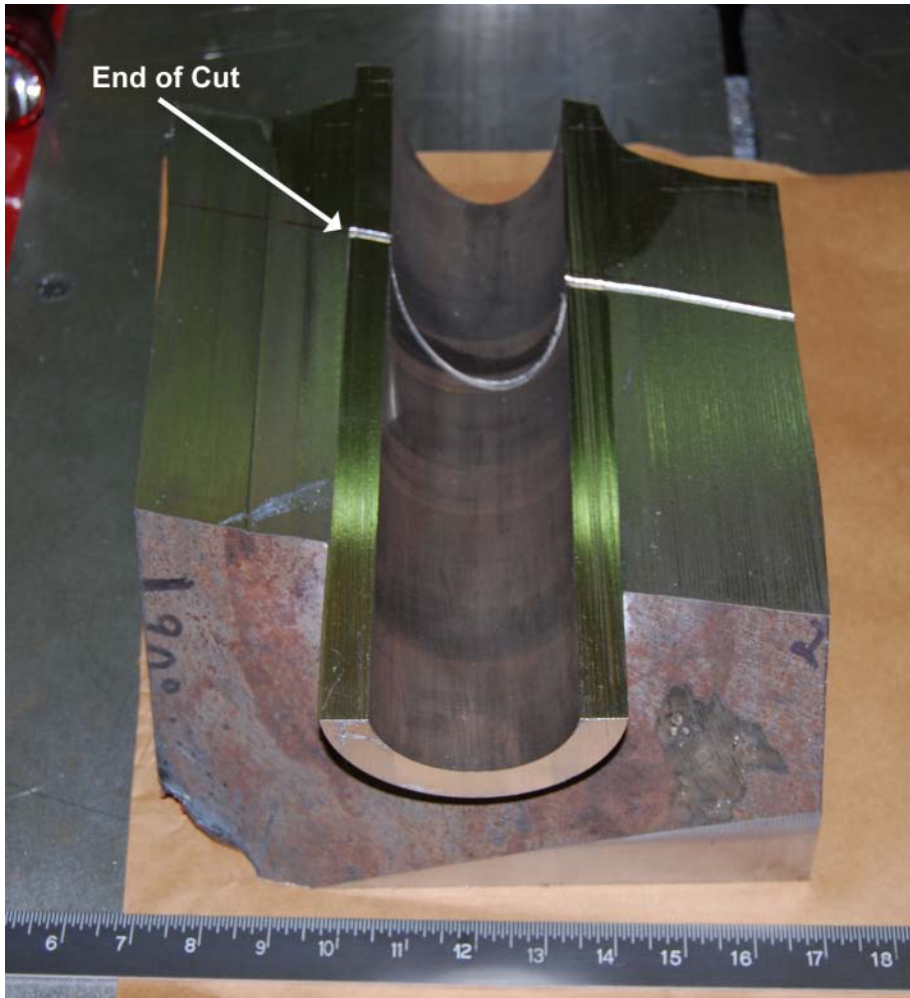
**Figure 6.4 End of J-groove Weld Removal Cut**

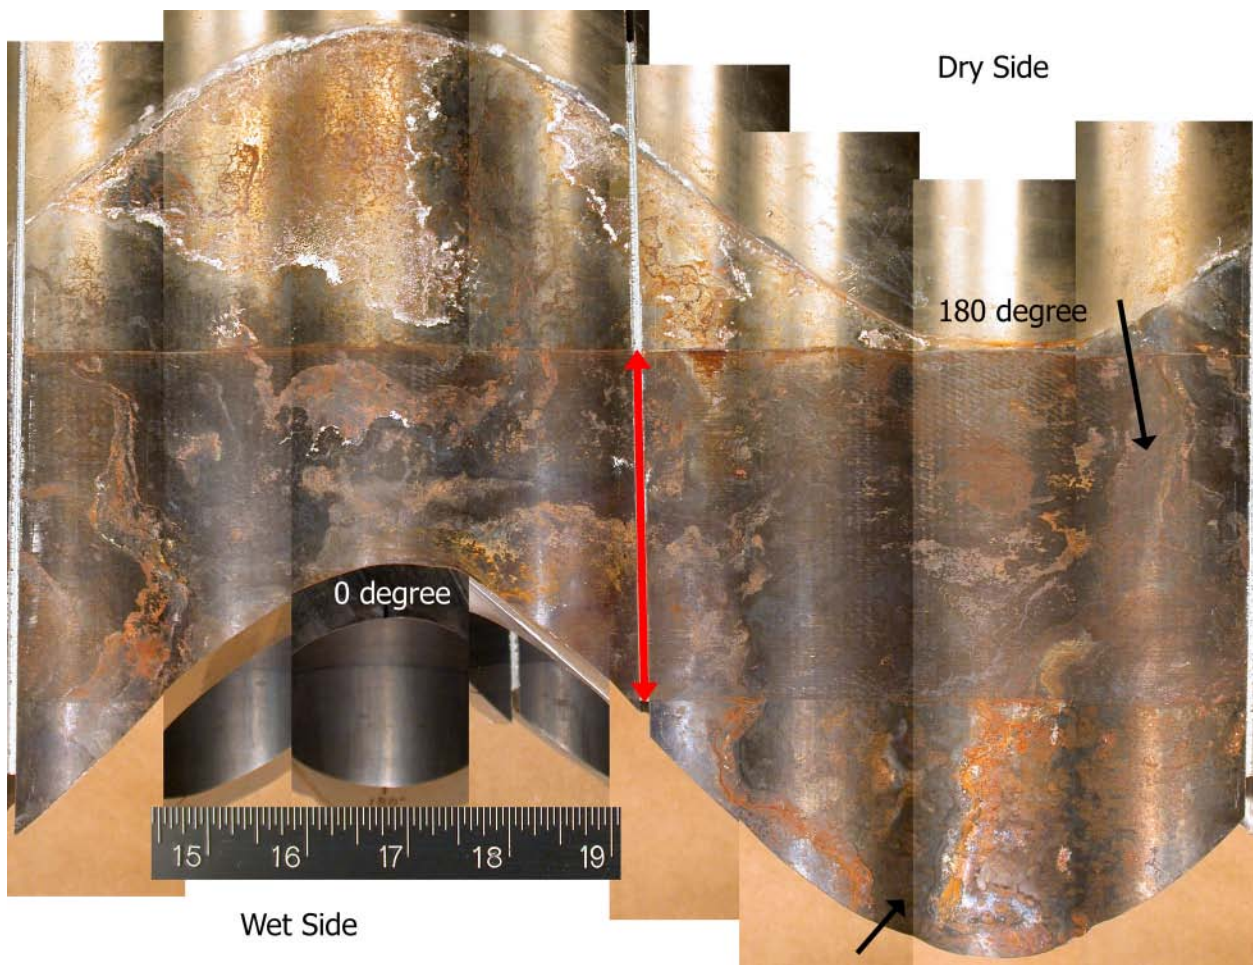
**Figure 7.1 Nozzle Surface.** The red line marks the interference fit region and the two black arrows identify the main leak path.

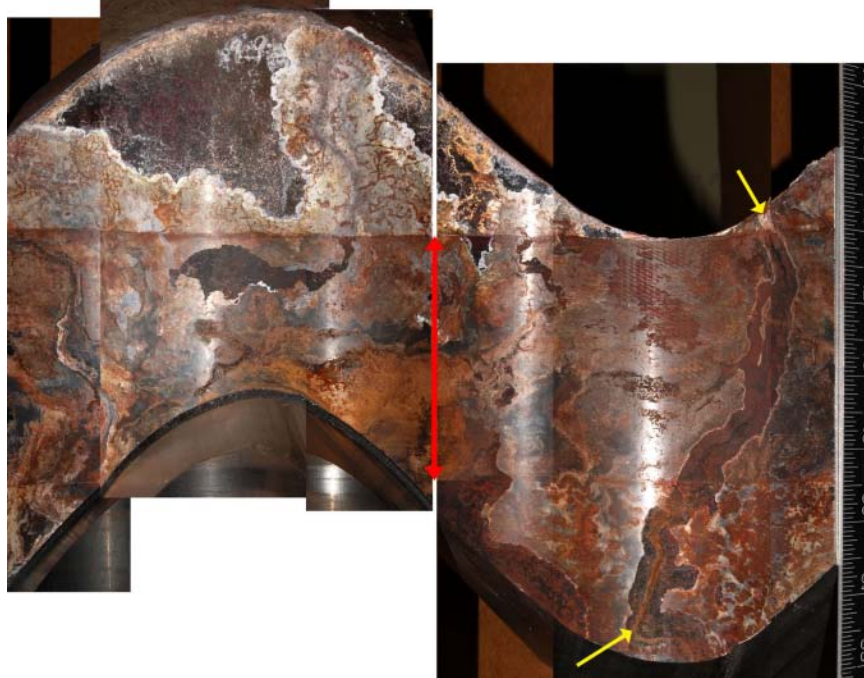
**Figure 7.2 RPV Head Surface.** The red line marks the span of the interference fit region and the two yellow arrows identify the main leak path.

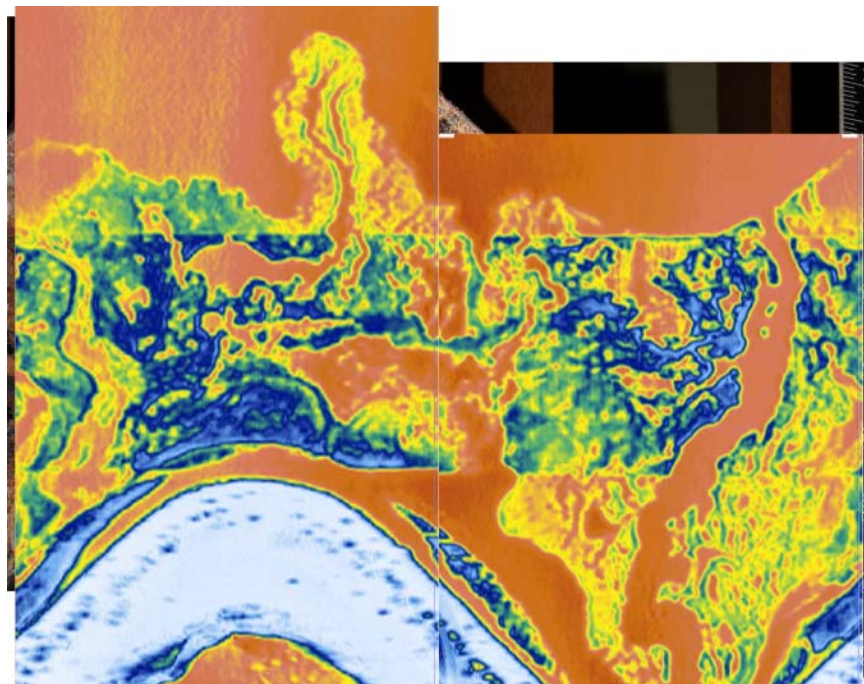
**Figure 7.3 Ultrasonic Data Stretched to Best Match the RPV Head Photograph**
