# **Ultrasonic Phased Array Assessment of the Interference Fit and Leak Path of the North Anna Unit 2 Control Rod Drive Mechanism Nozzle 63 with Destructive Validation**

## AVAILABILITY OF REFERENCE MATERIALS IN NRC PUBLICATIONS

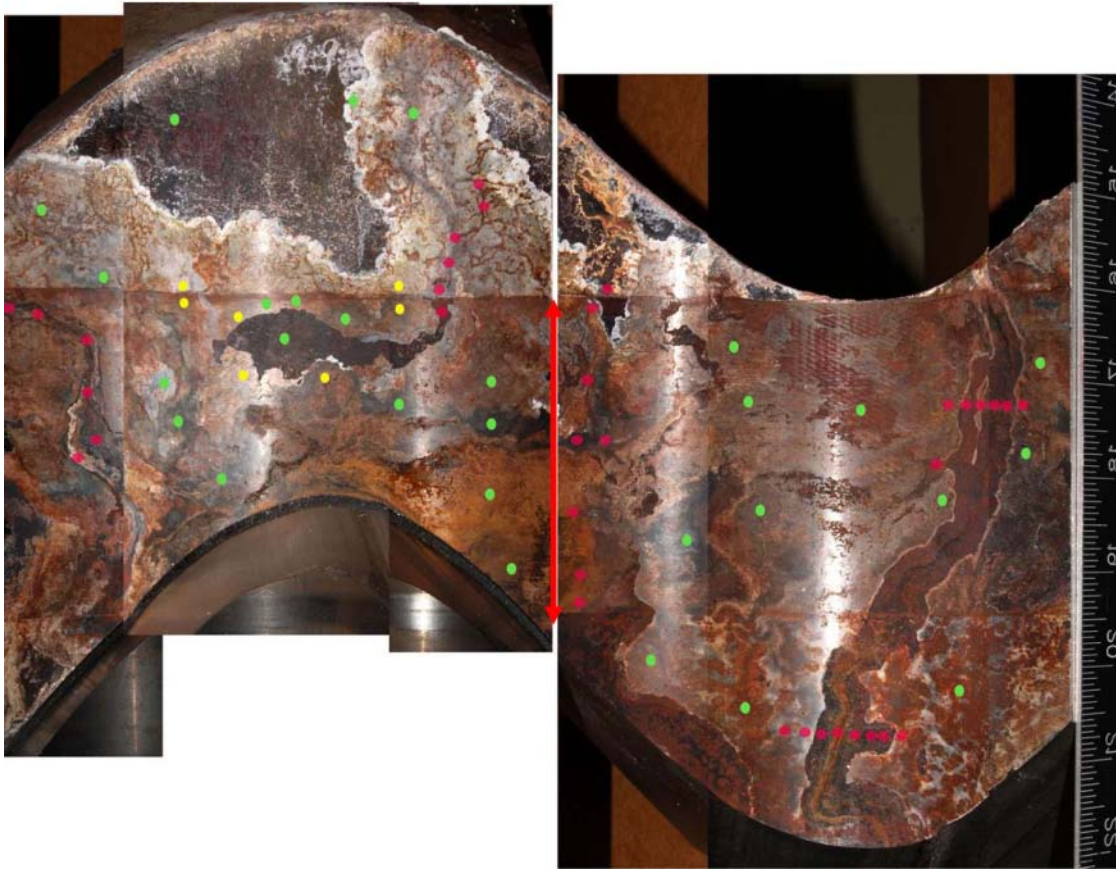
**Figure 8.1 Photograph of the RPV Head Material with Boric Acid Measurement Points. The interference fit region is marked by the red line.**

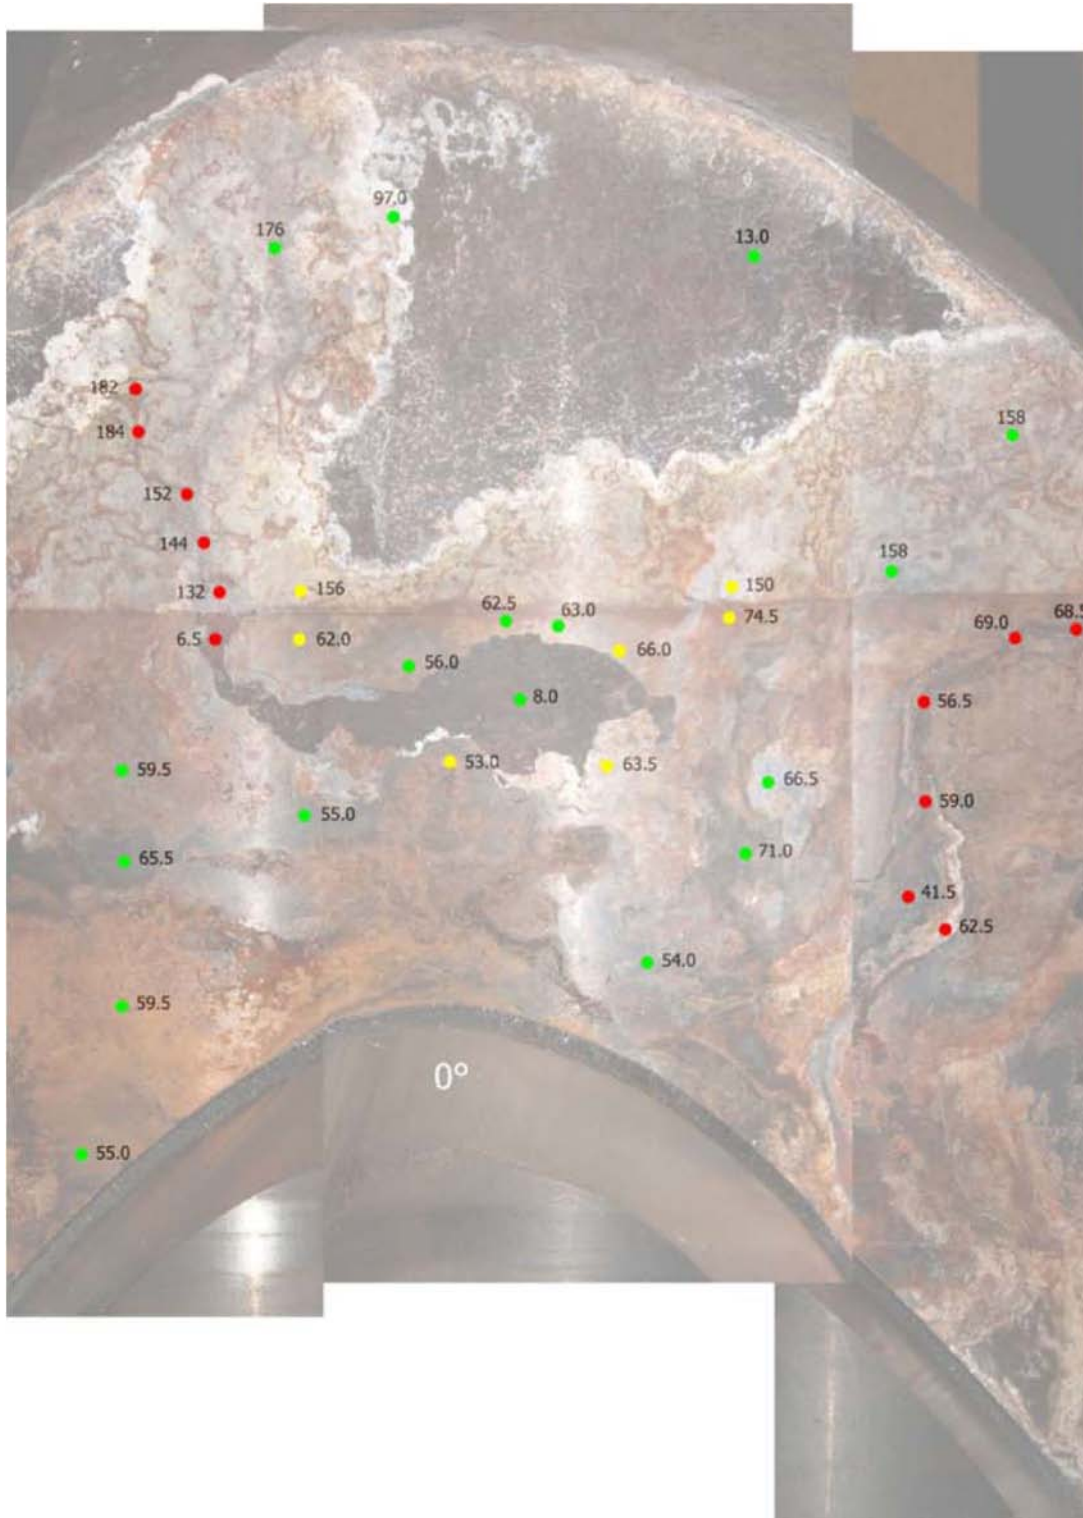
Figure 8.2 Boric Acid Deposit Thickness Values in Microns

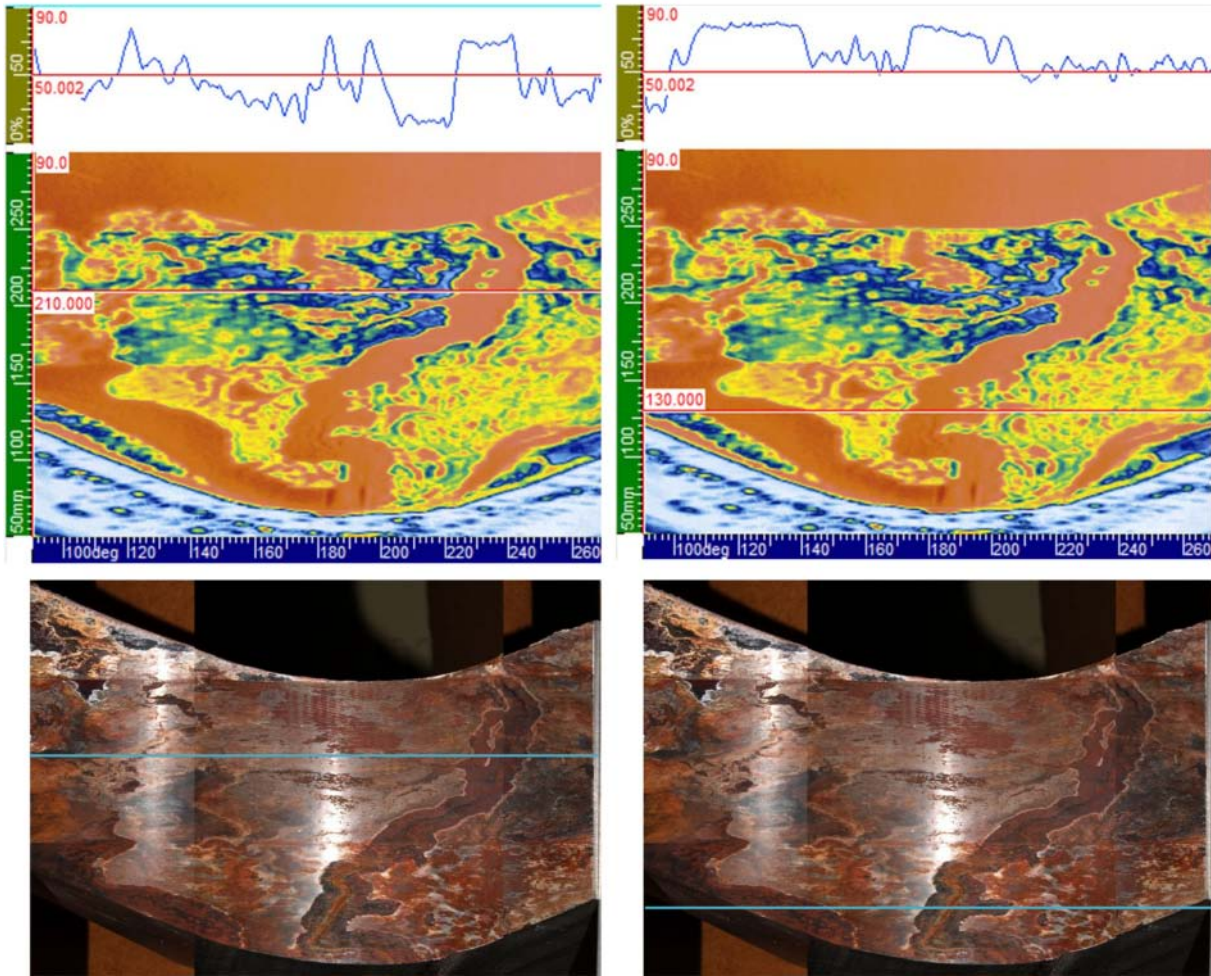
**Figure 8.3 Ultrasonic Response Profile at Top, Acquired Along the Red Horizontal Line in the Middle Image. The left image profile is in the interference fit and the right image profile is outside of the interference fit. Lower photographic images show the exposed interference fit on the low-alloy steel surface.**

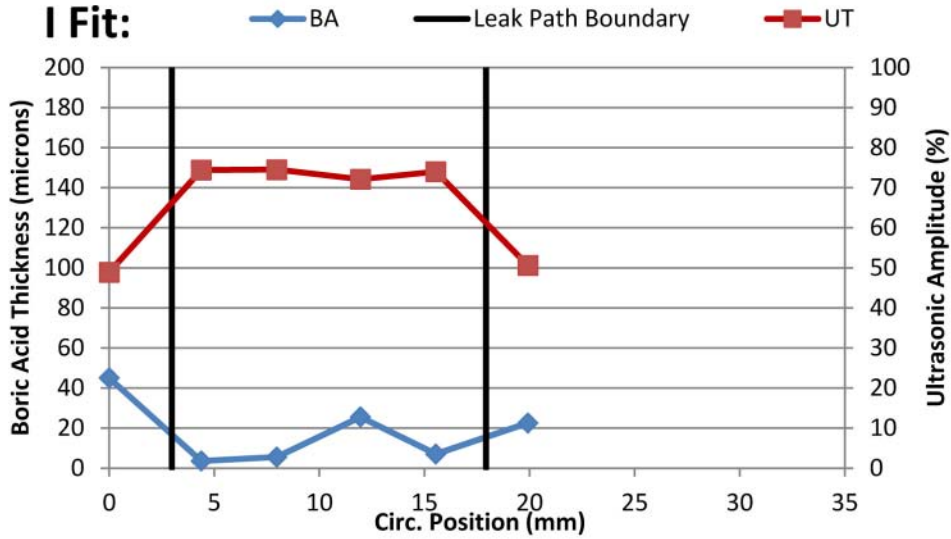
**Figure 8.4** Ultrasonic and Boric Acid/Corrosion Layer Thickness Along a Line Across the Main Leak Path in the Interference (I) Fit

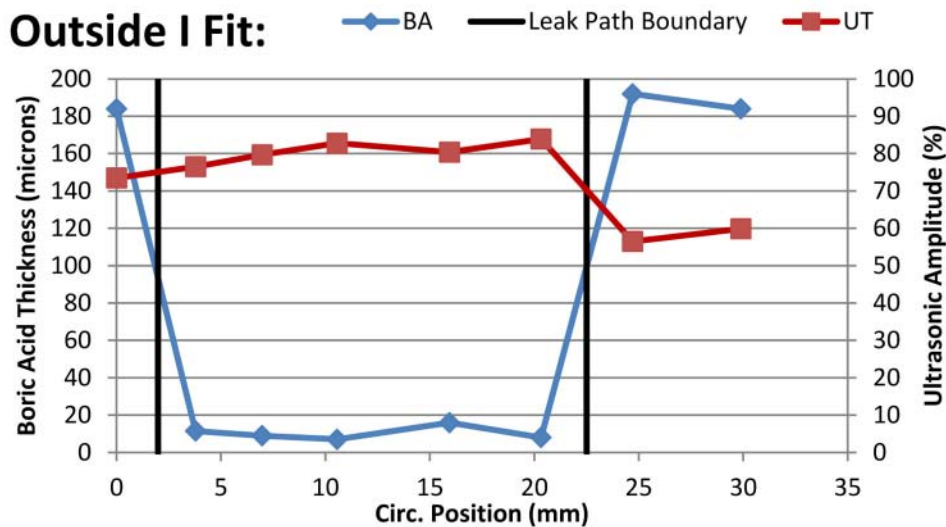
**Figure 8.5** Ultrasonic and Boric Acid/Corrosion Layer Thickness Along a Line Across the Main Leak Path Outside the Interference Fit

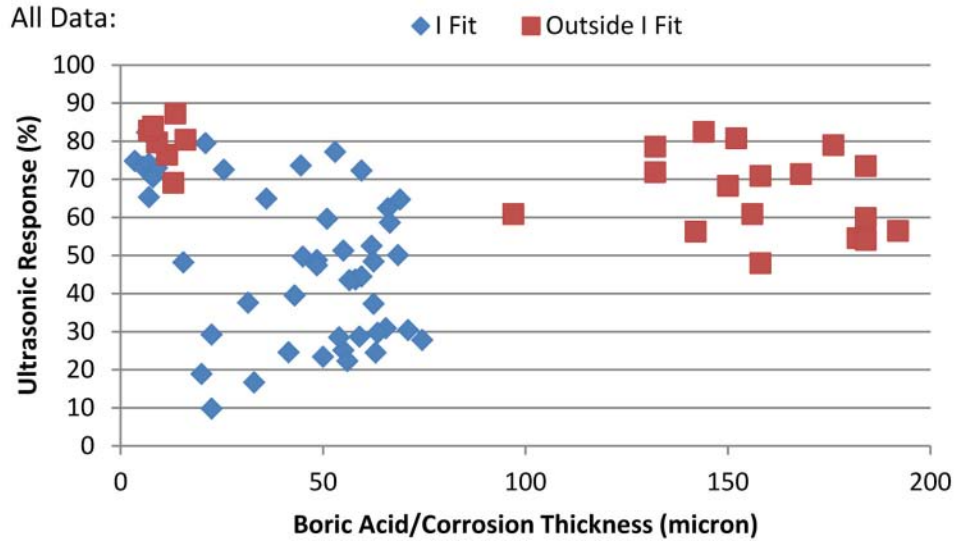
**Figure 8.6 Comparison of Ultrasonic Response and Boric Acid/Corrosion Layer Thickness at all 70 Acquired Data Points**

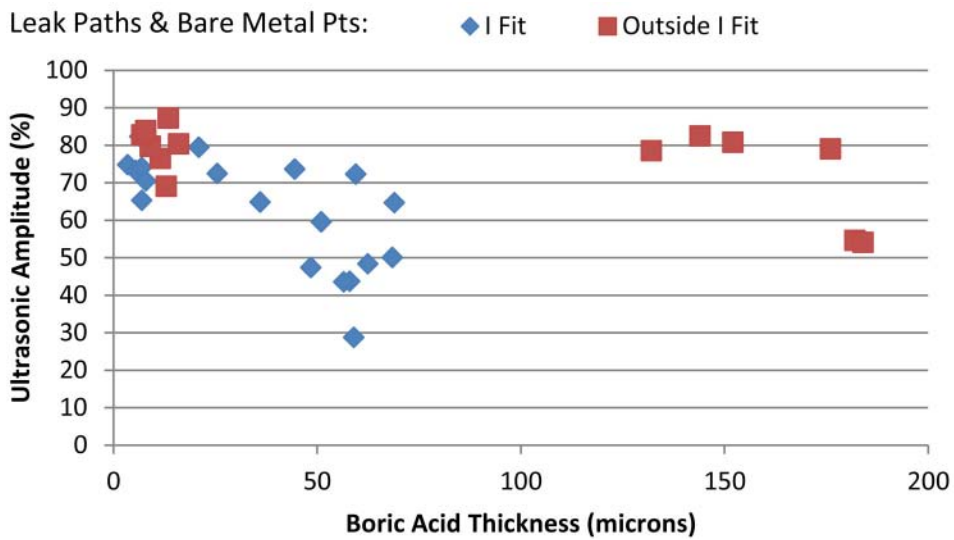
**Figure 8.7 Comparison of Ultrasonic Response and Boric Acid/Corrosion Layer Thickness at the Leak Path and Bare Metal Data Points**

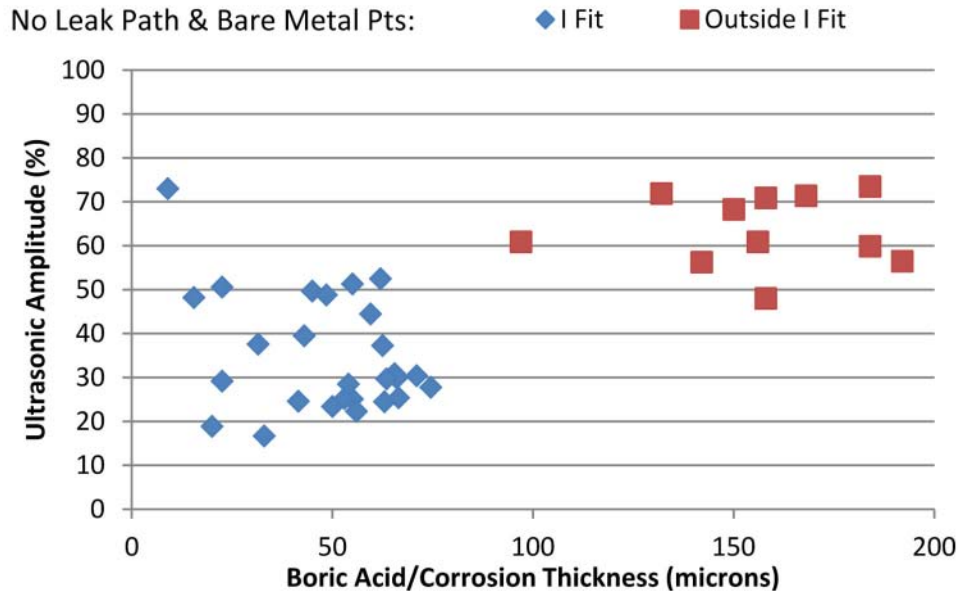
**Figure 8.8 Comparison of Ultrasonic Response and Boric Acid/Corrosion Layer Thickness at Data Points Not in the Leak Paths Nor at Bare Metal Points**

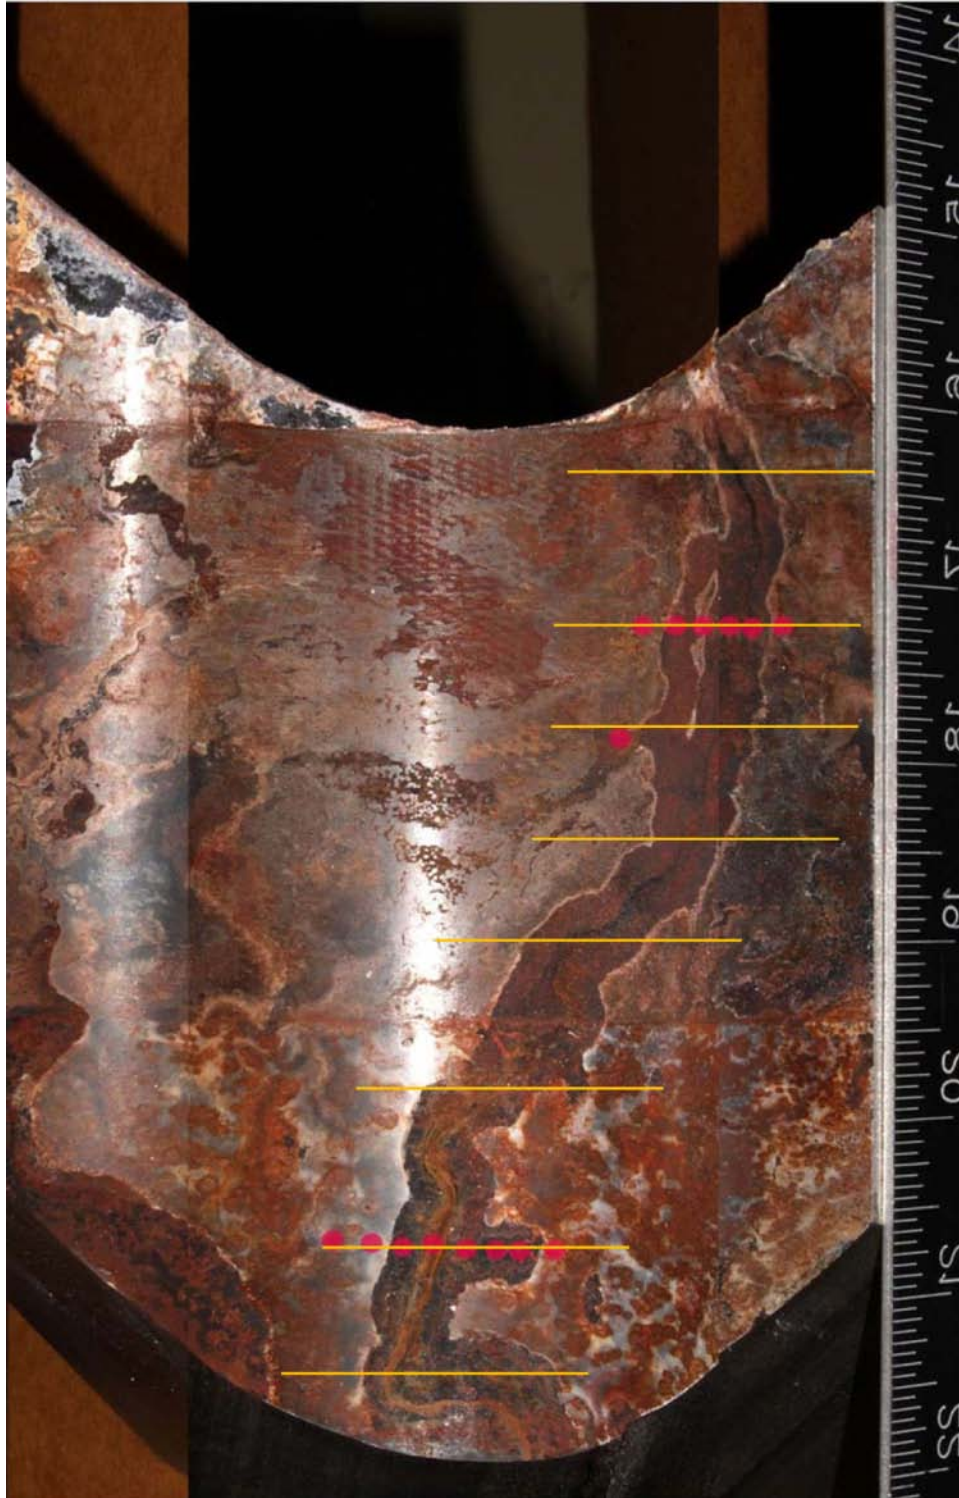
**Figure 8.9** Eight Areas Selected for Boric Acid Thickness Measurements on Cross-Sectional Slices of Microset Replica

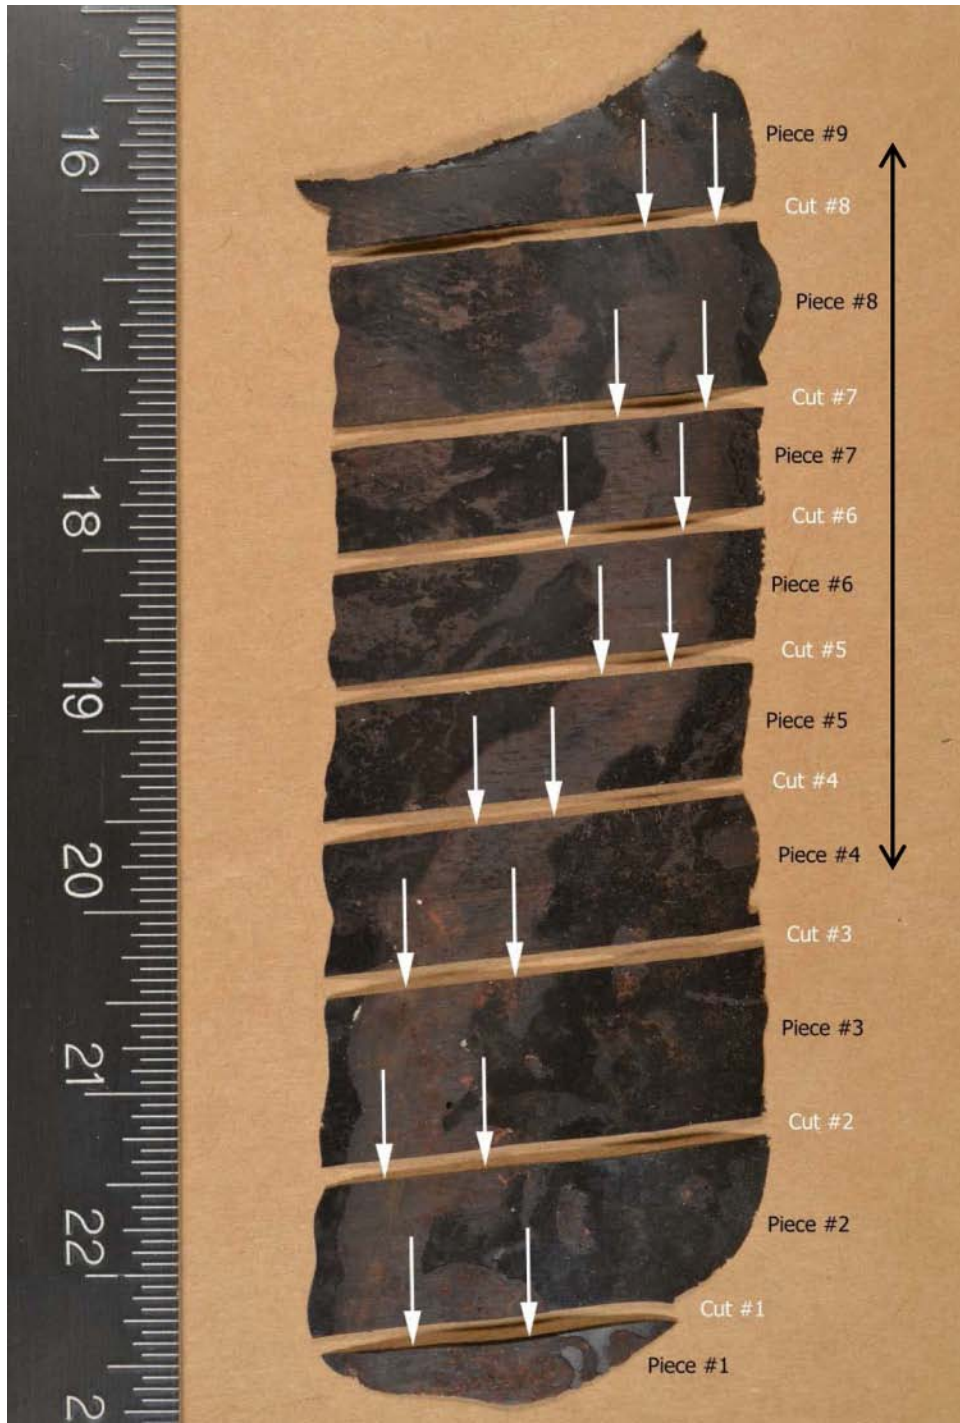
**Figure 8.10 Leak Path Replica with Cuts and Pieces Identified. The interference fit region is noted with the black line and is contained in pieces 4 through 9.**

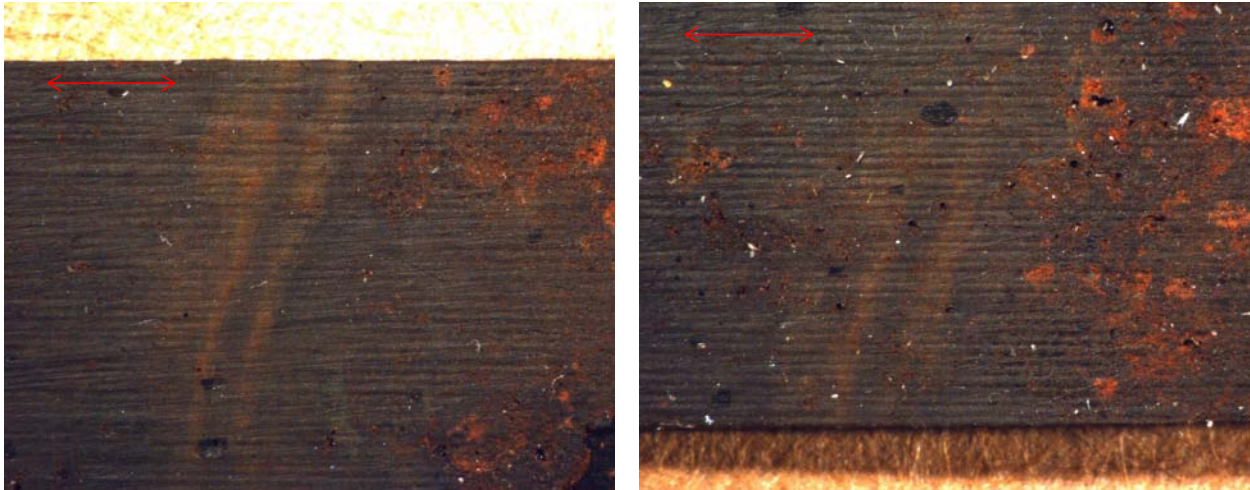
**Figure 8.11 Staining Streaks in the Leak Path Below the Interference Fit from Replica Pieces 2 and 3, Left and Right, Respectively. The red line represents 2.0 mm (0.080 in.) in length.**

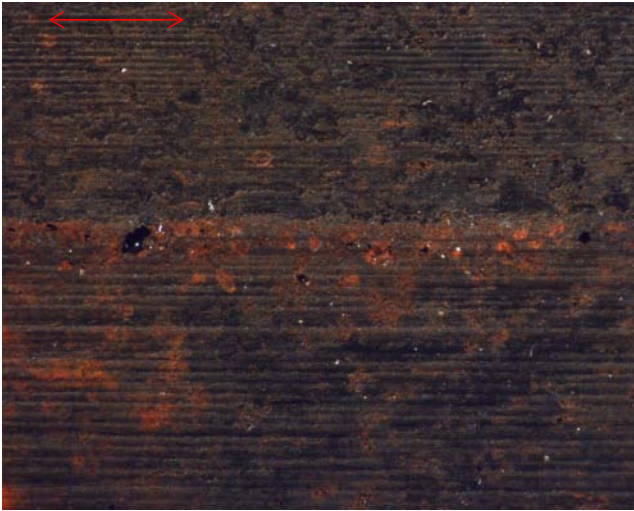
**Figure 8.12 Transition from Below the Interference Fit to the Interference Fit Region. Machining marks are evident in this replica piece 4. The red line represents 2.0 mm (0.080 in.) in length.**

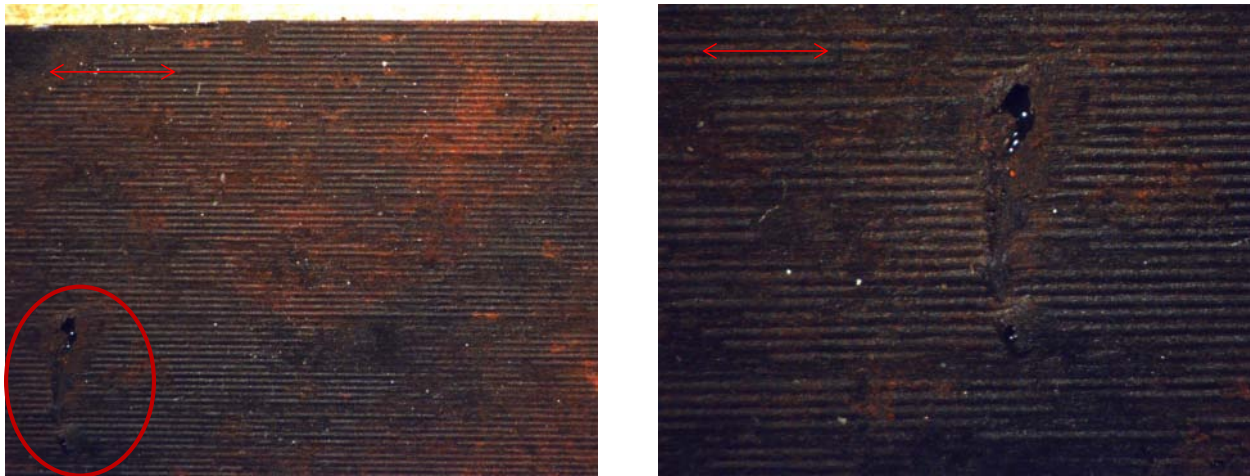
**Figure 8.13 Piece 5 from the Interference Fit Region Shows an Indication of a Scrape. In the left image the red line represents 2.0 mm (0.080 in.) in length. The image on the right at twice the magnification of the left shows more detail.**

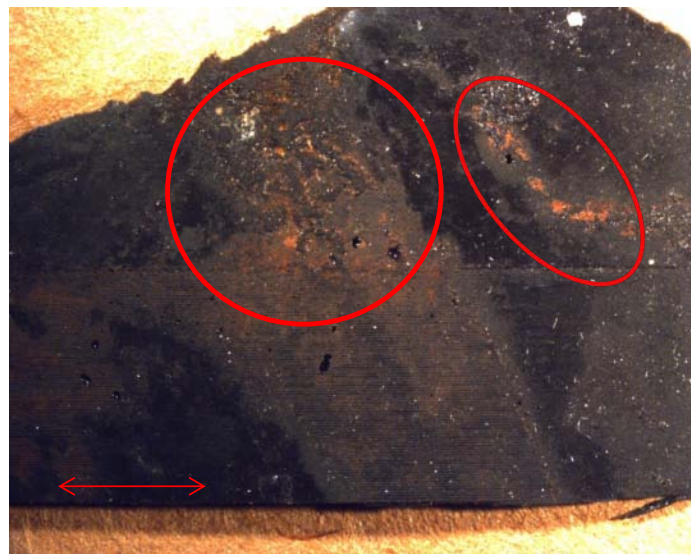
**Figure 8.14 Corrosion Areas Observed Above the Interference Fit Region. The red line represents 2.0 mm (0.080 in.) in length.**

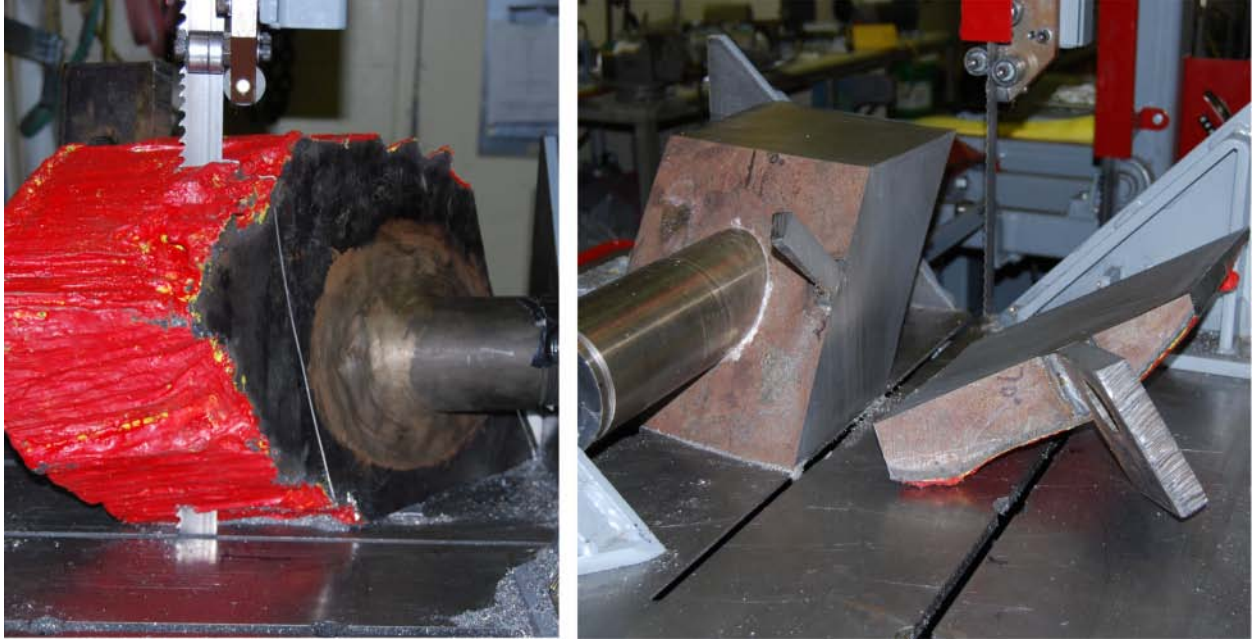
**Figure C.2 Size Reduction Cutting Activity**

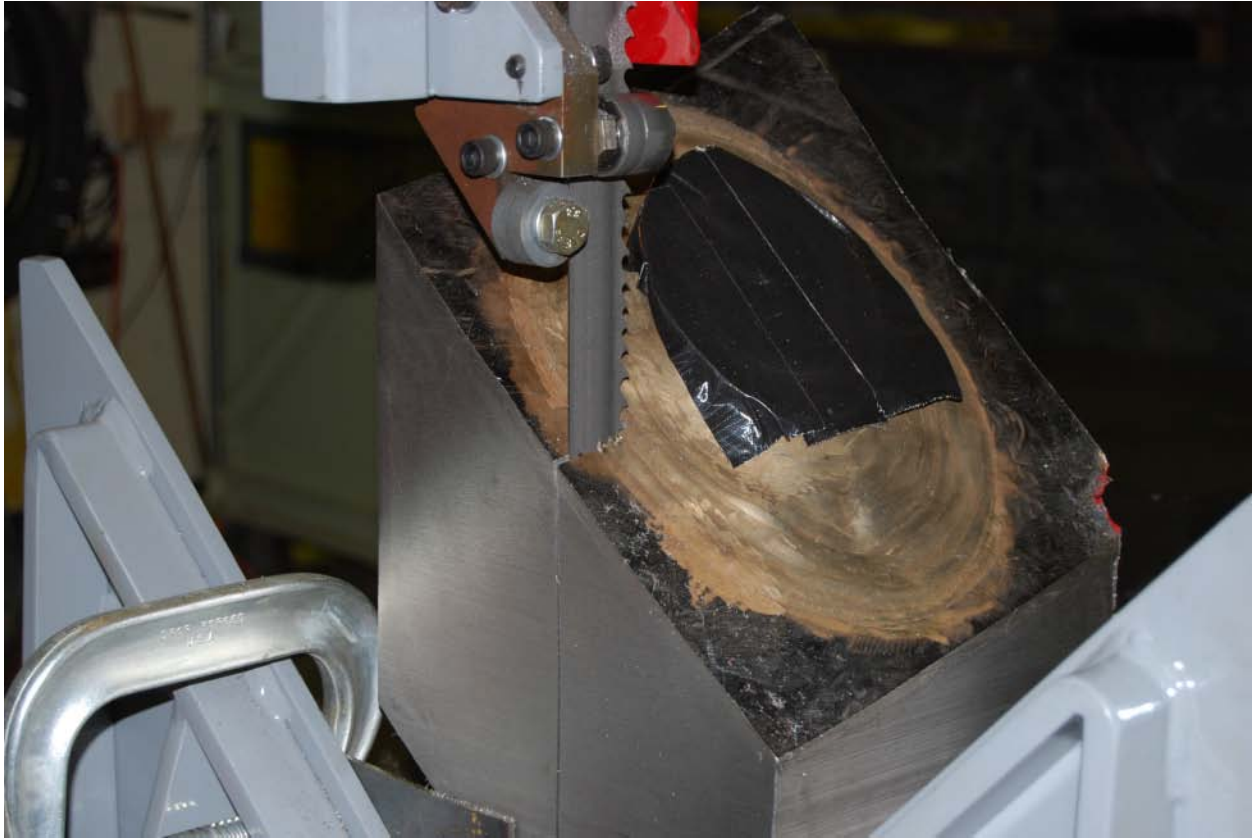
**Figure C.3 Start of the Dissection Cut**

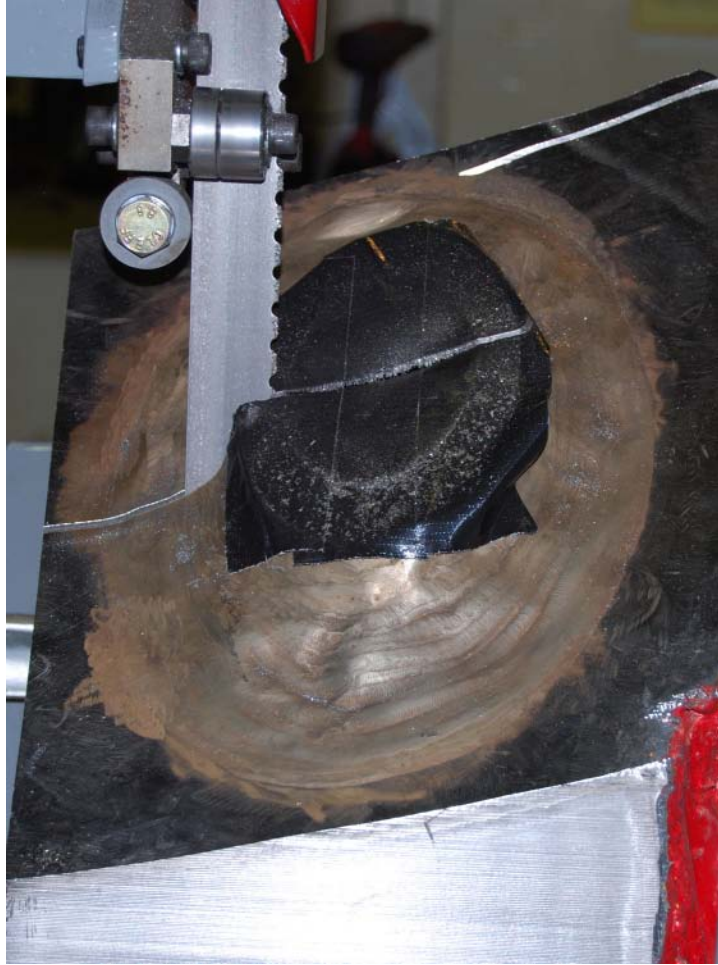
**Figure C.4 Abrasive Carbide Blade Progressing Through the Hard Spot**

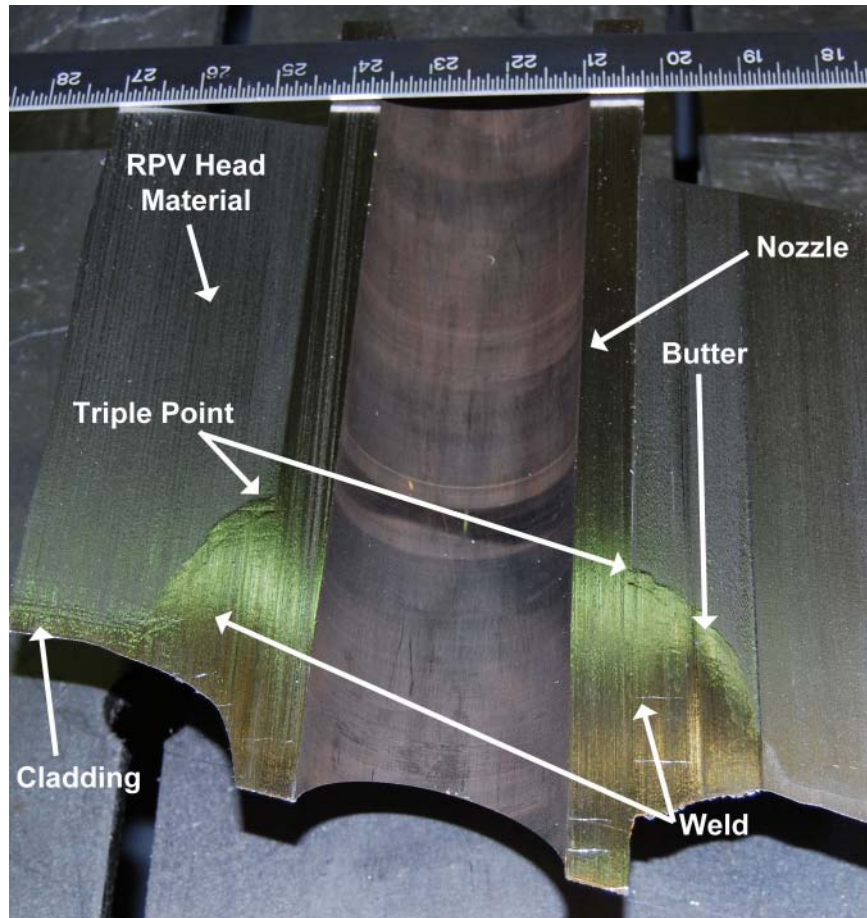
**Figure C.5 Nozzle 63 Assembly Cut in Half by Dissection Cut**

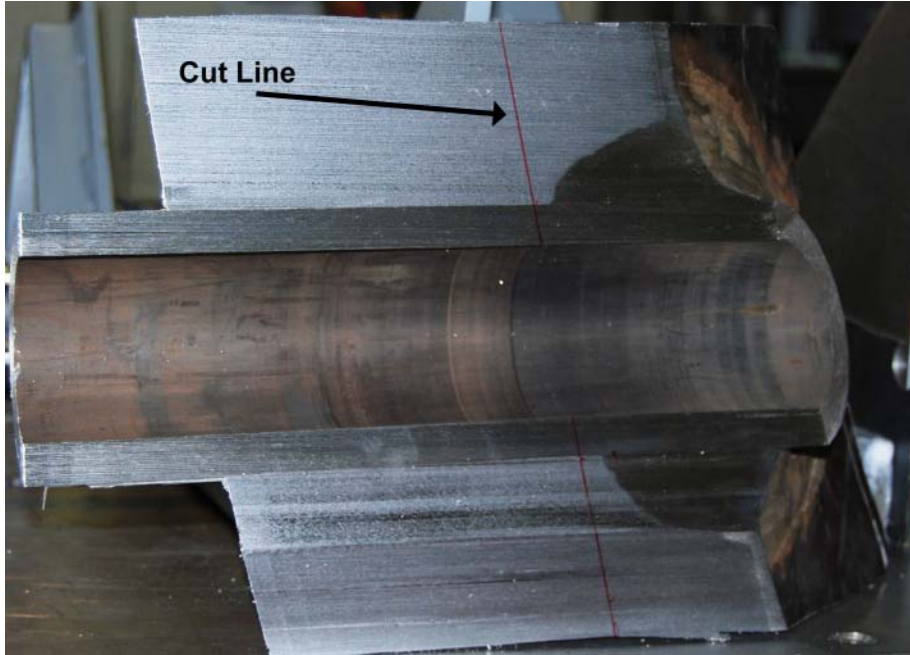
**Figure C.6 J-groove Weld Removal Cut Line Placement**

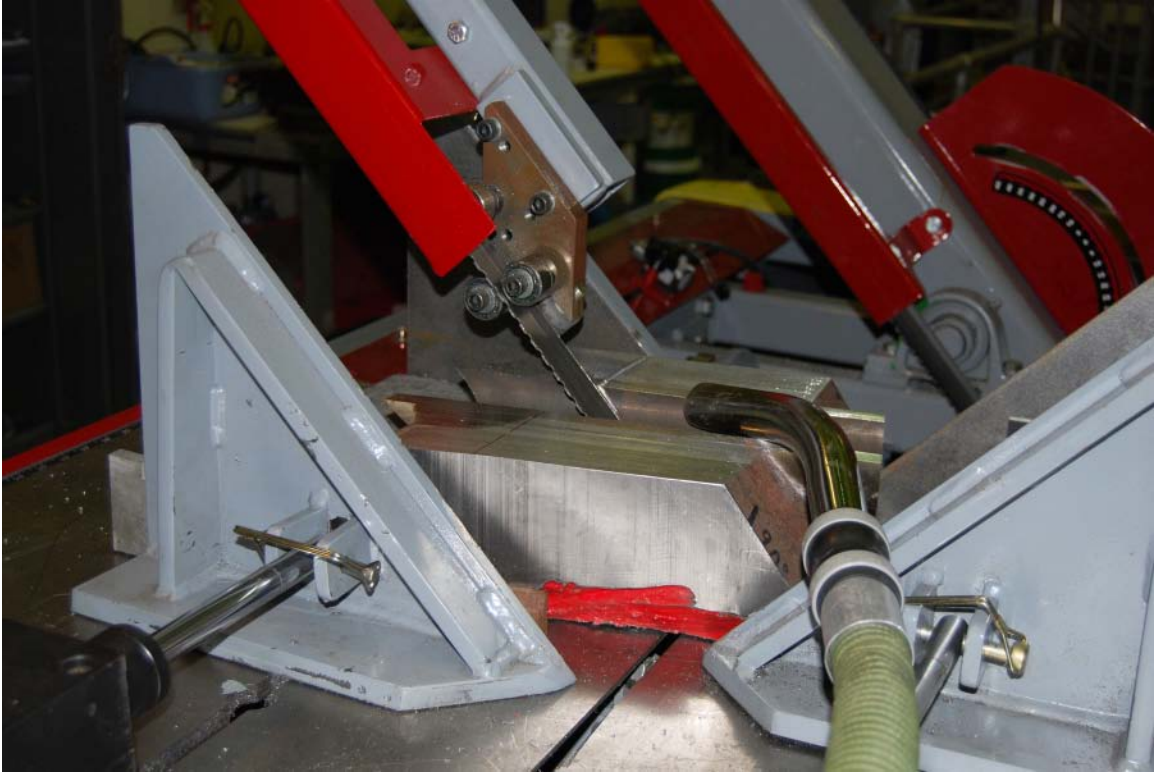
**Figure C.8 Abrasive Blade Cutting Through the Nozzle with a HEPA Vacuum Nozzle**

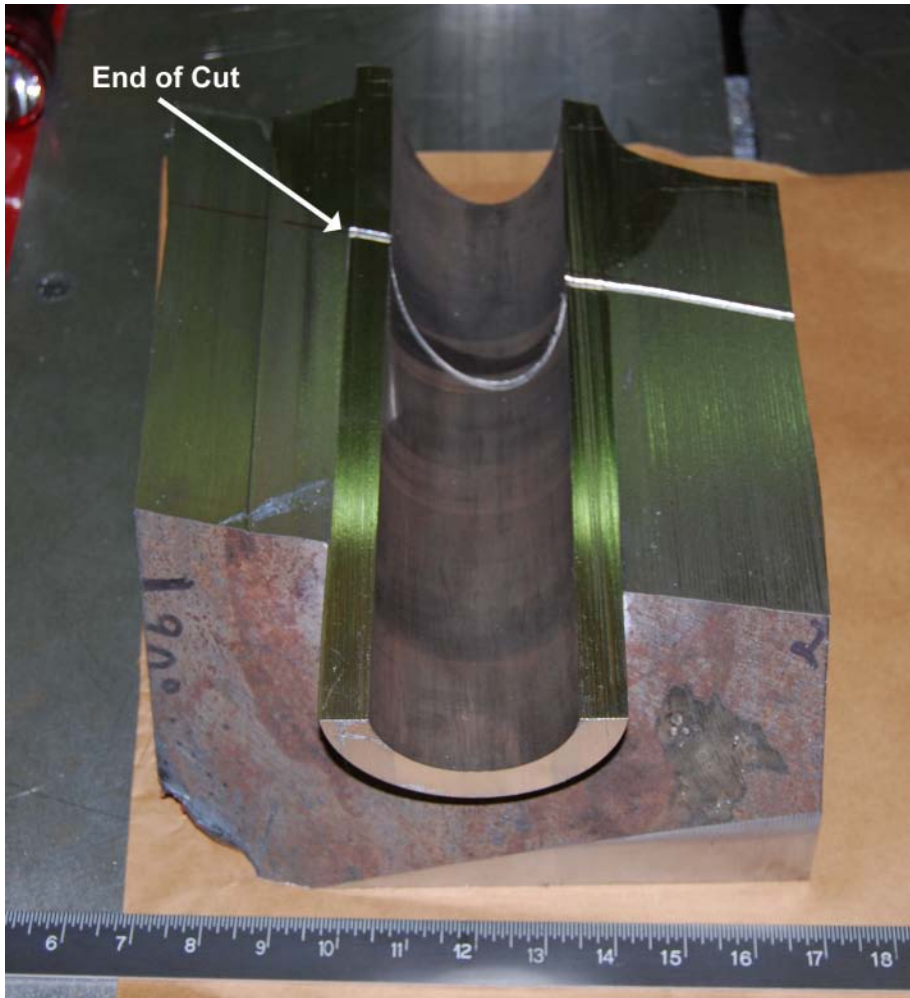
**Figure C.9 End of J-groove Weld Removal Cut**
