Status of Medical Events FY 2022

Medical Radiation Safety Team

May 15, 2023

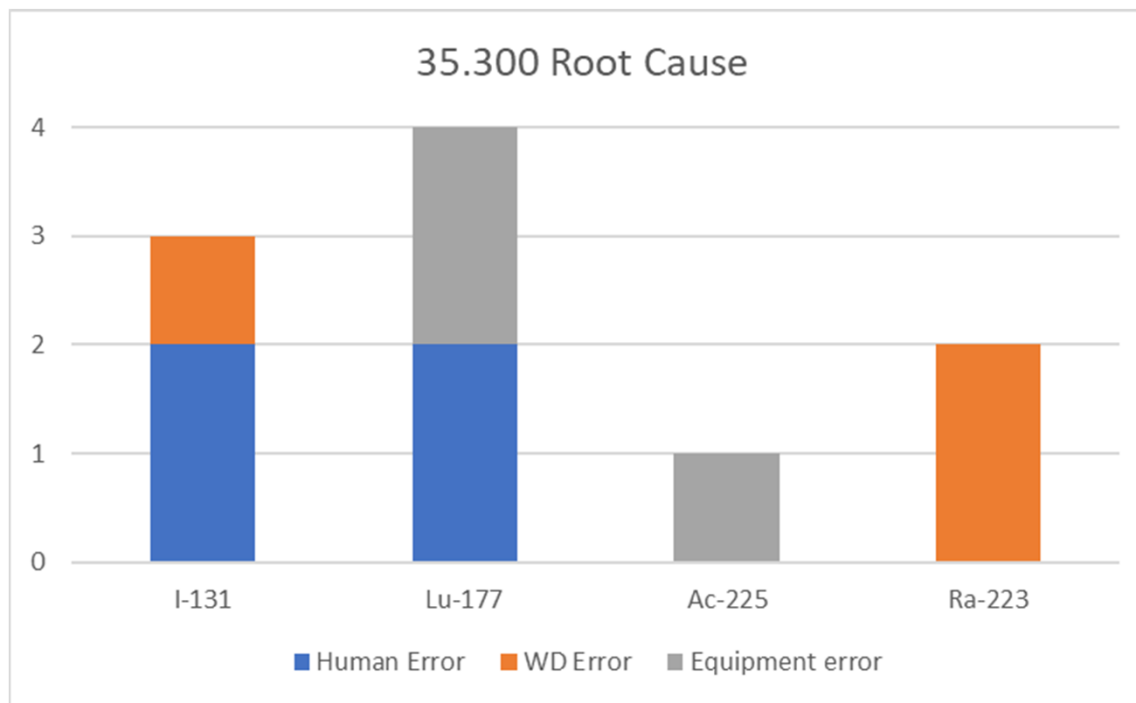
- 35.300
 - Delivered intended dose but incorrect WD
 - Full dose administration of Lu-177 but reduced dose on WD
 - Ac-225 difficulties with lead shielded syringe, resulting in leakage

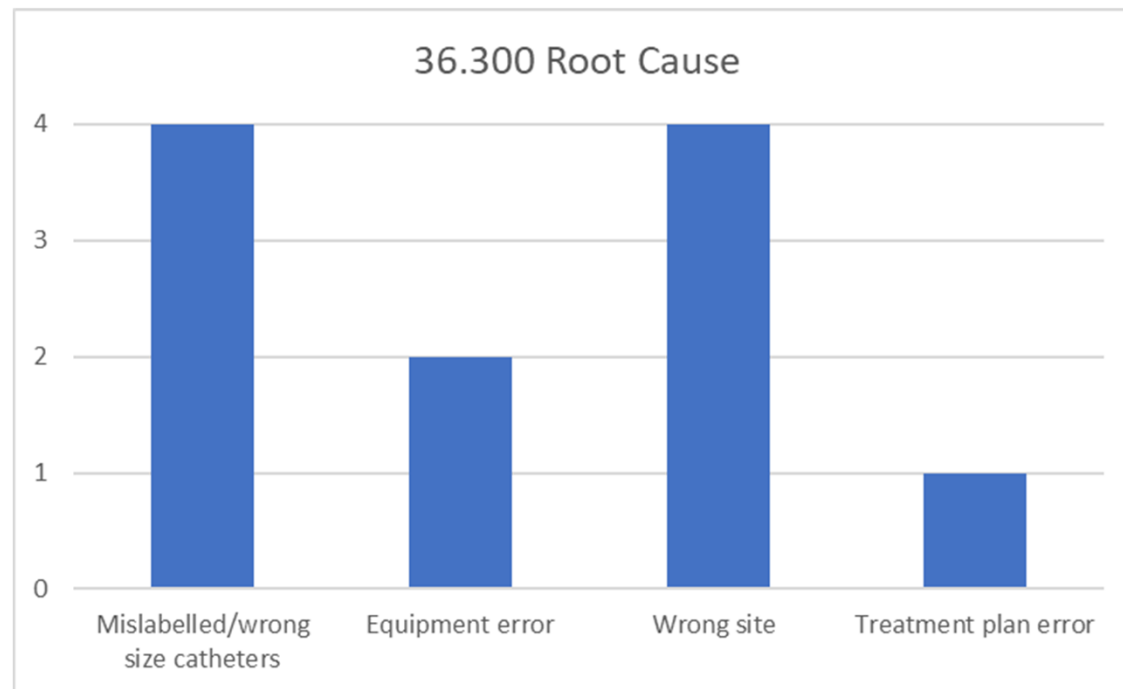
- 35.600
 - 4 misidentified lesion sites
 - Use of incorrect tube/catheter lengths
 - Multiple patients affected by single medical event, catheter/tube length problems

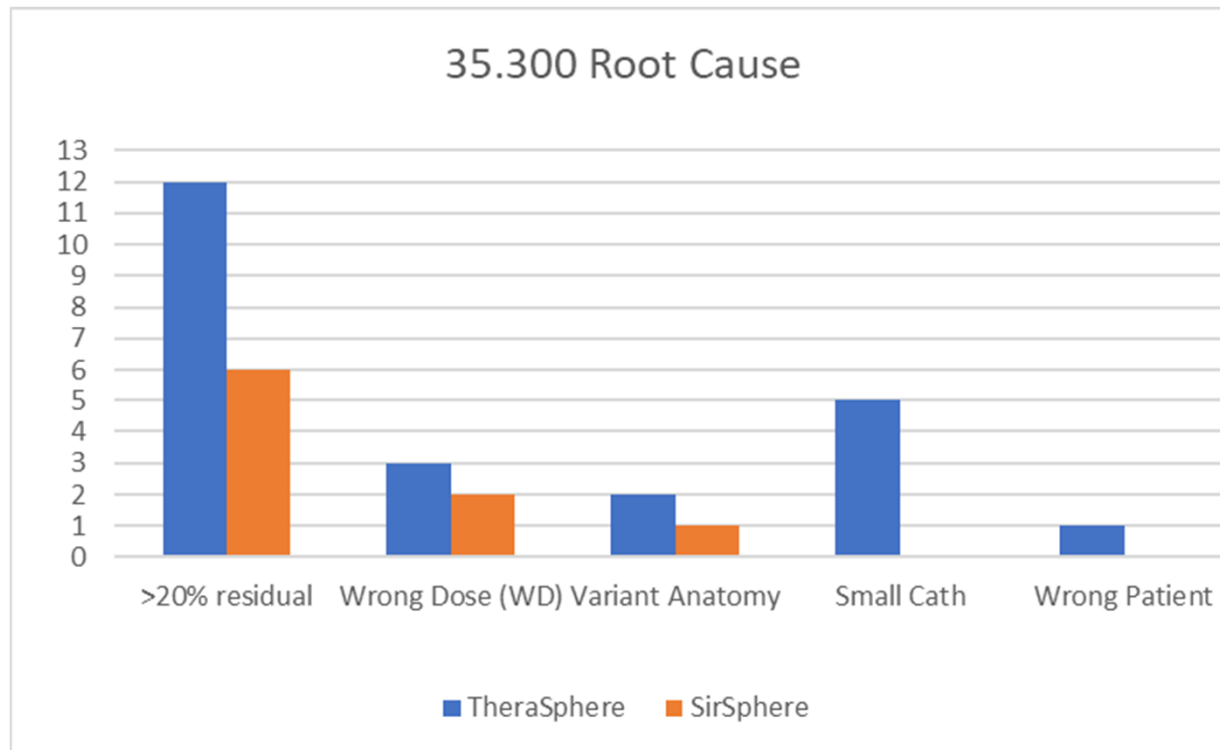
- 35.1000
 - Primarily Theraspheres, primarily underdoses
 - 4 events due to use of smaller than recommended catheters
 - 2 events due to malfunctioning Luer locks
 - 2 events due to unusually small doses
 - 3 of 6 overdose events were due to incorrect WD
