UNITED STATES  
NUCLEAR REGULATORY COMMISSION

April 20, 2000

**DOCKET NUMBER 50-483  
CALLAWAY PLANT UNIT 1  
UNION ELECTRIC CO.  
FACILITY OPERATING LICENSE NPF-30  
LICENSEE EVENT REPORT 2000-002-00**  
**Automatic Reactor Trip Initiated by Reactor Coolant Pump Trip Caused by Motor  
Current Imbalance Due to Transmission System Disturbance**

TITLE (4) **Automatic Reactor Trip Initiated by Reactor Coolant Pump Trip Caused By Motor Current Imbalance Due to External Transmission System Disturbance**

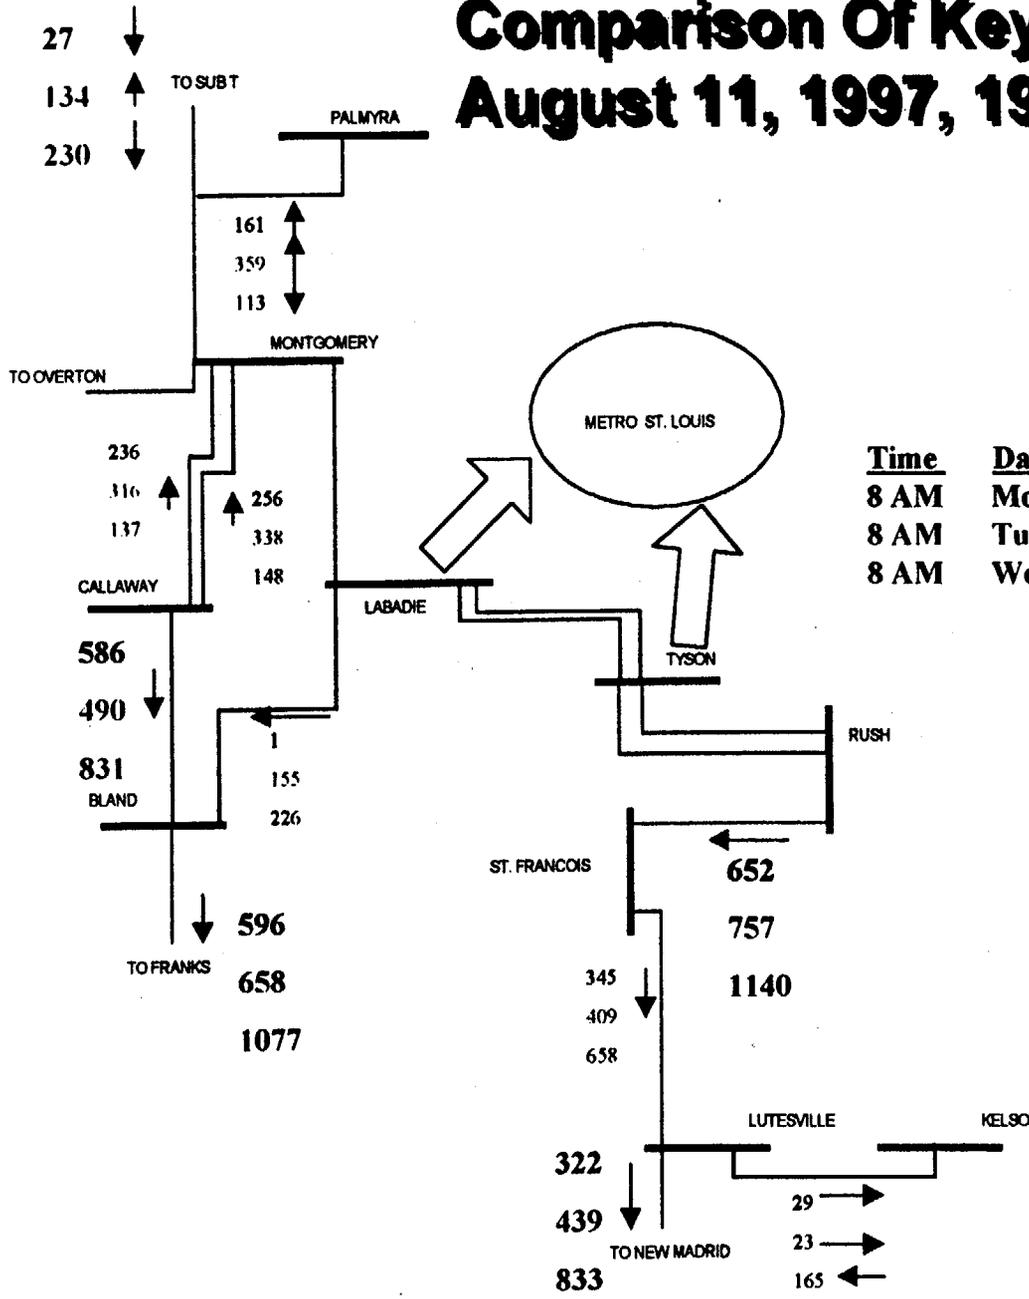
# Comparison Of Key 345 kV Line Flows August 11, 1997, 1998, and 1999

<u>Time</u>	<u>Day</u>	<u>Date</u>	<u>Ambient Temp (Min/Max)</u>
8 AM	Mon	8/11/97	73/89
8 AM	Tues	8/11/98	74/84
8 AM	Wed	8/11/99	71/87

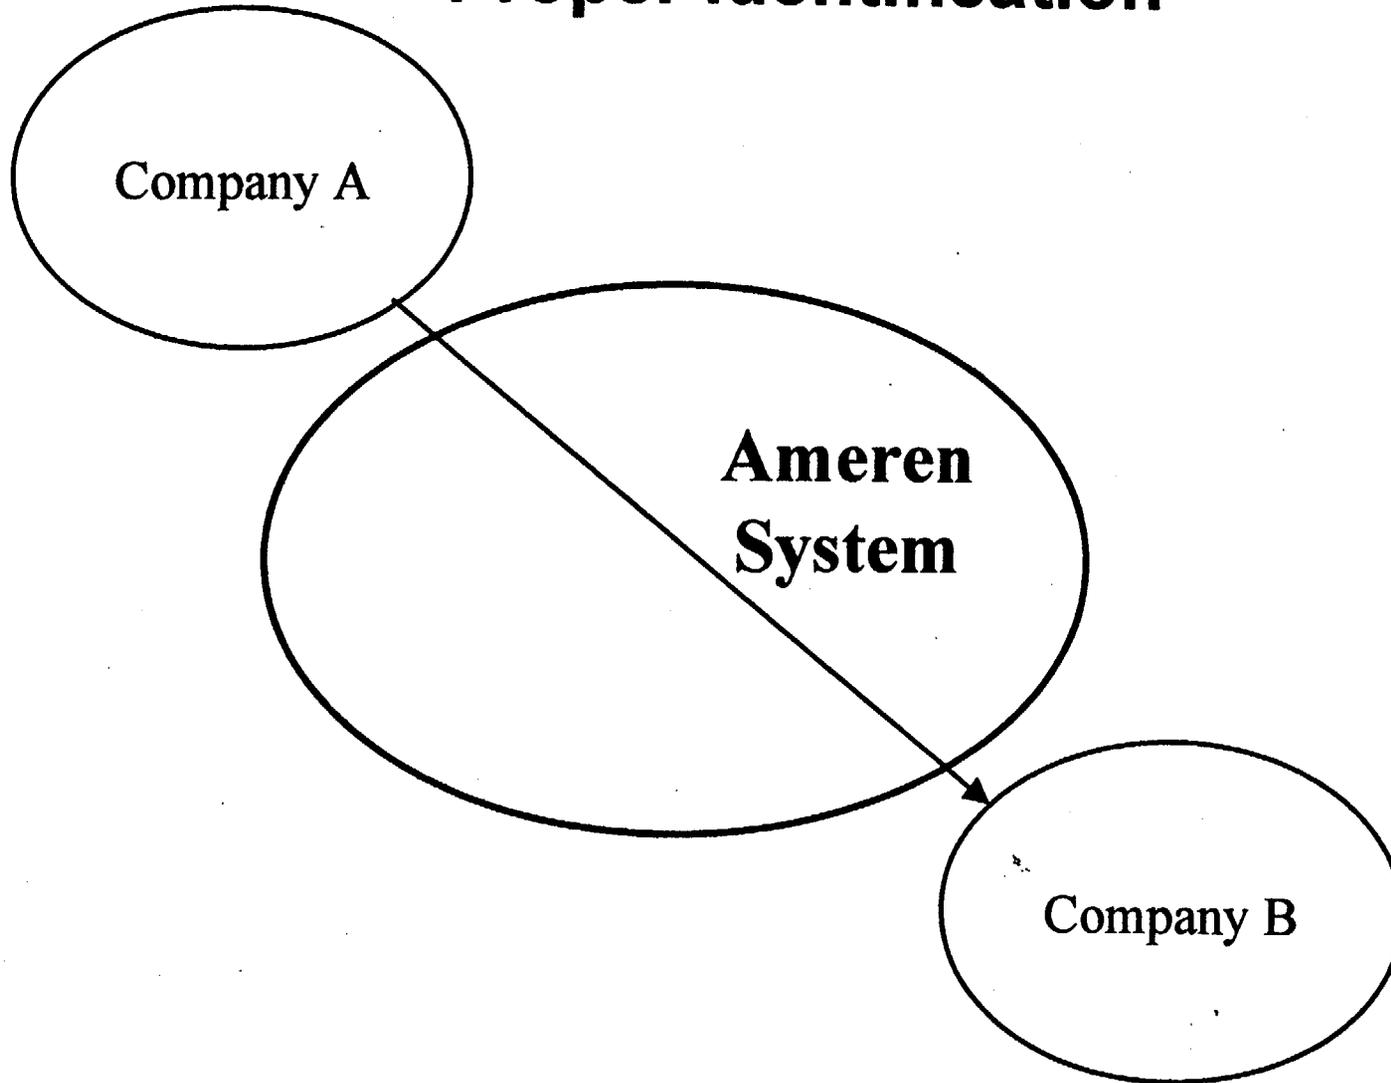
# Interchange Transactions

## Proper Identification

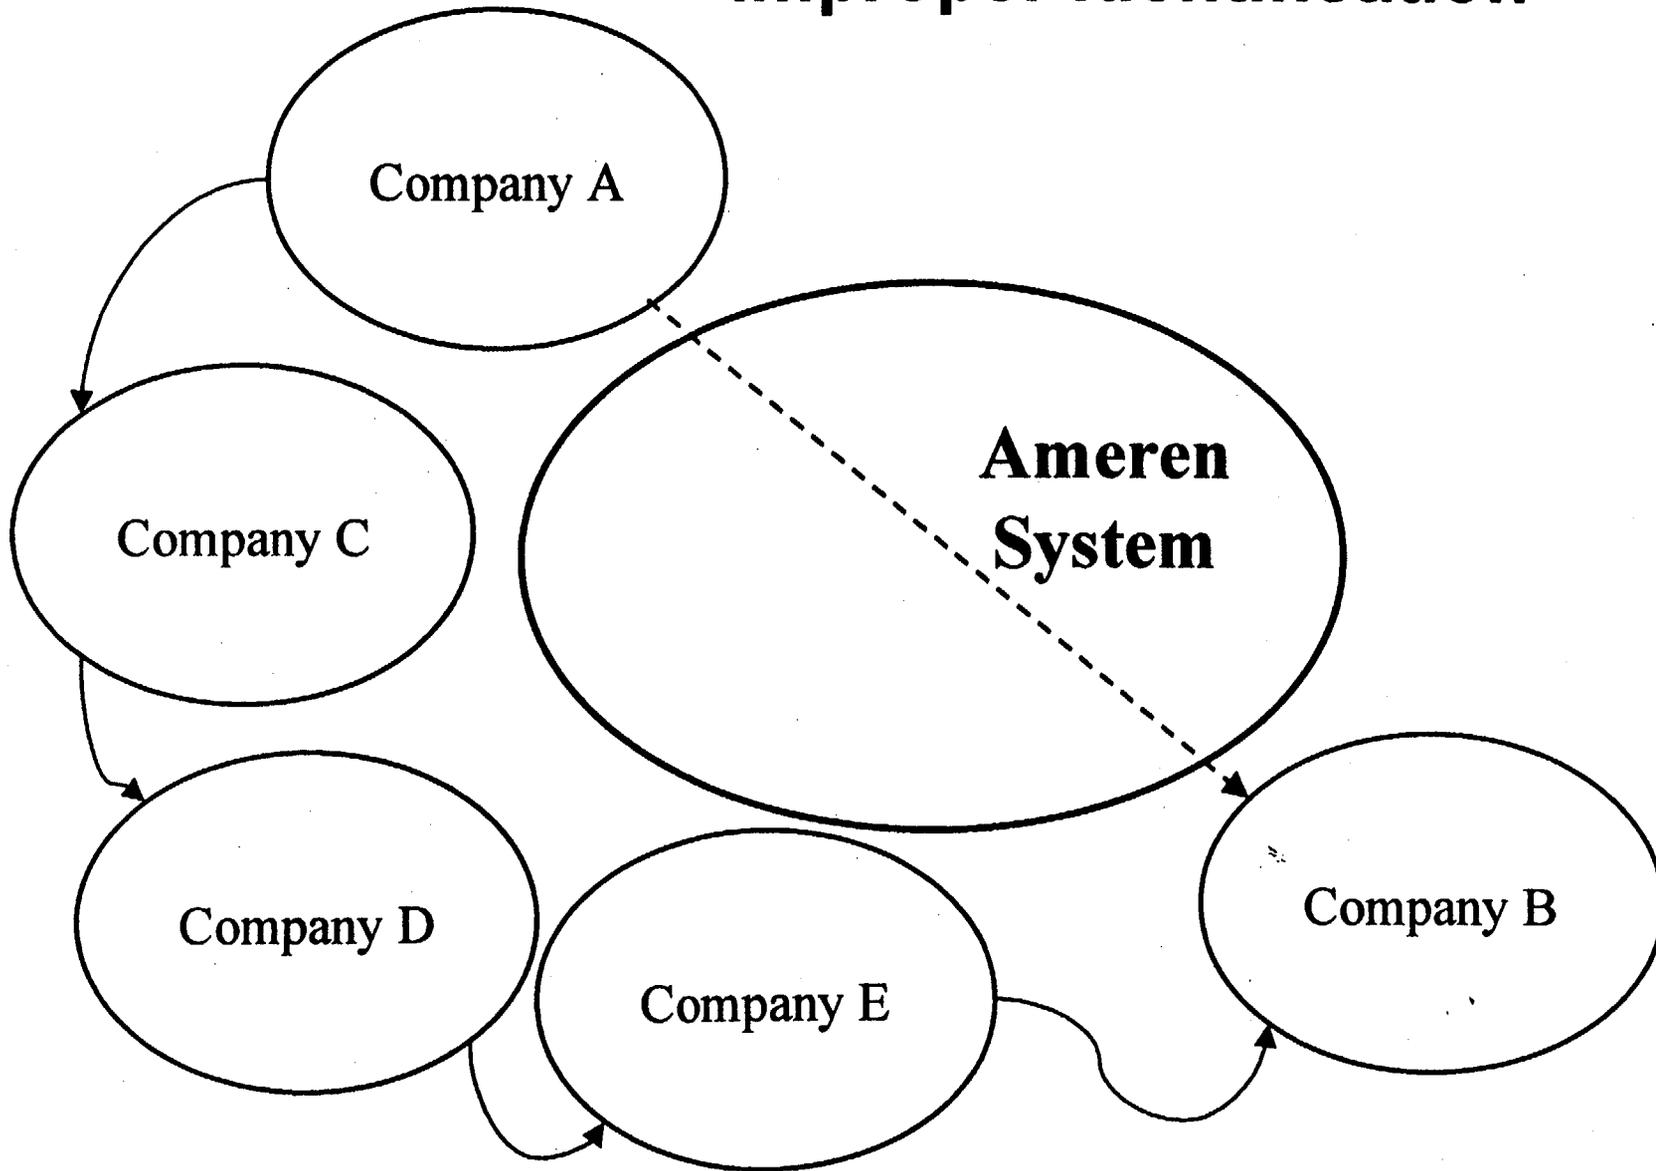
# Interchange Transactions

## Improper Identification
