Indian Point 2 Condition Monitoring Operational Assessment Plan

Tom Pitterle Westinghouse Electric Company

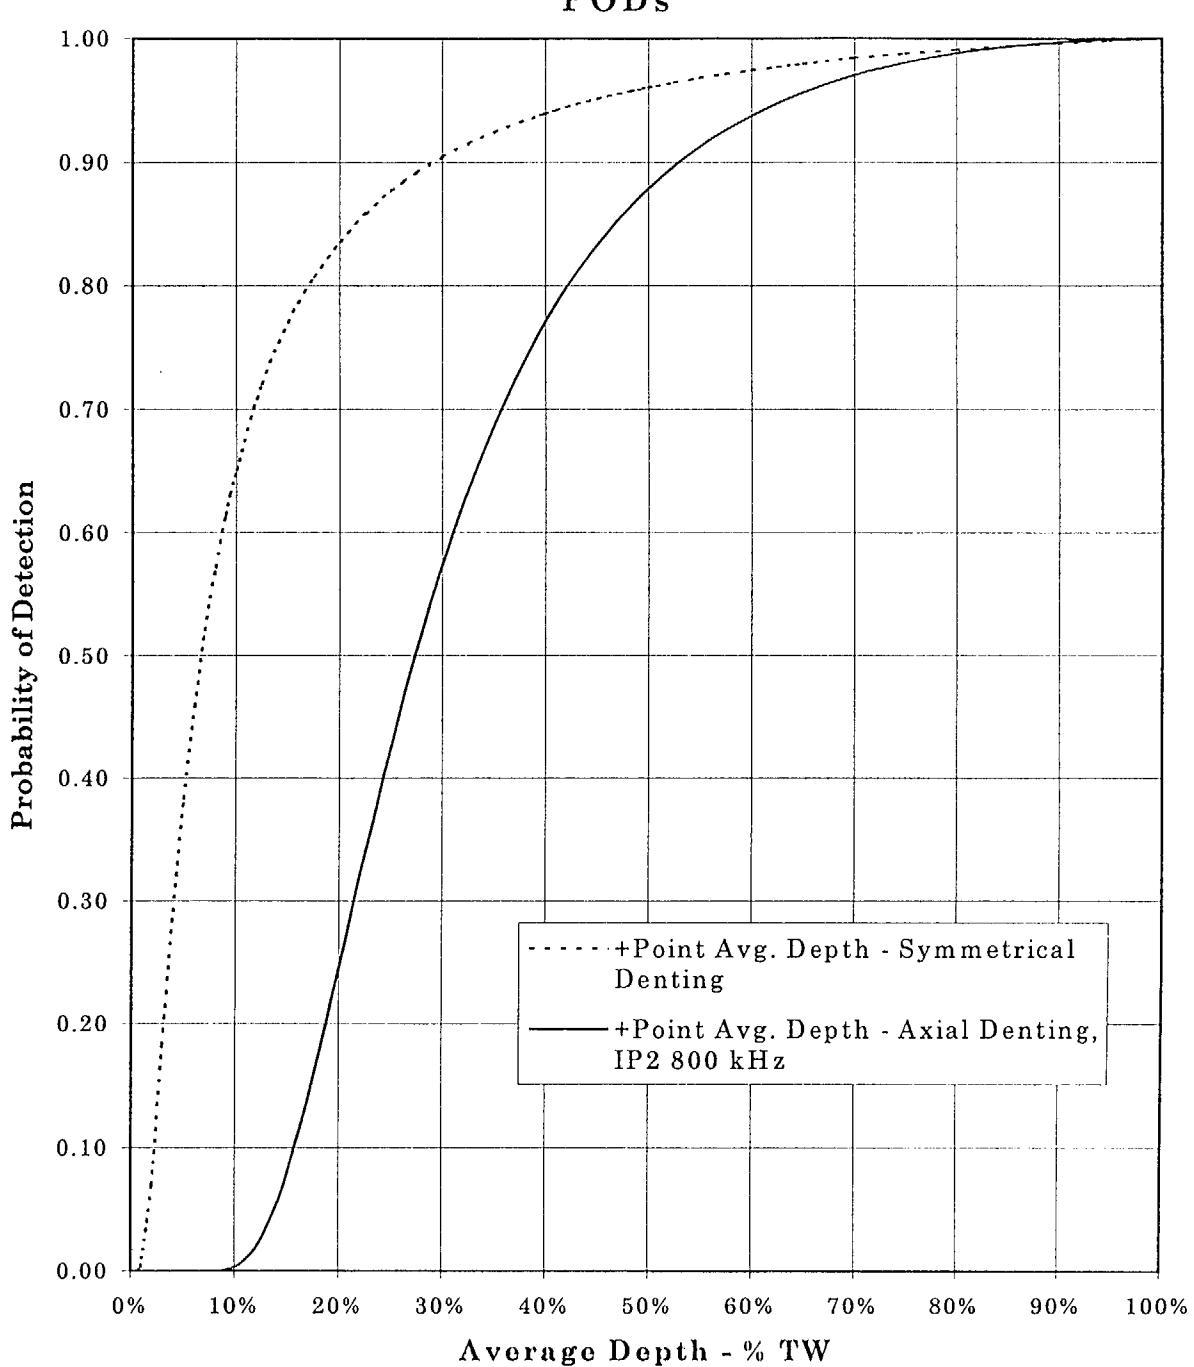
Figure 5-1. Comparisons of +Point Average Depth PODs

- R2C5 leaked in service
 - Would not have been "called"
 - Improvements in NDE would not leave an indication of this size in service in 2000 inspection
- POD
 - Improvements in analyst guidelines & training
 - High frequency probe has improved data quality & detection
 - Enhanced S/N ratio
 - Found additional smaller indications
 - No indications in rows 3 & 4
 - POD compared to other industry experience
 - PWSCC in symmetrical and axial dents
