James A. FitzPatrick Nuclear Power Plant 268 Lake Road P.O. Box 41 Lycoming, New York 13093

Subject: Docket No. 50-333 LICENSEE EVENT REPORT: LER-00-002-01 (DER-00-00348)

HPCI Inoperable Due To Speed Control Problem

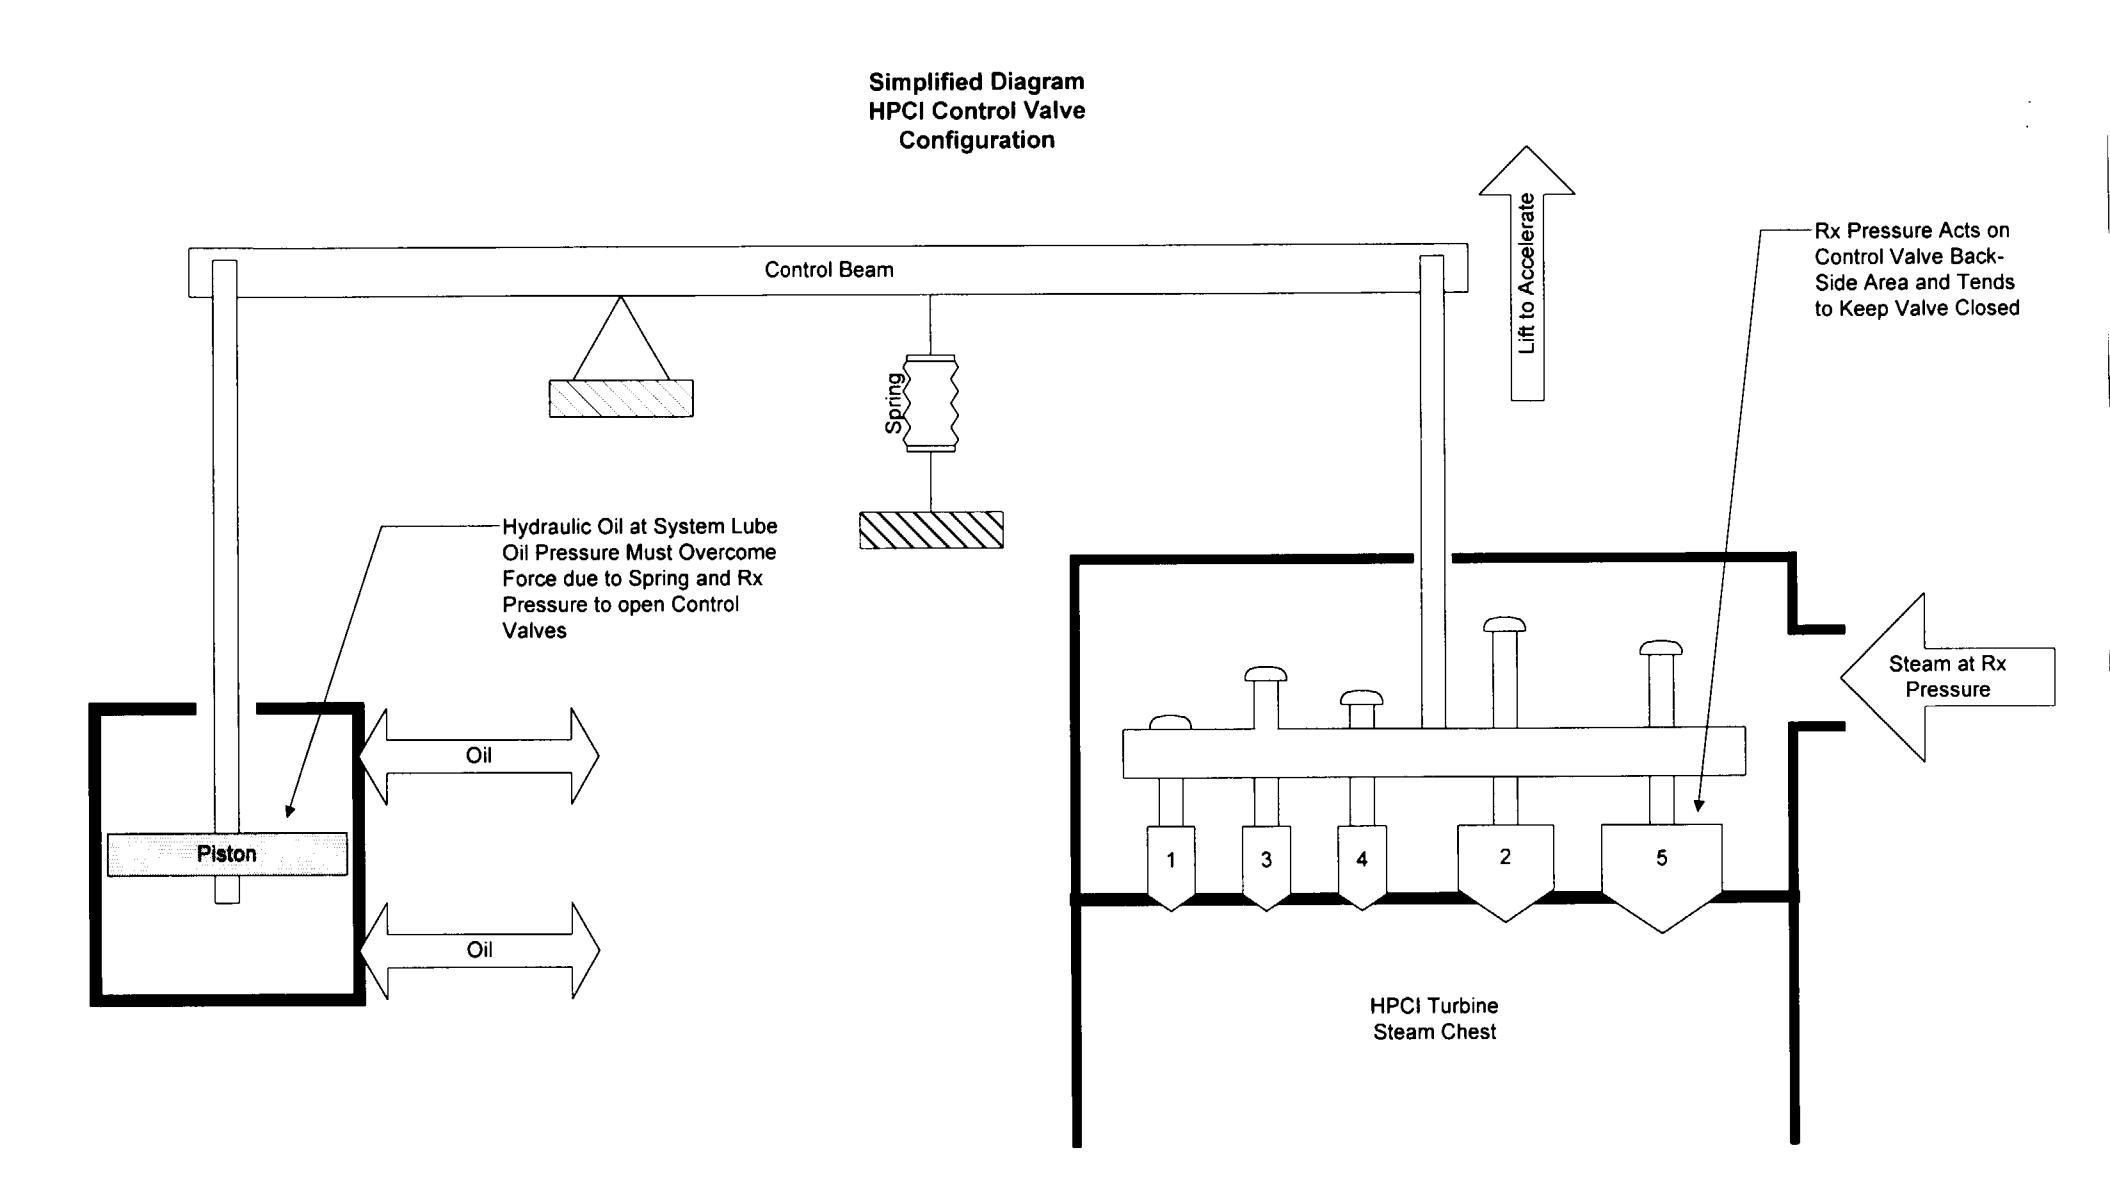
An evaluation was conducted based on the data captured during the January 31, run of ST-4P. Plant technical staff performed this analysis with the assistance of an individual with expertise in the design and operation of the HPCI turbine and speed control system. It was determined that the cause of the speed transient was improperly set (high) lubricating oil pressure for the HPCI system. The discussion below describes how high lubricating oil pressure causes the speed transient observed during the January 31, 2000 run of ST-4P as well as during previous HPCI surveillance tests. Refer to Figure 1 for this discussion.

The HPCI turbine steam chest is configured with 5 control valves (CVs) of varying diameters, which open in stages to admit steam to the HPCI turbine. These valves are sized to maintain adequate turbine horsepower over the entire spectrum of reactor pressures for which the HPCI system is credited (150-1195 psid-Reactor to Torus). In order to open any one CV, the hydraulic oil pressure must overcome the combined force of the spring, which closes all CVs on loss of oil pressure, and the force due to reactor pressure acting on the upstream side of the respective CV.

The high hydraulic oil pressure resulted in the equilibrium force balance on CV5 occurring at higher reactor pressures than intended by original design, resulting in opening CV5. When CV5 opened at these higher reactor pressures, high-energy steam was admitted to the turbine steam chest through CV5 causing speed transient which was corrected by the HPCI System speed control loop.

Post event evaluation also determined that the spring tension on the HPCI governor control beam was not in accordance with the vendor manual. This discrepancy had an effect analogous to high system oil pressure because it took less force from the hydraulic control system to open CV5 than it would have with the spring tension set in accordance with the vendor manual.

The HPCI system oil pressure was reset to a lower value with the turbine running at 4000 RPM. This resolved the degraded condition. (Complete) NRC FORM 366A
