### Church Rock Flooding Damage Summer 1999 with Photos, Map, and Gamma Survey

Compiled in July 2000

#### **CHURCH ROCK FLOODING DAMAGE SUMMER 1999**

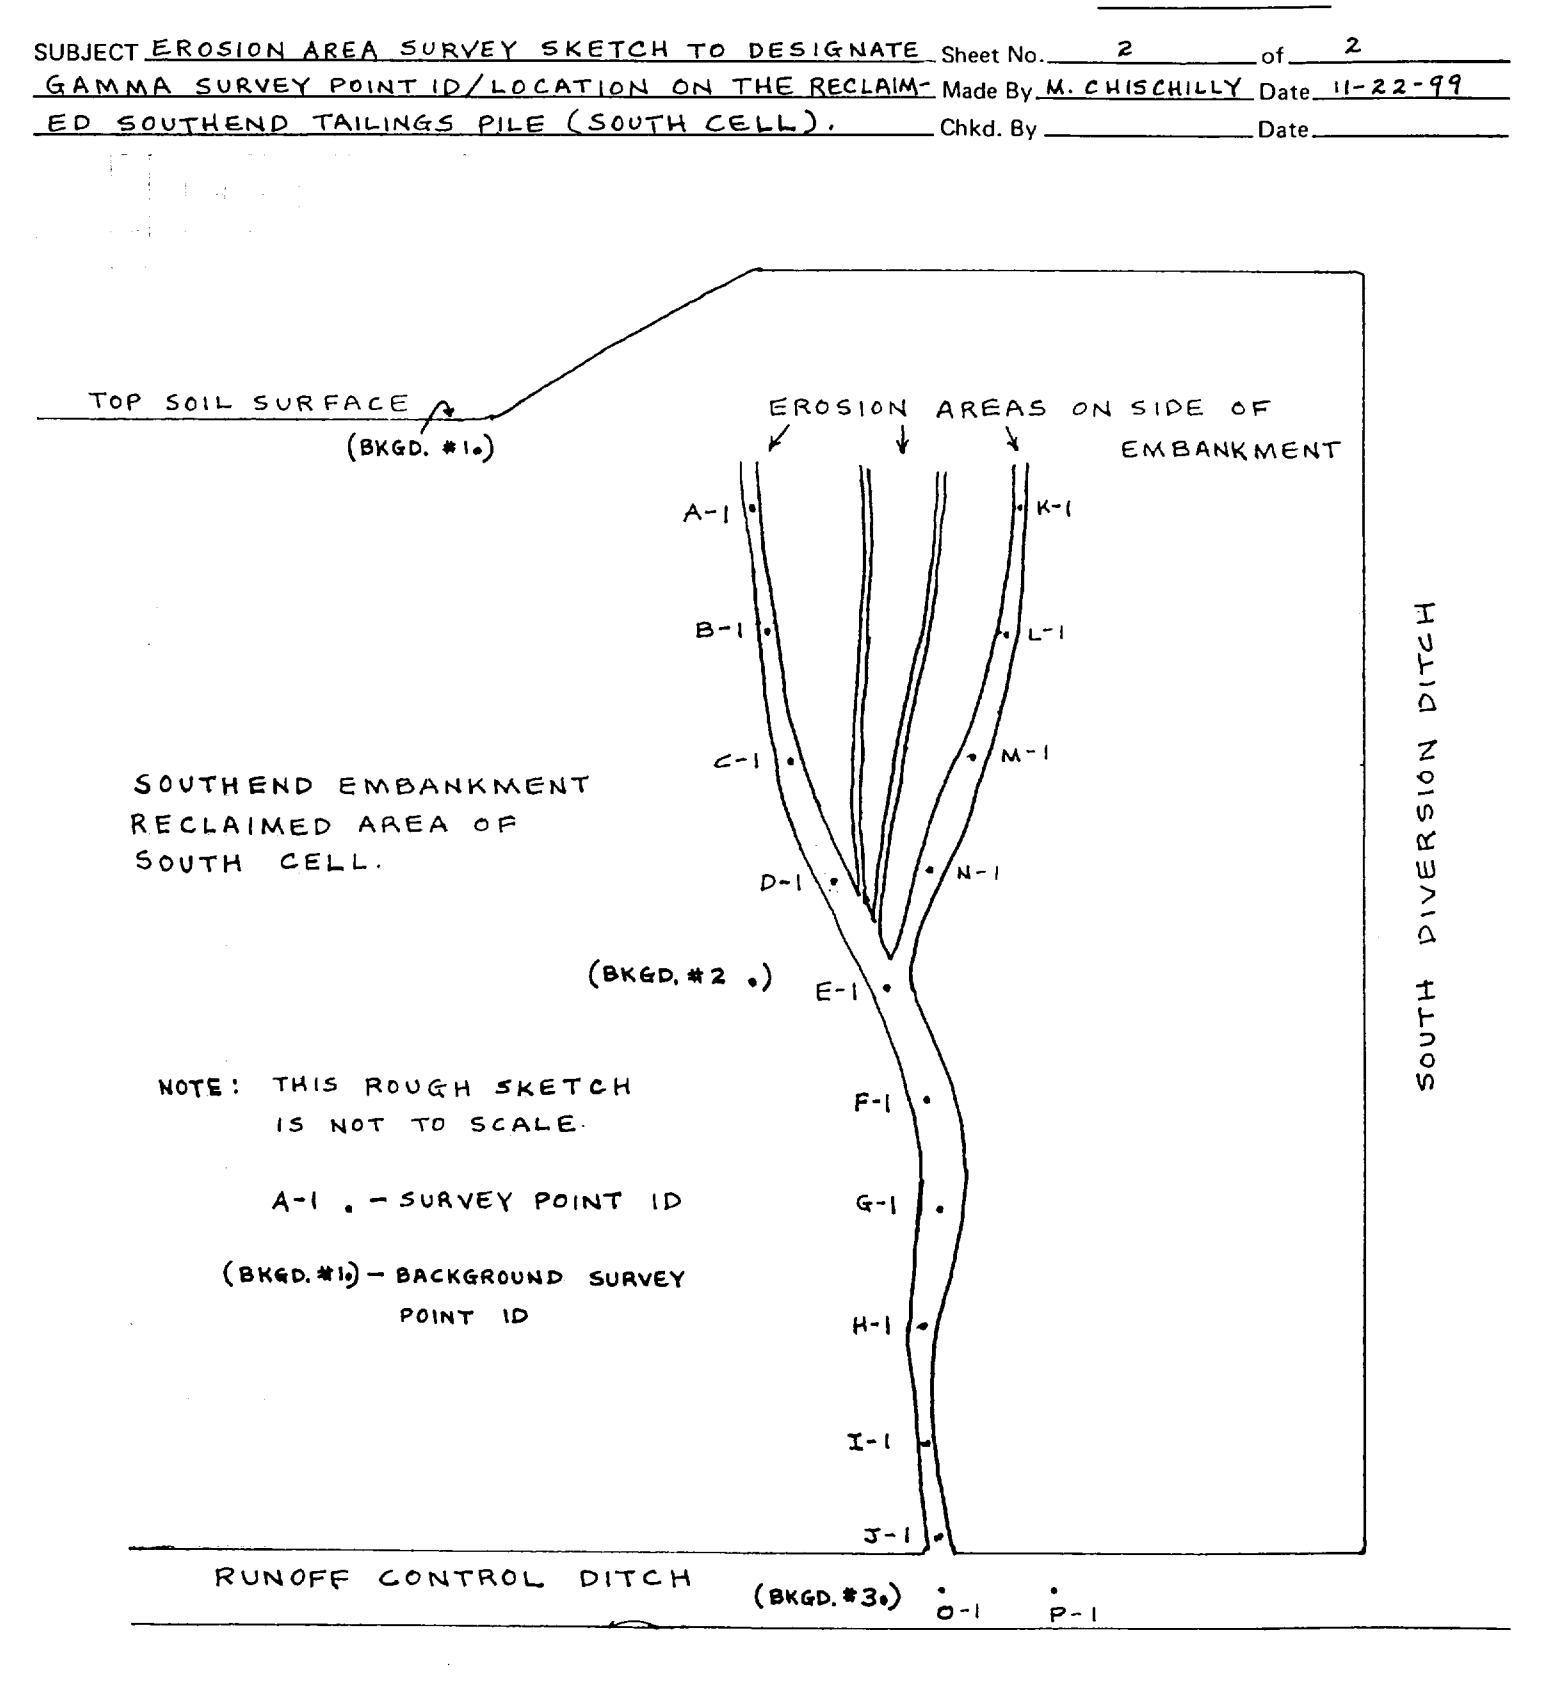
16-18				тор	1.11-11		+
		@ 2	17-19		<u>N-1</u>	10 X 1	SURFACE	19-16		
		BOTTOM	18-21				BOTTOM	19-17		
		TOP				1-4 -1	TOP			
E-1	4'4"x2'4"	SURFACE	15-18			19.2	SURFACE	15-17		
		<u>@</u> 1'	18-20				(@)	15-11		
	+	@ 2	16-20				BOTTOM	15-16	1	
		<u>C 3'</u>	18-20			111.1.4	TOP			<u> </u>
		BOTTOM	18-21		M-1	23x23	SURFACE	14-17		
		TOP					<u>e</u> i	17-20		<u> </u>
F-1	4'x 3'2"	SURFACE	17-20				BOTTOM	18-21		
		01	16-18				TOP			<u> </u>
		0 2'	17-20		N-1	4'10 x 2 B	SURFACE	15-17		
		0 3'	18-20		<u> </u>		<u>(@ 1'</u>	16-19	<u> </u>	
		BOTTOM	18-22				@2'	16-20	+	
	· ·	TOP					03	18-21		
G-1	4'7"x3'8"	SURFACE	16-20	Į			BOTTOM	17-22	+	
		@ 1'	16-19			BOTTOM	TOP			+
		0 2'	18-22		0-1	DITCH	SURFACE	14-17		
		@ 3'	19-21		<b>_</b>	BOTTOM	TOP			
		BOTTOM	18-22		P-1	RUNOFF	SURFACE	14-17	<u> </u>	<u> </u>
REMARK	S.: Gam	Ma SULA	ey grid p	oints ≈ 1	o' inter	vals on th	ne side a	F Souther	<u>d tailing</u>	; pile
L	area	. Surve	<u>x findings</u>	indicate	no an	omalies.	Sketch o	f survey	is attach	ned.
