Sherwood Tailings Reclamation Plan

Responses to NRC Comments

Prepared by Washington Department of Health
Environmental Health Programs
Division of Radiation Protection
Waste Management Section

July 2000

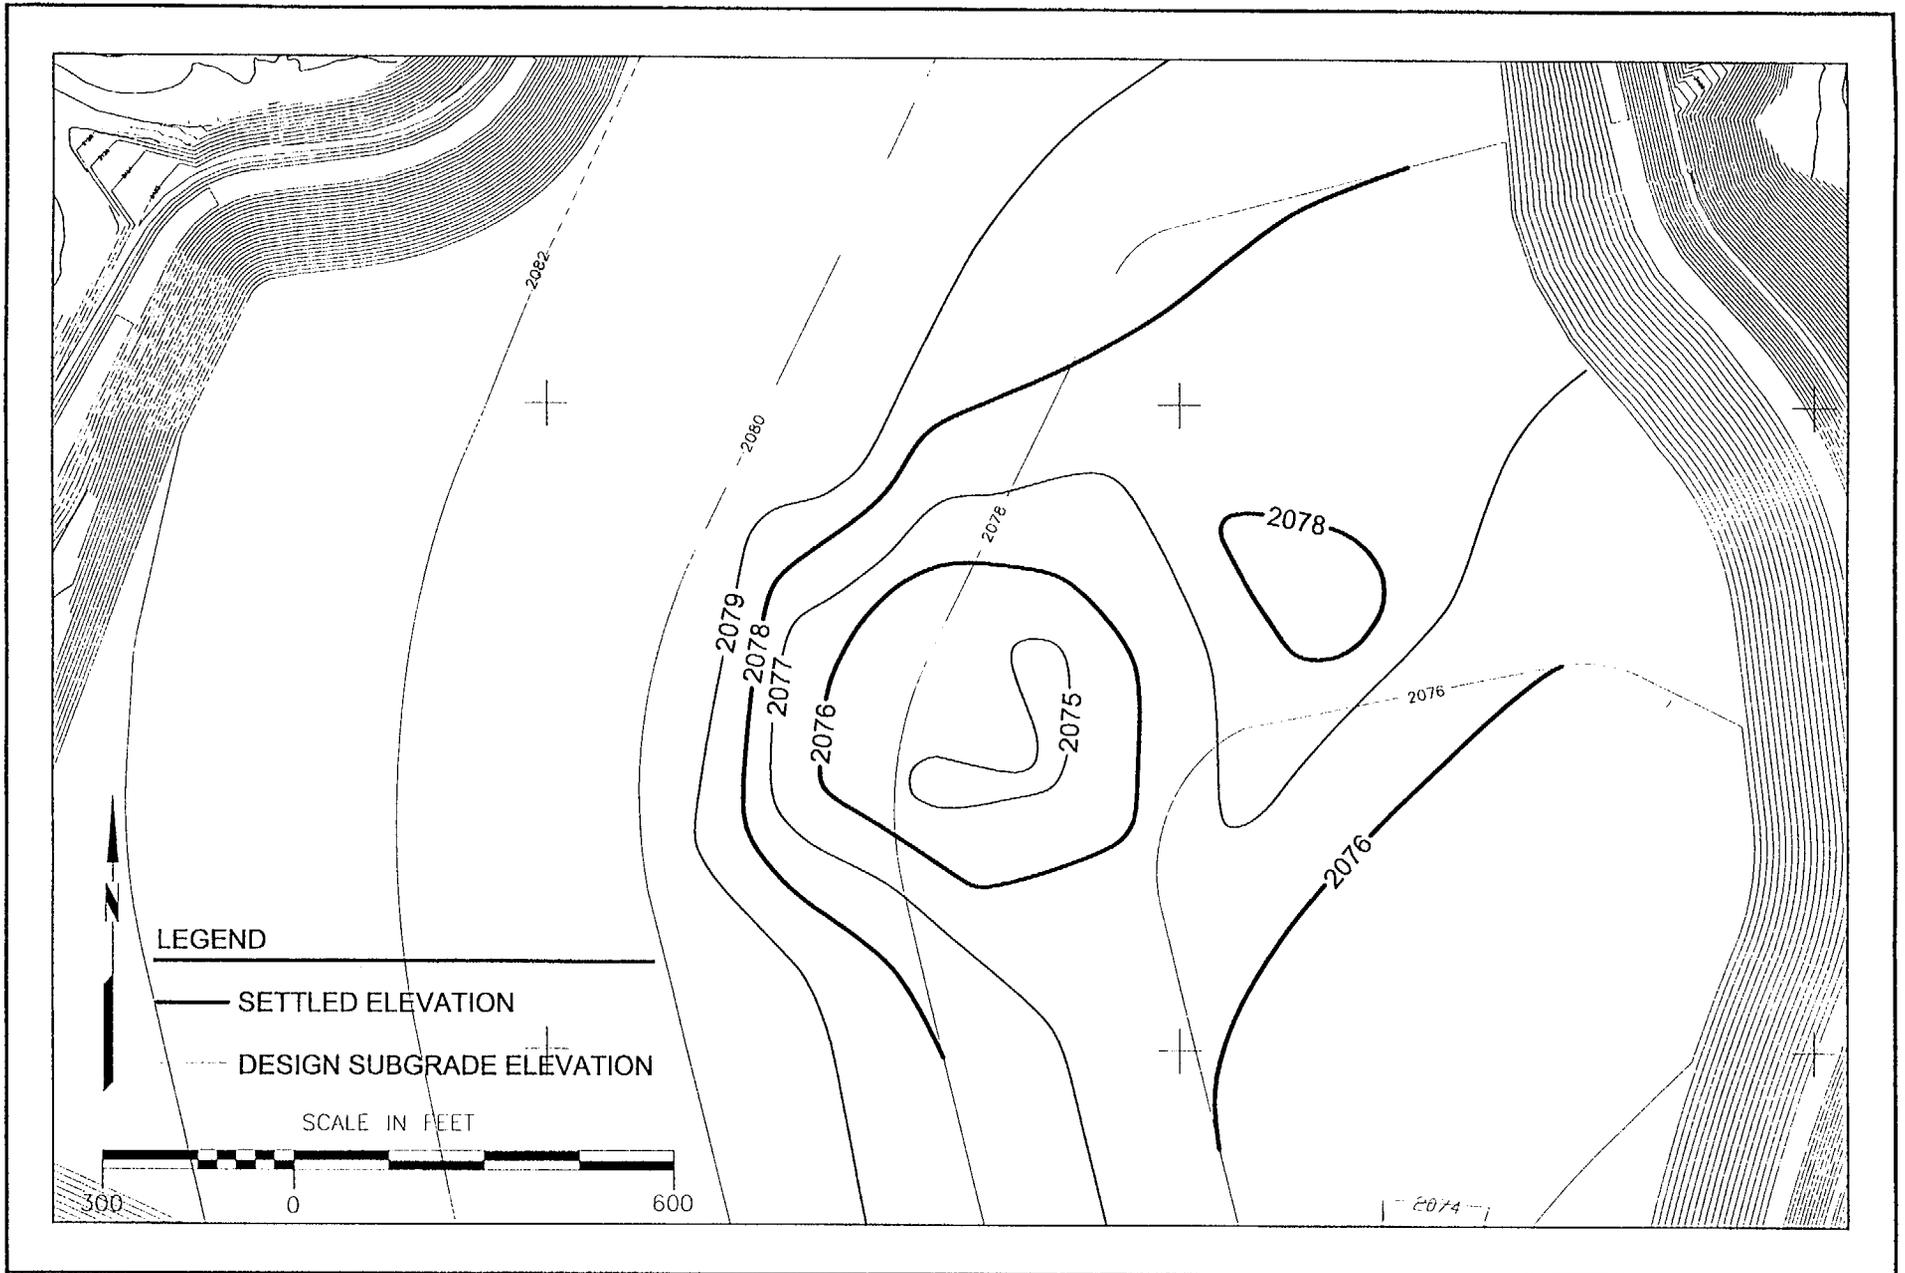
FIGURE 1
 TAILINGS COVER ELEVATIONS
 AS OF 10/5/98

During further discussion at the September 22, 1998 meeting, your staff requested further information about the settlement area. In response to this request, we submit the following. Attached to this letter is an evaluation of the settlement measured to date and an evaluation of erosional stability given the observed settlement. These evaluations were based upon level survey data collected in October 1998 utilizing the construction verification grid.

Settlement measured at 27 stations is shown in Table 1 of Attachment 1; Settlement Analysis. Level survey data were taken relative to the elevation of a point located on exposed quartz monzonite where settlement is zero. Maximum settlement was 3.86 feet while the 12/94 TRP predicts settlement up to 6.1 feet. Settlement outside of the settlement area has occurred in varying degrees up to approximately 1 foot. The settlement analysis concludes that observed settlement is consistent with predicted settlement.

The predicted curve for SM-2 was plotted with actual data from survey points 240, 274, and 305. The predicted curve for SM-(5-6) was plotted with actual data from survey point 276. The predicted curve for SM-8 was plotted with actual data from survey points 279, 311. SM-2 and SM-(5-6) were chosen because they produced the highest predicted settlement. Points 240, 274, and 305 are all about the same distance from SM-2. Point 276 is the closest point to SM-(5-6). SM-8 was chosen because of its proximity to point 279. As can be seen, the observed settlement is consistent with the predicted settlement.

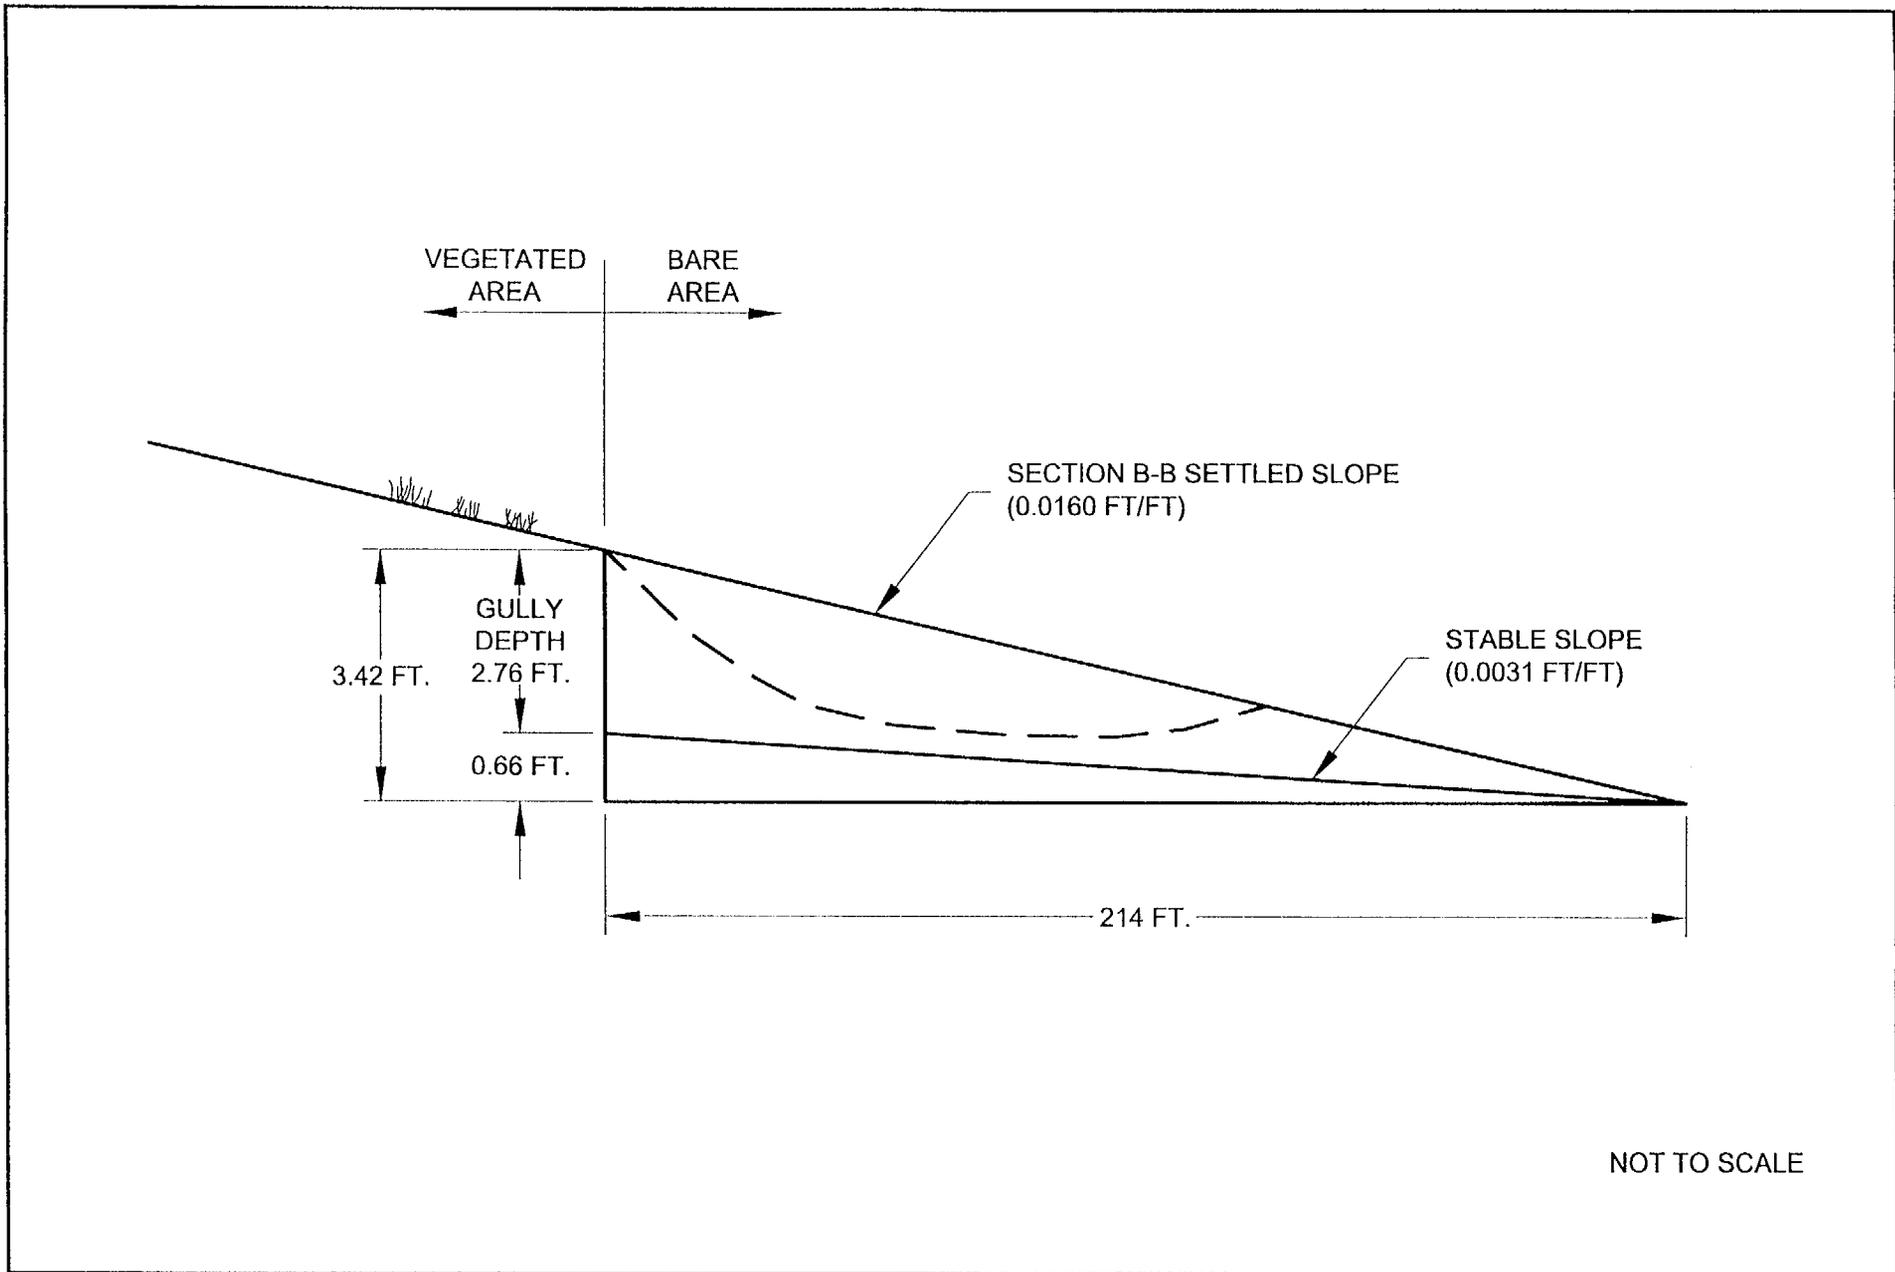
FIGURE 1
PREDICTED SCOUR ON
IMPOUNDMENT SURFACE

The erosional stability analysis (Attachment 2) shows that a gully of up to three feet in depth may occur during worst case conditions, ie.; a PMF event. However, impact to the surface cover system is minimal since erosional impacts only occur within the settlement area.

The analysis, which was performed assuming worse case conditions, is included in Attachment 2. This analysis indicates that erosion could occur for the unvegetated surface. Additionally, the analysis indicates that the maximum depth of the erosional gully would be approximately 3 feet. Material from the erosional gully would be deposited in the bottom of the low area.

The analysis shows that under worse case assumptions, a gully approximately 3 feet deep could occur over the surface. This erosion will not however adversely impact the performance of the cover. First, since the cover is 13.6 feet thick (only 12.6 feet was required), removal of a small portion of the total thickness of the cover over a very small area would not cause any change to the overall radon flux from the cover. The area over which the erosion would occur would be so small as to be insignificant relative to the area of the rest of the reclaimed impoundment. In addition, the material removed from the erosion feature would be deposited over another portion of the cover. Therefore the total material covering the tailings would not change. Furthermore, the water content in this area will be greater than the water content assumed for the radon modeling (likely saturated in at least the lower portion of the cover which would eliminate all radon flux from the tailing). Therefore, the flux from this area and the overall average flux from the reclaimed tailing impoundment will be less than 20 pCi/m²/s requirement.

In summary, an evaluation was performed that indicated that a minor amount of erosion could occur under worse case conditions. These conditions could only exist for a few years until vegetation becomes established. Any erosion that might occur will not impact the performance of the cover. Therefore, the area where the seasonal pond exists could be excluded from the vegetation success requirements presented in the monitoring and stabilization program without impacting the performance of the reclamation system.

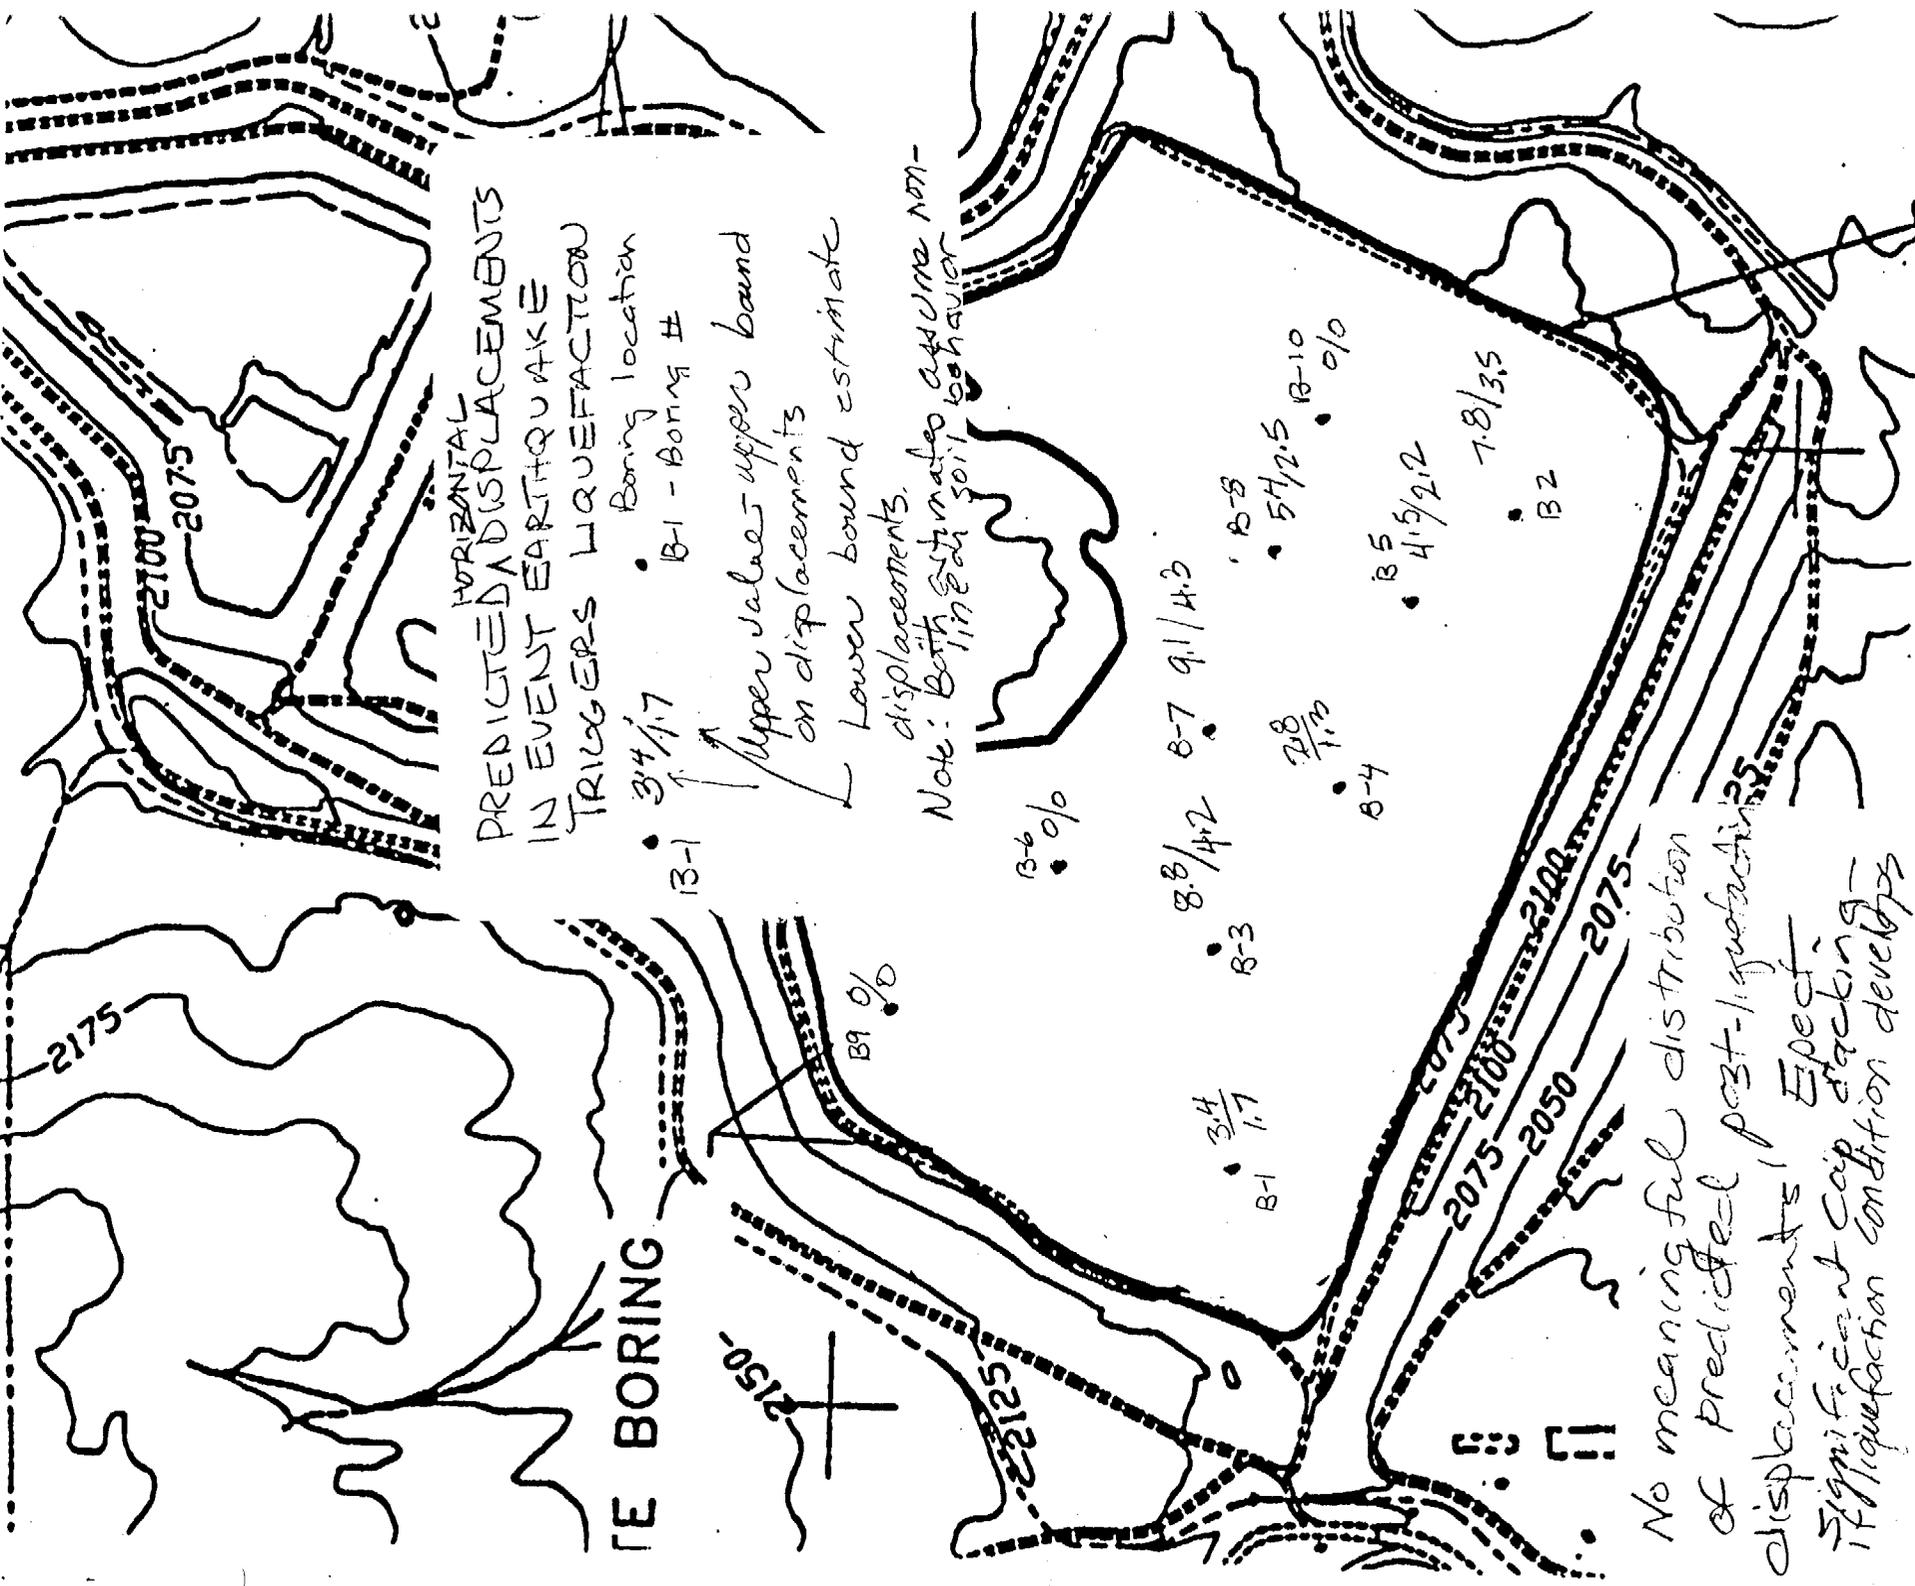
HORIZONTAL
 PREDICTED DISPLACEMENTS
 IN EVENT EARTHQUAKE
 TRIGGERS LIQUEFACTION

In the event such ground movements occurred, the cap surface would probably resemble a series of soil "plates" that had shifted differentially both horizontally and vertically relative to one another. The majority of the differential movements between "plates" likely would be expressed as cracks at the perimeter of the plates. Additionally, a small volume of the liquefied slimes would likely erupt through these cracks and spill unto the ground surface. It is the outside our expertise and purview to comment on the acceptability of such a remote occurrence.

No meaningful distribution
 of predicted post-liquefaction
 displacements. Expect
 significant cap strapping
 if liquefaction condition develops

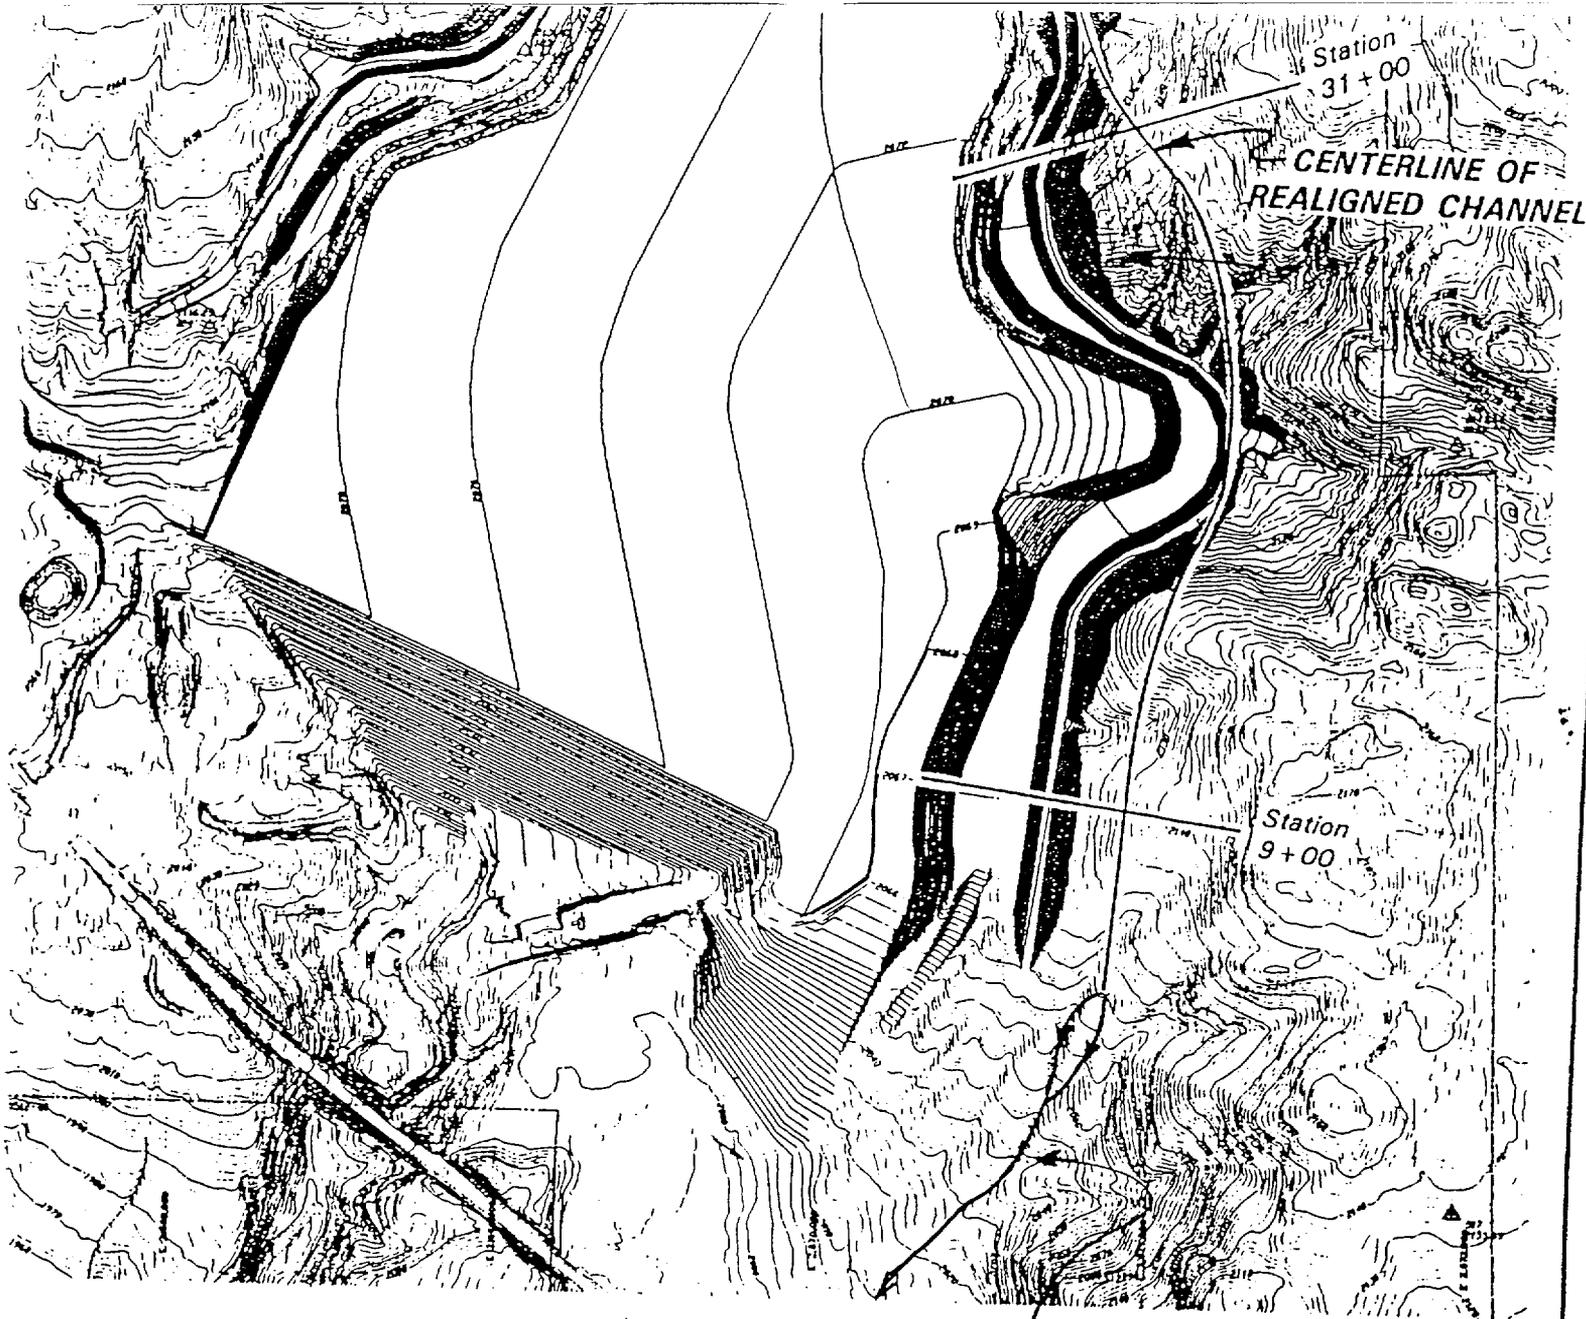
PROBABLE FLOW PATH
FROM DIVERSION CHANNEL

The only comment regarding the design is that the tributaries to the diversion channel will carry sediment into the diversion channel during storm events. If this channel is not maintained, the diversion channel will silt in over time resulting in the diversion channel being blocked at each confluence, and flow and sediment passing onto the tailings cap. While this will likely not result in the failure of the dam, the introduction of flow onto the cap may have other undesirable impacts to the project.
