WSRC-TR-2001-00163

**Degradation and
Failure Characteristics
of NPP Containment
Protective Coating Systems**

Preliminary Evaluation of Plant Coating Specimens

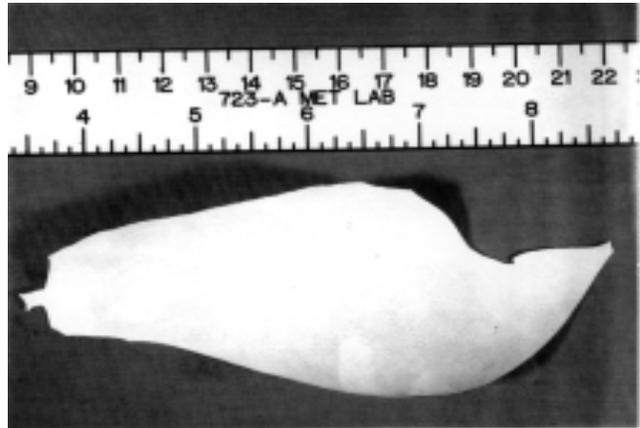
The topcoat is off-white and the IOZ primer is gray in color. A close-up view of the largest coating chip is shown in Figures 2-2 and 2-3, with the topcoat side up. Although the primer was observed to be well adhered to the topcoat, powder residue was readily removed during routine handling. In addition, the topcoat thickness appeared to be greater than that of the primer adhered to the topcoat. The amount of primer remaining on the substrate is currently unknown. It is assumed that the majority of primer thickness was left on the carbon steel substrate.

Figure 2-2. Overall photograph of largest chip as-received (topcoat-side)

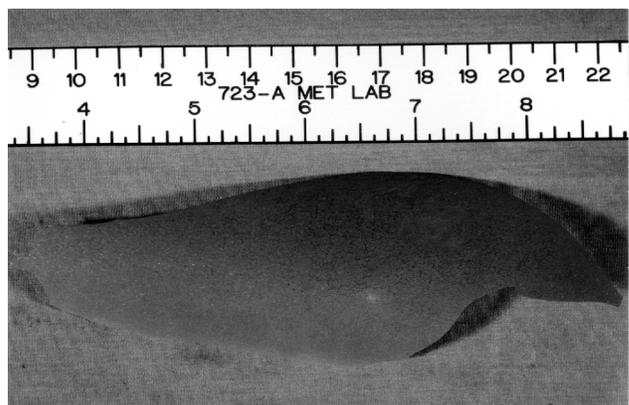
Figure 2-3. Overall view of largest chip received (IOZ primer side)

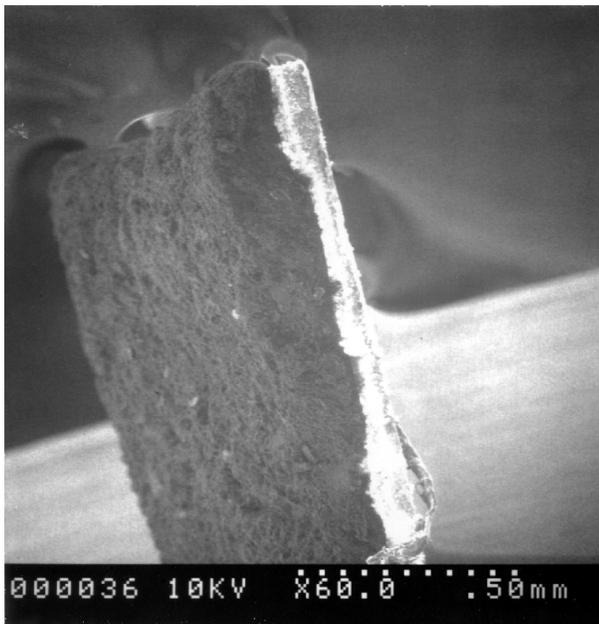
The chip samples were examined using an SEM to reveal surface morphology and characteristics of the IOZ primer. Samples were examined using a Hitachi scanning electron microscope at low voltage (10-20KV). A low magnification view of a chip sample is shown in Figure 2-4, with the topcoat (white) charging slightly due to its non-conducting nature. Samples were grounded in the microscope using conductive carbon tape to minimize such effects. Non-conducting samples can be sputter-coated with gold or carbon, but surface defects and other important features can often be masked or covered at microscopic levels. From Figure 2-4, the overall chip thickness was estimated to be approximately 180 microns or approximately 7 mils. Although only a rough estimate from an angular view, this is consistent with a 4-6 mil thick topcoat and a 2-3 mil primer which has cohesively split (2-3 mils for the primer would be acceptable, with all other application factors ideal).

Figure 2-4. SEM photomicrograph of a representative paint chip (60X)

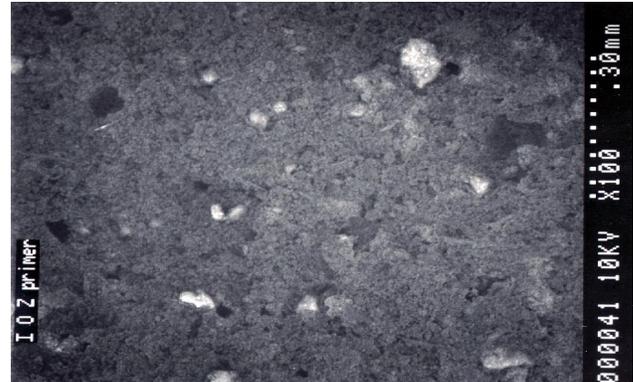
In Figures 2-5 to 2-10, higher magnification views are shown, with zinc/zinc oxide (ZnO) particles observed to be relatively spherical and intact. Although difficult to ascertain after disbondment, the presence of such uniformity indicates that the topcoat possibly failed initially due to tensile stress in the topcoat that was not supported by the IOZ primer layer. That is, tensile stresses would be expected in a coating for which

volatilization of the carrier material occurs. This condition, coupled with the (assumed) low cohesion strength within the IOZ, due to possible non-uniform distribution of the ethyl silicate binder as a result of inadequate moisture and/or excessive thickness, led to cracking in the topcoat and splitting within the IOZ layer to form chips.

Figure 2-5. Surface of inorganic zinc primer (100X)

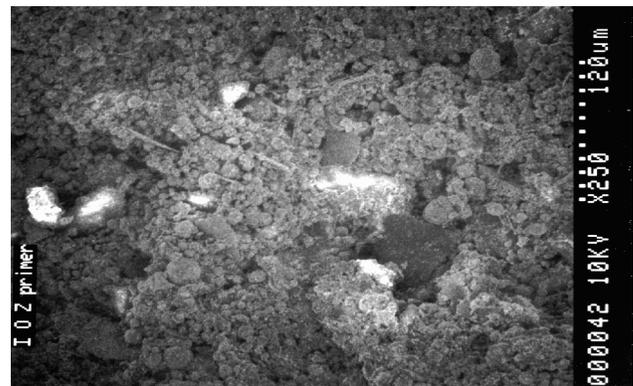
**Figure 2-6. Surface of inorganic zinc primer (250X)
(white particles are assumed to be charged regions of the epoxy-phenolic topcoat)**

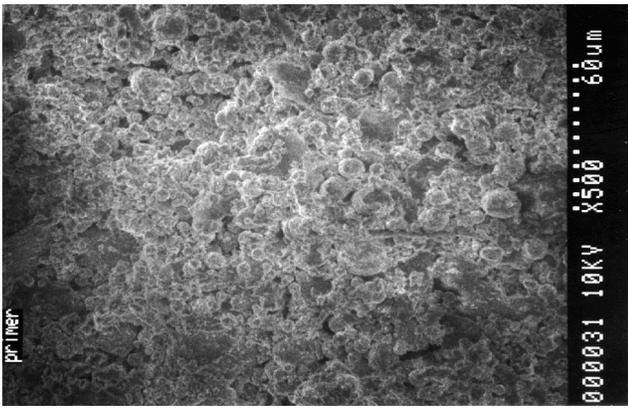
At 500X (Figure 2-7), zinc oxide particles were estimated to be approximately 10-30 microns in diameter, which closely corresponds with observations made in other studies of similar systems. Although most particles were intact, some of these were believed to have been disturbed during failure and during subsequent handling and motion. Surface particles present were believed to be dust that was lightly adhered to the underlying layers and were not necessarily representative of the actual fracture interface. Examination of the fracture surface in such a material is therefore more difficult than for a rigid crystalline material. At higher magnifications (Figures 2-8 to 2-10), cleavage or fracture lines on spherical particles were more obvious. At higher magnifications, discrimination of these features became more difficult due to low voltage beam fluctuations and surface contrast.

Figure 2-7. Inorganic zinc primer (500X)

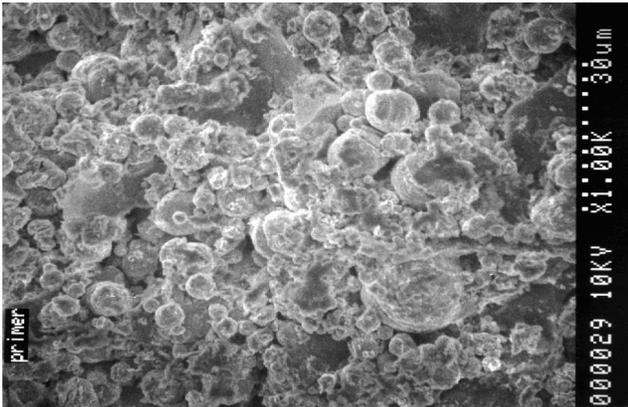
Figure 2-8. IOZ primer, with zinc/ZnO particles exhibiting cleavage planes (1000X)

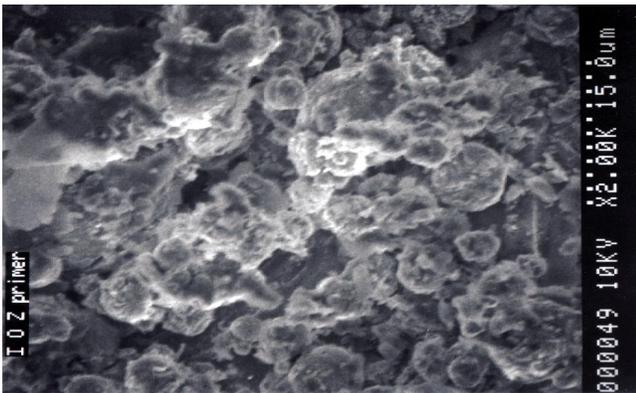
Figure 2-9. IOZ primer, zinc/ZnO particles (2000X)

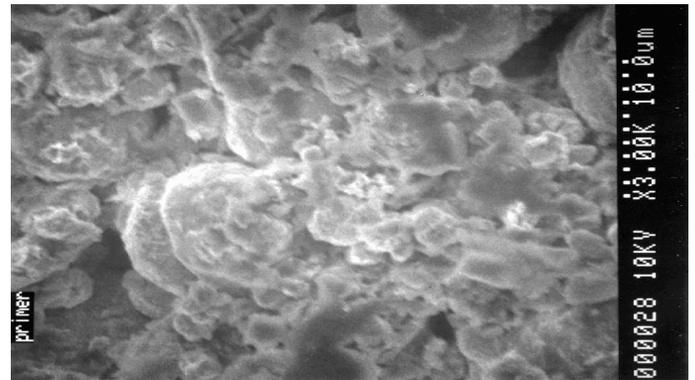
Figure 2-10. High magnification view of zinc particle in cleavage plane (3000X)

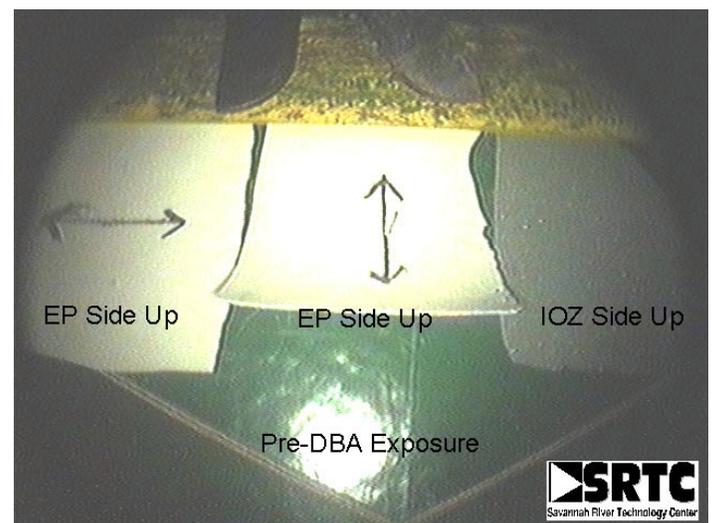
A real-time videotape record of the response of the chips was made during a simulated DBA/LOCA exposure. Figures 2-14 and 2-15 show stills from this video before and after exposure. The chips were in the following initial conditions:

Figure 2-14. Still from video of chips before exposure to 300°F steam for 1 hour

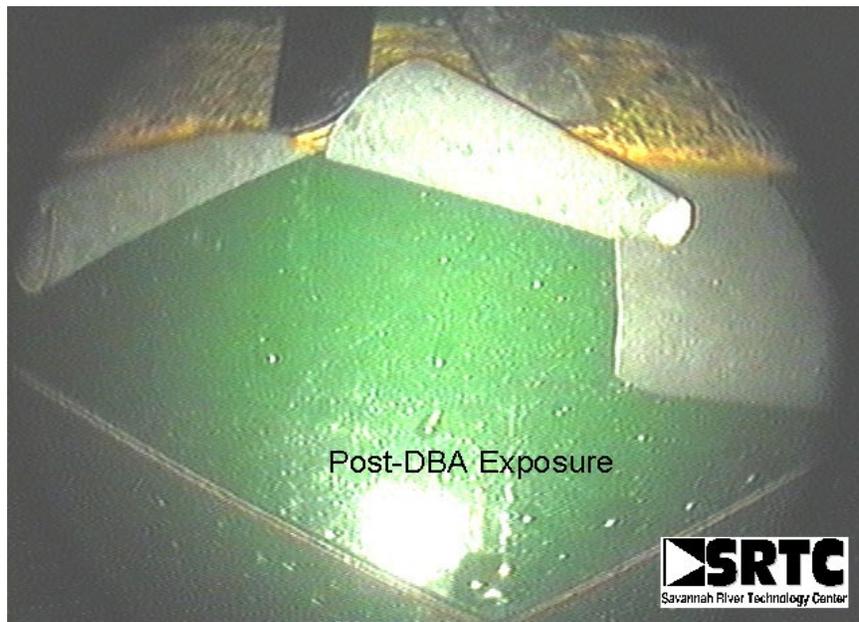
The as-received specimens had an initial curl or “curl-bias.” During chamber heat-up the chips showed an initial relaxation of this curl followed by a re-curl to the initial or even greater curled condition. With steam exposure, extreme tight curling occurred at a relatively constant rate throughout the first approximately 30 minutes. A relatively minor amount of additional curling occurred beyond the first 30 minutes. A large loss of powder from the specimen was observed on the specimen holder plate. The specimens also showed an approximate 20% loss in weight. The specimens always curled with the IOZ layer on the outside and the epoxy-phenolic layer on the inside. No consistent trend of final curl direction with respect to the initial bias was noted. The steam exposure greatly softened the chips and allowed plastic flow. The effects of temperature and moisture have been observed to soften the epoxy-phenolic [ref. WSRC-TR-2001-00067]. Qualitatively, the

Figure 2-15. Stills from video of chips after exposure to 300°F steam for 1 hour

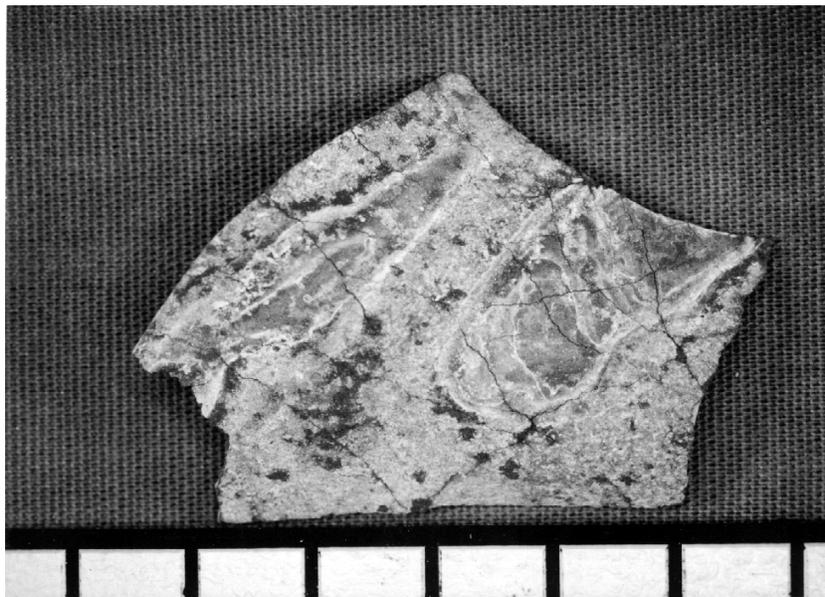
The pre-irradiated specimens did not curl to the extent of the non-irradiated specimens. The irradiation embrittled the chips, as qualitatively noted by the reduction in ability to bend the specimens before breaking for the irradiated chips, compared to the non-irradiated chips. The steam exposure softened the chips and allowed plastic flow, since bending in excess of that at room temperature was observed. The IOZ layer of the irradiated chips was also observed to contain numerous small cracks following the steam exposure, as shown in Figure 2-16. This was in contrast to the non-irradiated exposed chips, which did not show formation of cracks.

Figure 2-16. IOZ side up of chip specimen exposed to 300°F steam following additional radiation to 0.2×10^9 R

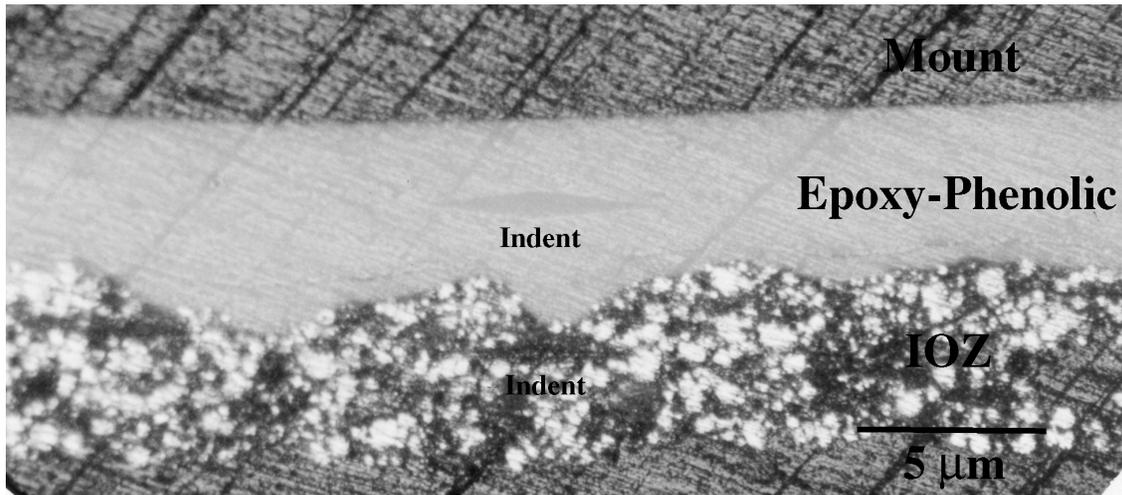
Additional characterization of the failed chips was performed. The as-received chips were mounted in cross-section and polished to show the two-layer system (see Figure 2-20). The Knoop hardness (HK) was determined using a 10 gram load. Measurements were made in the epoxy-phenolic layer with an average hardness number of

Figure 2-20. Photomicrograph of the failed chip in cross section showing the two-layer system with the Knoop hardness indents in the epoxy-phenolic and IOZ layers

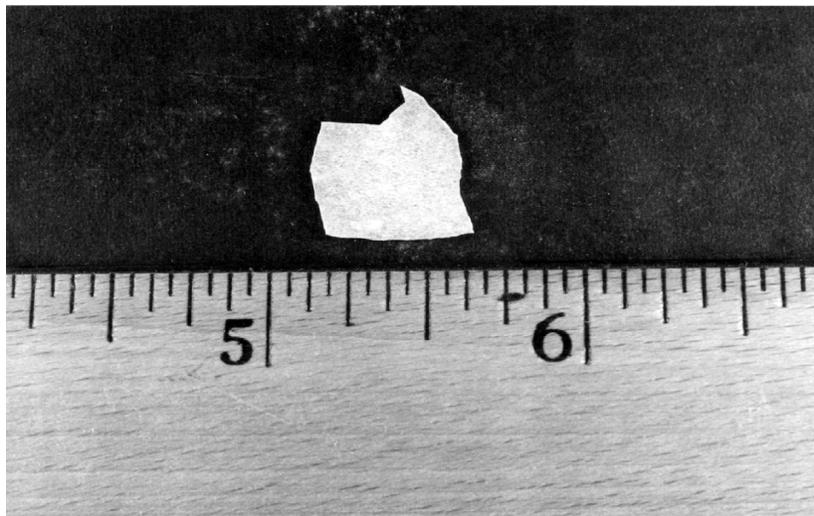
Figure 3-1. As-received coating chip, topcoat side – Rx Polar Crane location

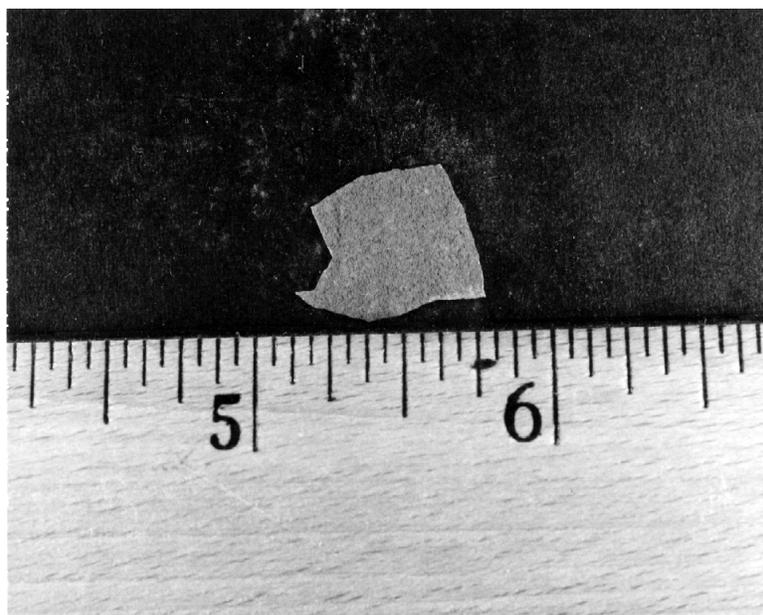
Figure 3-2. As-received coating chip, primer (inorganic zinc) side – Rx Polar Crane location

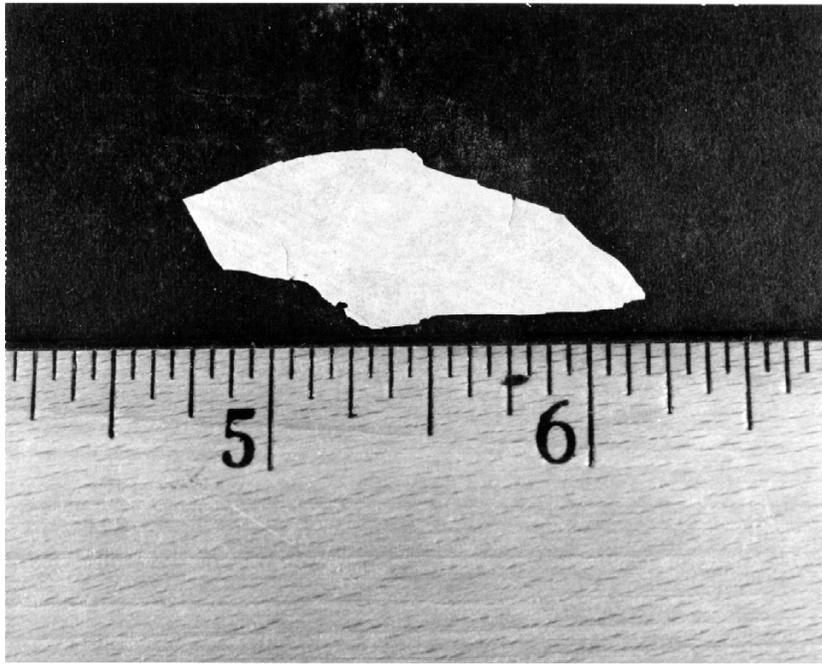
Figure 3-3. As-received debris, ceilings/wall location, 3rd Floor ceilings– topcoat with surfacer attached (note ¼" cracks)

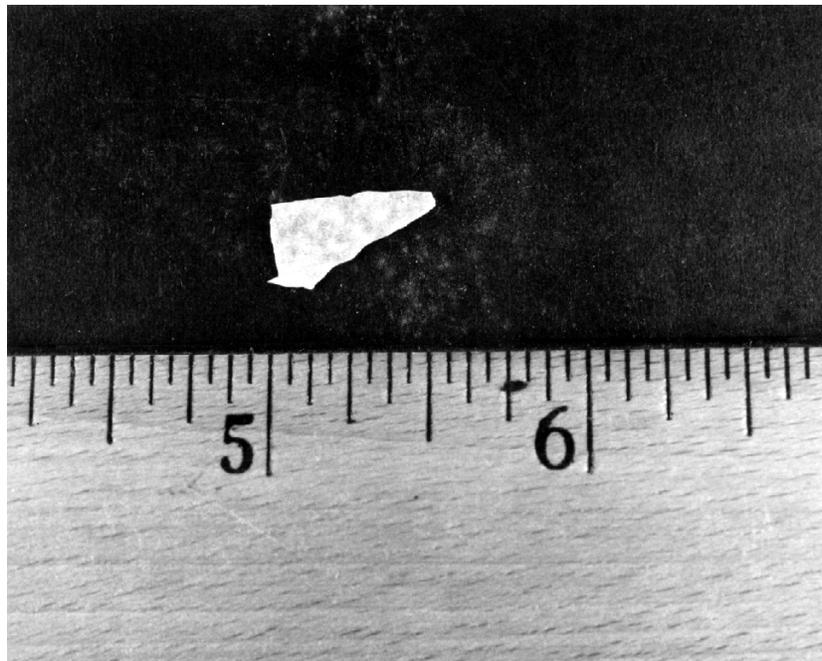
Figure 3-4. As-received chip from Rx spray – header steel location

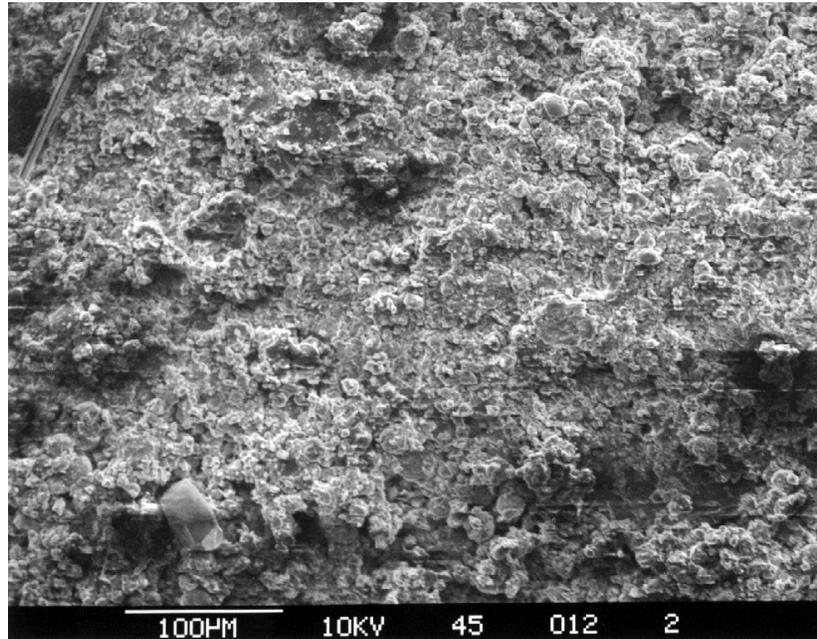
(Figure 3-5). Particles were assumed to be primarily zinc oxide in a silicate matrix, with some possible unreacted or unoxidized zinc metal in regions unexposed during curing and post-failure exposure to the environment. Due to the relatively high reactivity of zinc, however, the majority of exposed metal dust/particles were assumed to have either reacted with the ethyl silicate binder to form either a zinc silicate “polymer” or zinc oxide.

Figure 3-5. Secondary electron (SE) image of inorganic zinc primer – header steel location (200X)

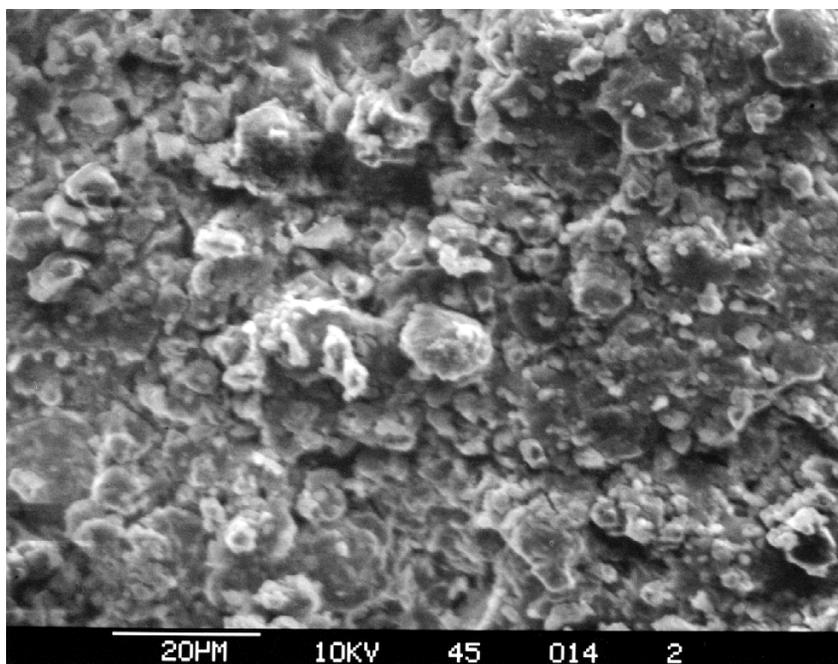
Secondary electron images of the same general area and features are shown from 500 to 5000X in figures 3-7 to 3-10, with the majority of zinc oxide particles observed to be less than 20 μm in diameter. At the higher magnifications, cleavage planes (splitting of the particulates) were observed. Cleavage of particles may have occurred during coating failure or may be an artifact of the coating curing process.

Figure 3-8. Secondary electron image of inorganic zinc primer (1000X)
Note size of Zn/ZnO particles (<20 µm)

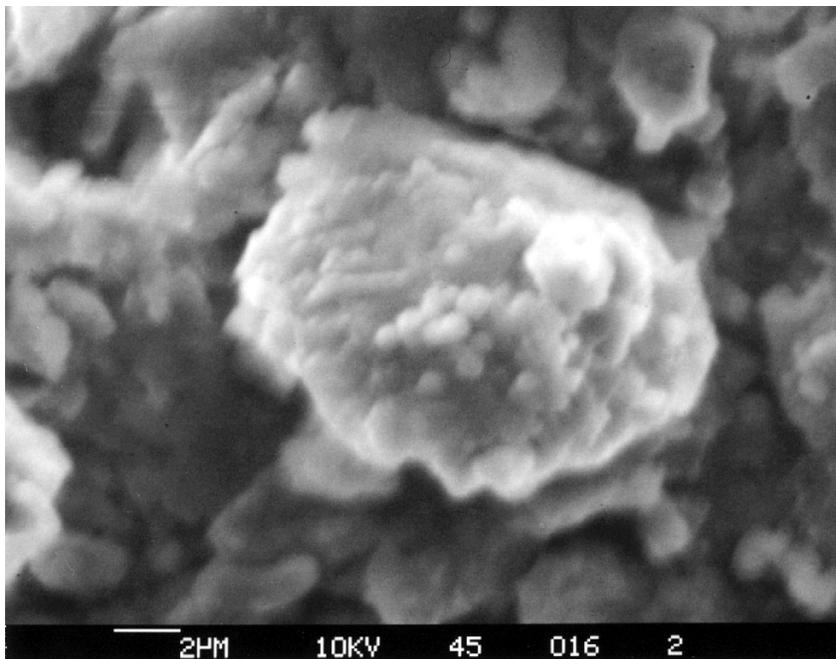
Figure 3-10. Secondary electron image of larger particle, note cleavage plane (loss of clarity at high magnification), 5000X

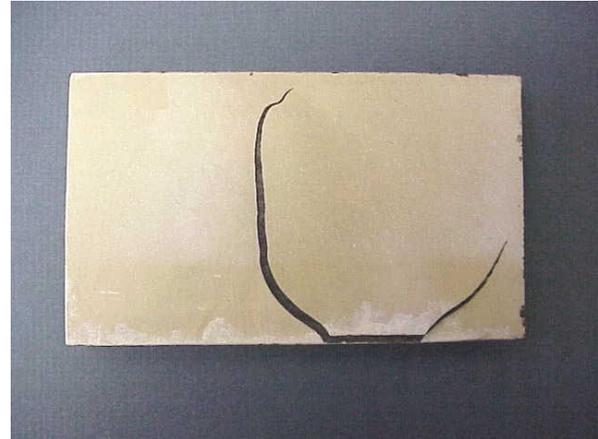
Figure 4-1. Overall view of snubber support base plate specimen as it appeared after DBA testing

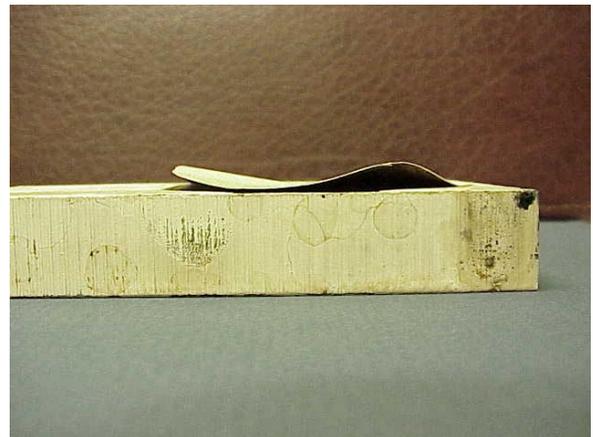
Figure 4-2. Side-view of the test specimen illustrating the extent of coating delamination

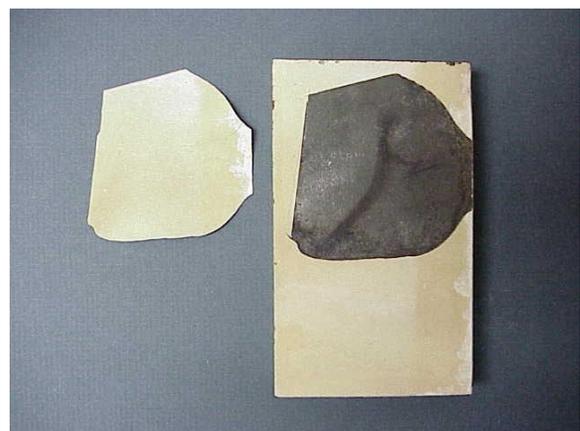
Figure 4-3. Overall view of the test specimen after removal of the failed chip.

Note: The chip was removed approximately along the bond/non-bond interface.

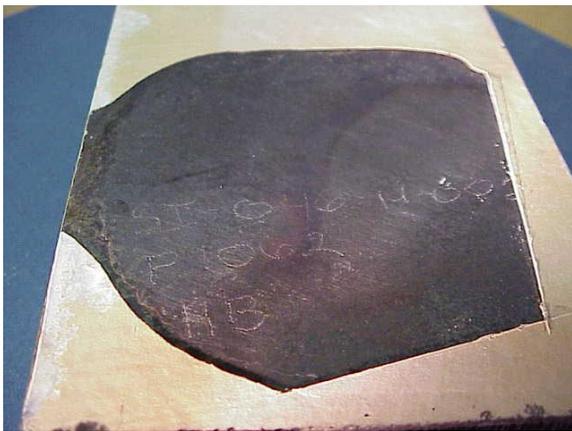
Figure 4-4. Close-up view of the test specimen revealing identification markings in the steel plate surface beneath the failed chip.

Note: The surface in this area appeared smooth, with minor surface scratches similar to what might be expected from wire brushing.

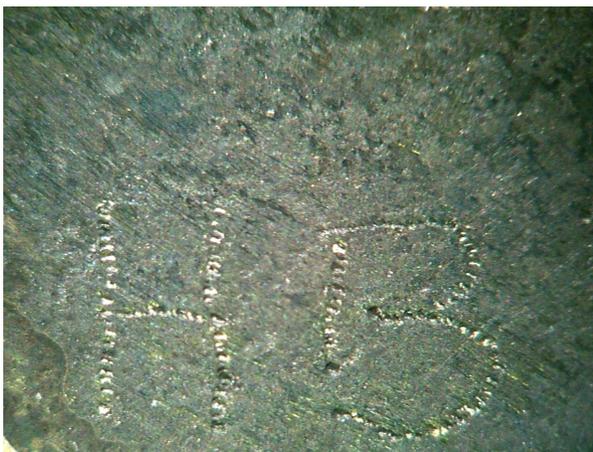
Figure 4-5. Close-up view of the surface of the steel plate beneath the failed chip illustrating the smooth, lightly brushed appearance.

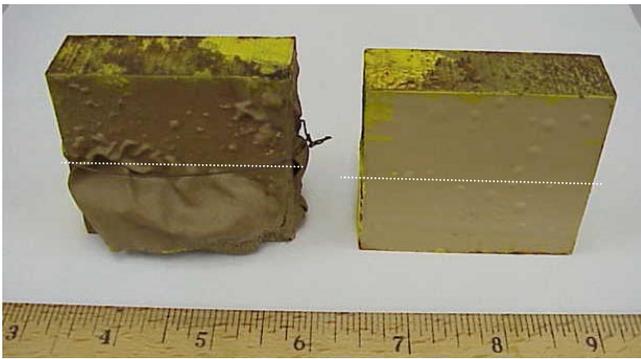
Figure 4-8. Overall view of the snubber support plate specimens following DBA/LOCA testing. The irradiated specimen (left) exhibited delamination and blistering of all of the coated surfaces. The non-aged specimen exhibited minor blistering. The dotted lines indicate the approximate immersion level.

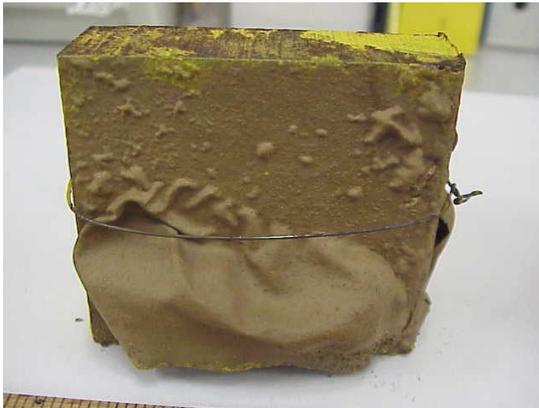
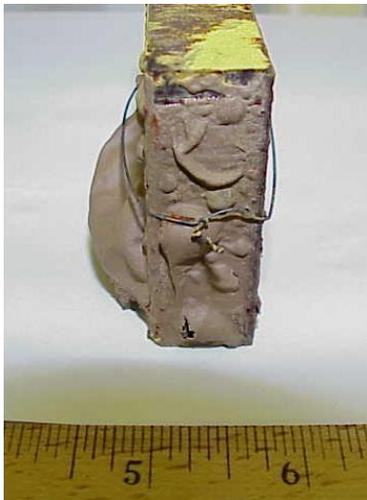
Figure 4-9. Front and side views of the irradiation-aged specimen illustrating the extensive blistering present following DBA/LOCA testing.

Examination of the irradiation-aged specimen revealed the thickness of the coating in the delaminated chip to be about 0.012 inch, considerably thicker than the 0.001 - 0.002 inch blisters which developed during testing of similar, irradiation-aged coatings, which were freshly applied. This suggests the exposure to the plant environment may have made the coating more susceptible to damage during irradiation-aging. As there is evidence coating damage results from a combined effect of irradiation and oxygen permeation, this difference in depth of damage can, perhaps, be explained as a difference in the depth of oxidation of the coating, which occurred prior to irradiation.

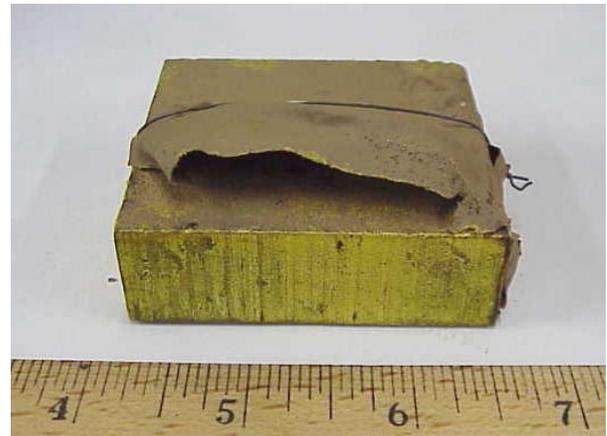
Figure 4-10. Bottom view of the irradiation-aged specimen illustrating the delamination that occurred in the immersed portion of the specimen during DBA/LOCA testing. The coating was split intra-coating (i.e., a portion of the coating remained on the steel substrate).

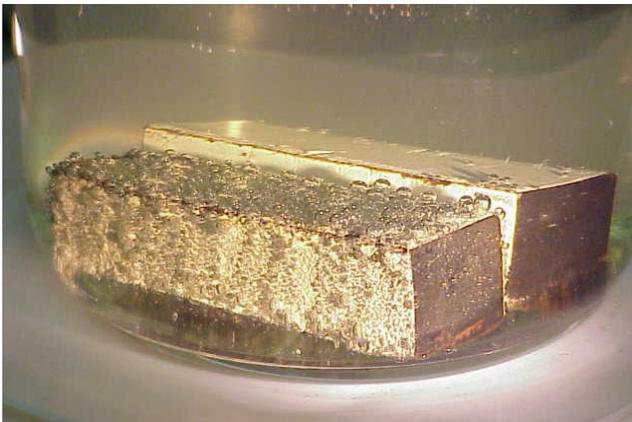
Portions of the aged and non-aged coating specimens were immersed in room temperature water, which was then heated to 200°F (Figure 4-11). As the water was heated, gas bubbles appeared on the coated surfaces of the irradiated specimen, accompanied by the formation of blisters in the coating as the temperature approached 200°F (Figure 4-12).

Figure 4-12. Overall view of the aged and non-aged specimens after immersion for approximately 2 hours in 200° F water. Note the formation of gas bubbles and blisters on the coated surfaces of the irradiation-aged specimen.

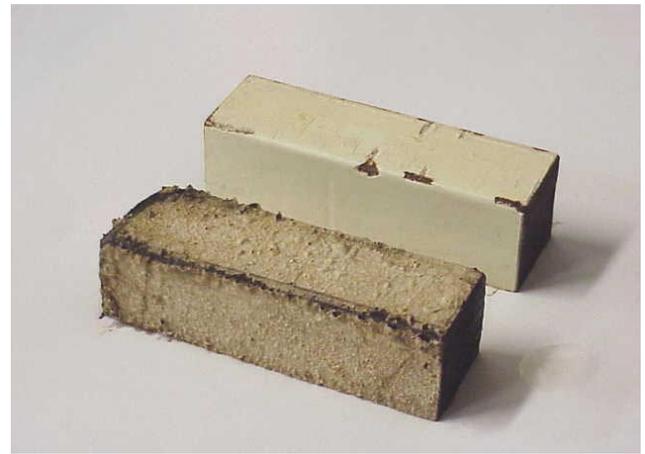
When the specimens were removed from the immersion test bath, the entire surface of the irradiation-aged specimen exhibited blistering of the coating, whereas the non-irradiated specimen was unaffected (Figure 4-13). The coating did not “fail”, according to the failure criteria in ASTM D3911-95, however, no effort was made to collect debris particles that may have been released from the coating.

Figure 4-13. Immersion test specimens following removal from the test vessel. No evidence of coating degradation was observed on the non-aged specimen.

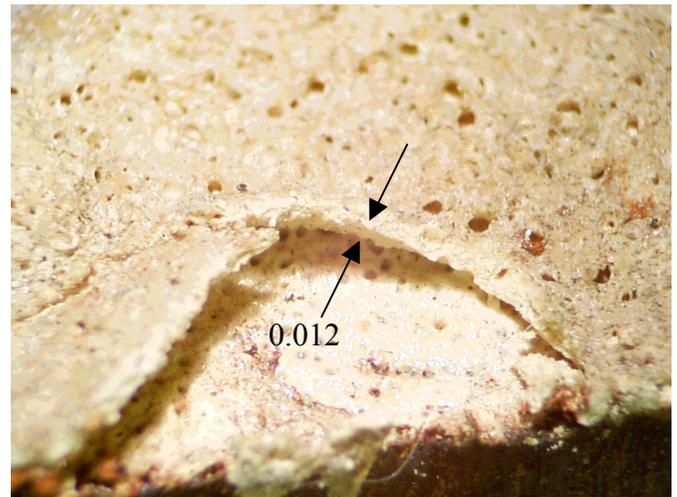
Microscopic examination of the irradiated specimen revealed an extensive network of pores and blisters throughout the coating. Measurements of the coating thickness made in broken blisters revealed a delamination depth similar to that seen in the DBA/LOCA testing. As before, a remnant of coating remained on the substrate beneath the blisters (Figure 4-14).

Figure 4-14 Photomicrograph of the surface of the irradiation-aged specimen following immersion testing. The thickness of the broken blister is approximately 0.012 inch – which is consistent with the delamination observed in the DBA/LOCA test. Note, also, the presence of minor blisters and pores in the surface of the coating. Magnification approximately 10x.

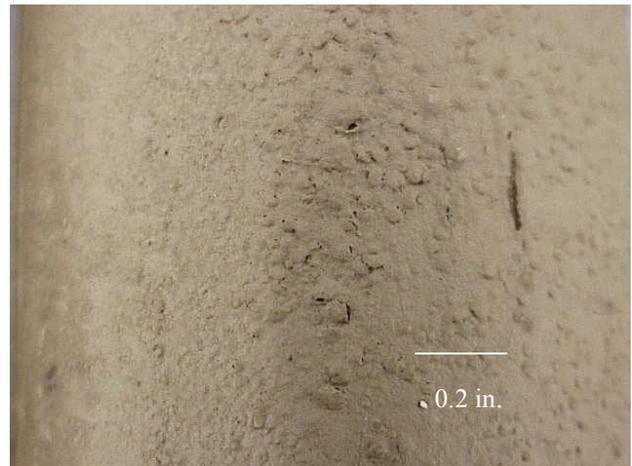
Figure 4-18. Macroscopic view of the surface of the irradiation-aged specimen, revealing the presence of intact blisters

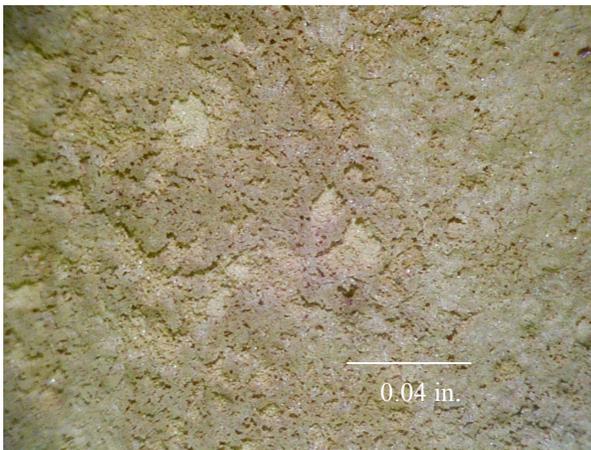
Figure 4-19. Microscopic view of the surface of the irradiation-aged handrail specimen, following DBA-LOCA testing. Magnification is approximately 7x.

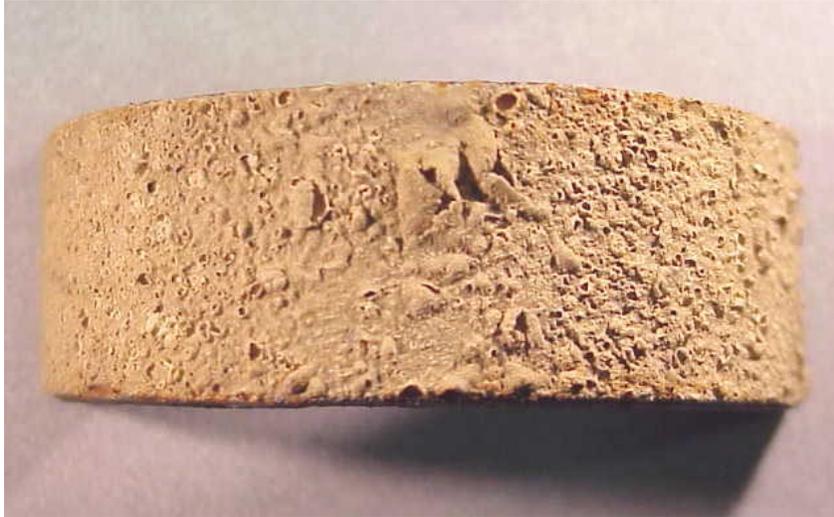
Figure 4-23. Irradiation-aged handrail specimen after removal from the water immersion test

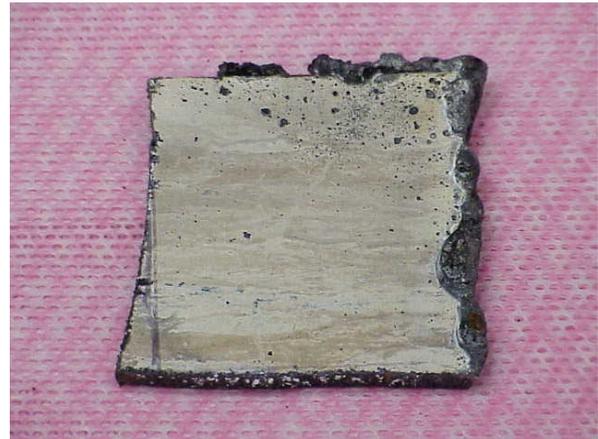
Figure 5-3 Overall view of the coated plate specimen as it appeared after immersion in 200° F water for approximately 24 hours. Only minor corrosion of the saw-cut edges of the specimen was observed.
