CENTRAL L	ABORATORIES SERVICES	Report No. 95-1021			
	NUMBER DEPOST	Sheet No.: 1 of 2			
TECHNICAL REPORT		Date of Report: JUN 1 9 1995			
Plant/Project:	Watts Bar Nuclear Plant				
Subject:					
Standards Used:	904694, 901387, 516825				
Copies Sent to:	Vonda Sisson, IOB 1M-WBN (4); I	RIMS; Lab Files			
Prepared by:	Daryl A. Smith / LAB	Approved by: Delsa Z. Frazler

EXHIBIT _______ PAGE _____ OF 28_PAGE(S) Ice Condenser Basket Screws, Watts Bar Nuclear Plant, Unit No. 1. Customer Identification No. 95-07, Figure 1: Laboratory Report No. 95-1021.

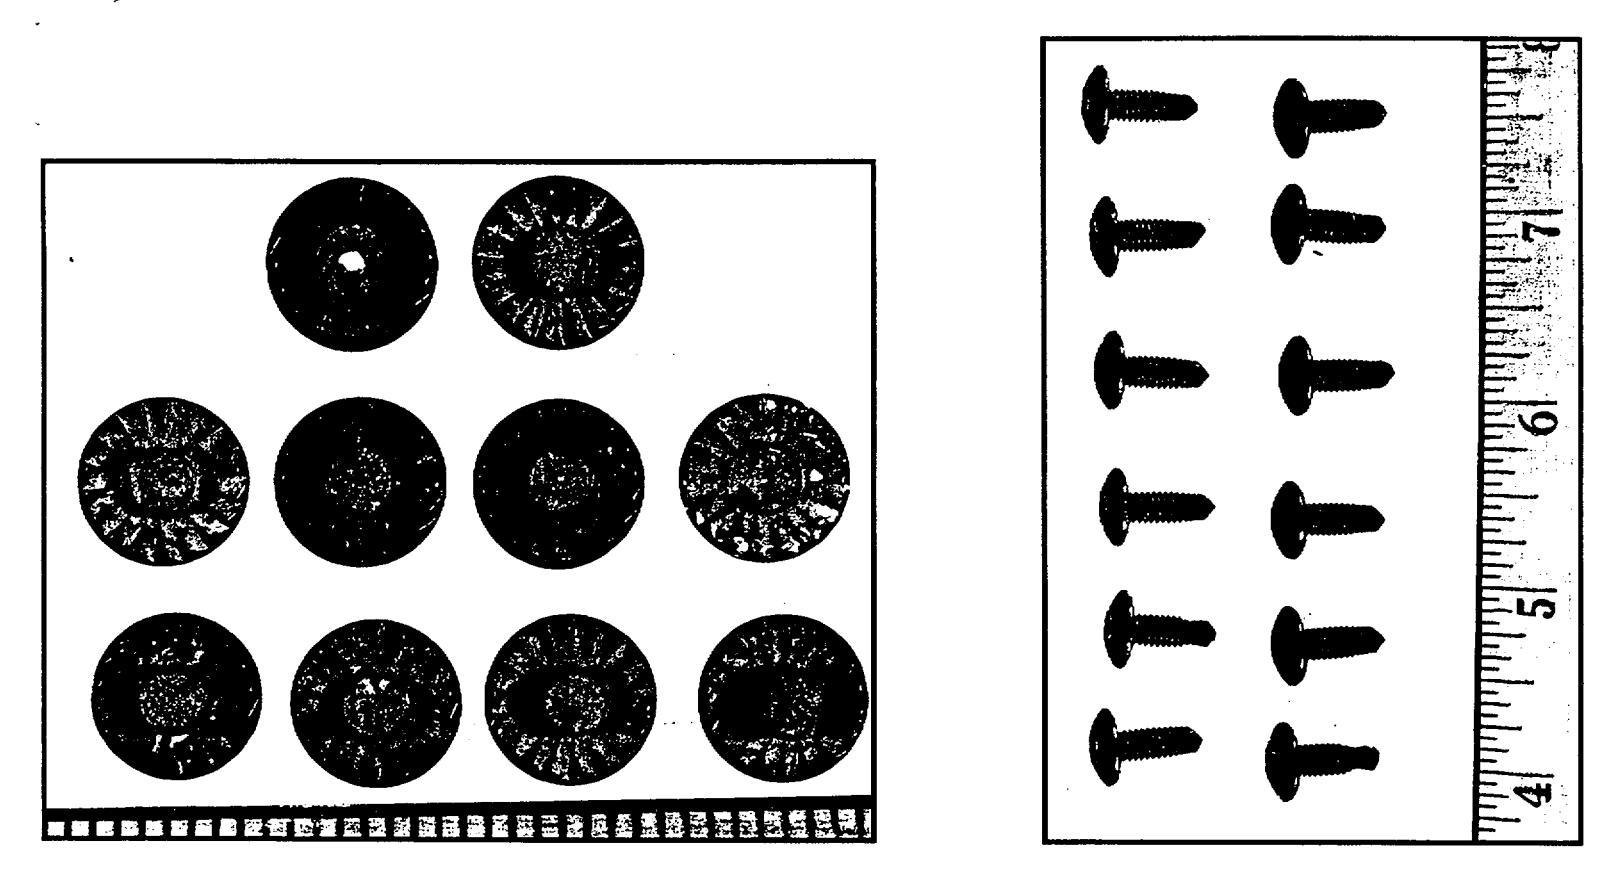
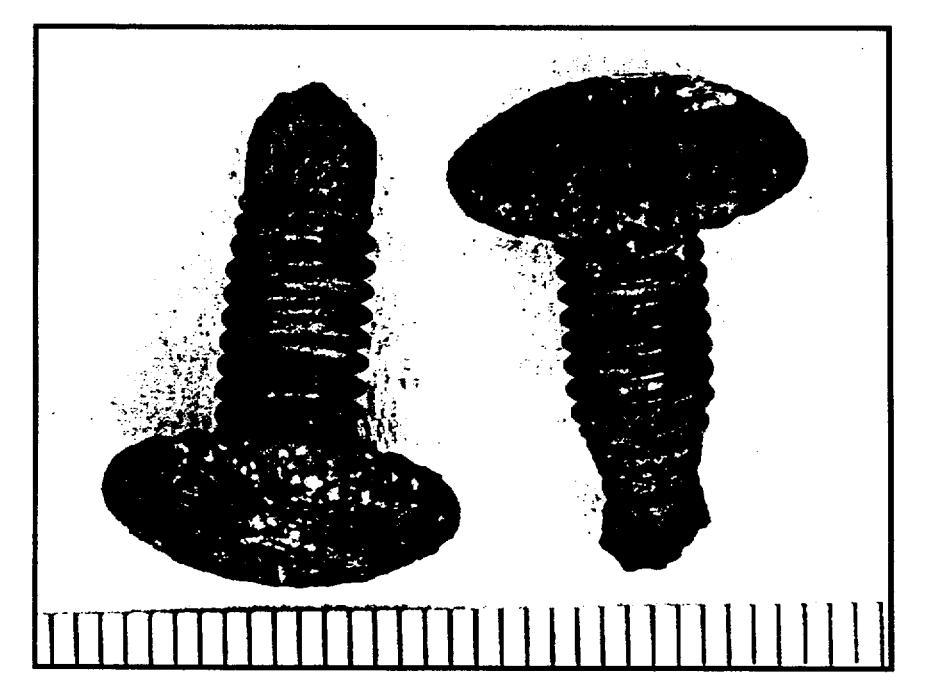
Set "A" : Ten fractured screw heads that were in service (seen in the upper left view of Figure 1) , and one whole screw that was not in service (not shown).

Set "B" : Twelve new screws, seen in the upper right view of Figure 1.

All screws removed from service had varying amounts of corrosion products on them, mostly in the threaded region. The lower view of Figure 1 shows a typical set of screws that were removed from service.

Left: As-received photograph of the fractured screws (set "A"). Note that the unfractured screw from this set is not shown. Right: As-received photograph of the new screws (set "B").

As-received photograph of a typical pair of used screws. Note that each set of used screws (set "C" through set "H") varied in degree of corrosion.

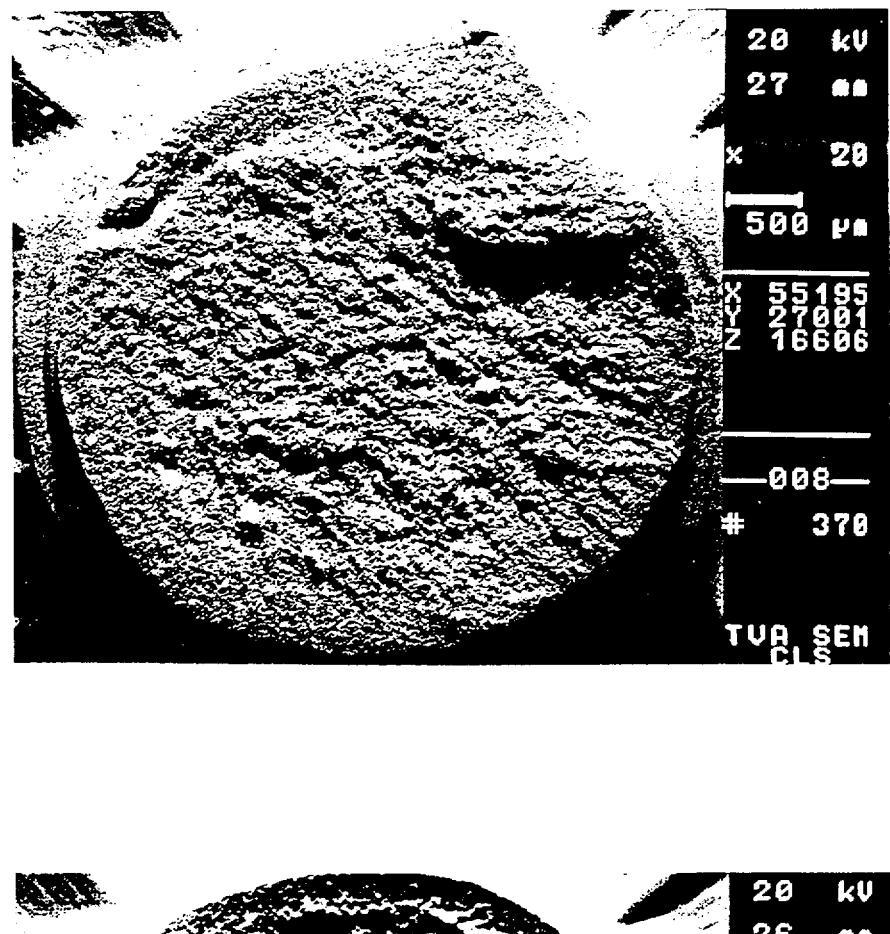
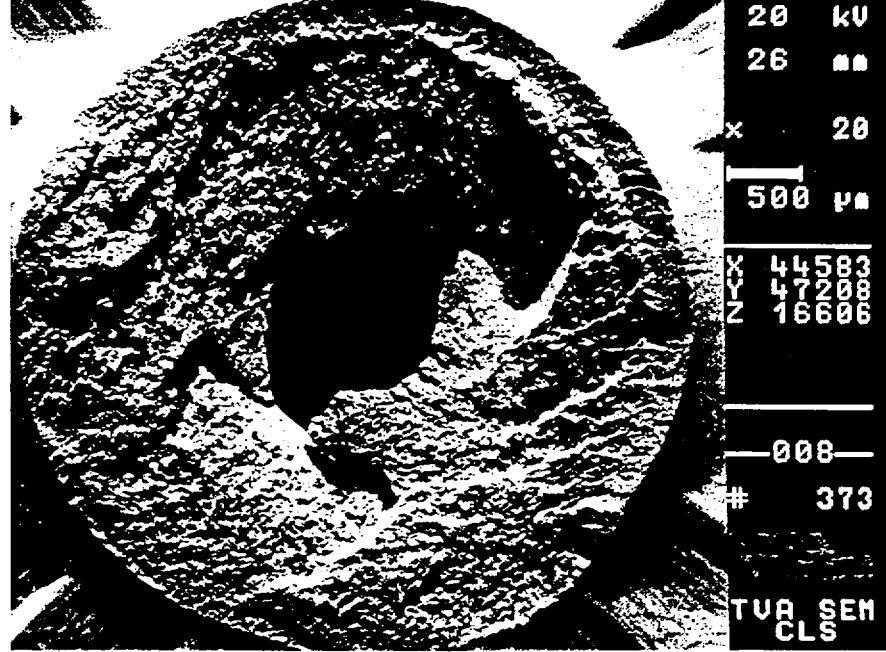
Figure 2: Ice Condenser Basket Screws, Watts Bar Nuclear Plant, Unit No. 1. Customer Identification No. 95-07, Laboratory Report No. 95-1021.

The fractured screws that were in service in set "A" were examined in a Scanning Electron Microscope (SEM) in order to determine the mode of failure. Figures 2 and 3 show that the screws fractured in a brittle manner

as indicated by the intergranular failure mode seen on the screws that were examined. There was usually a small final-fracture area on the fracture surface near the center of the shank that failed in a ductile manner.

SEM photographs of typical fracture surfaces taken from fractures screws (set "A"). Note that all fractured screws received in set "A" failed in a brittle manner (except for the small final fracture area near the center which failed in a ductile manner). 20X.

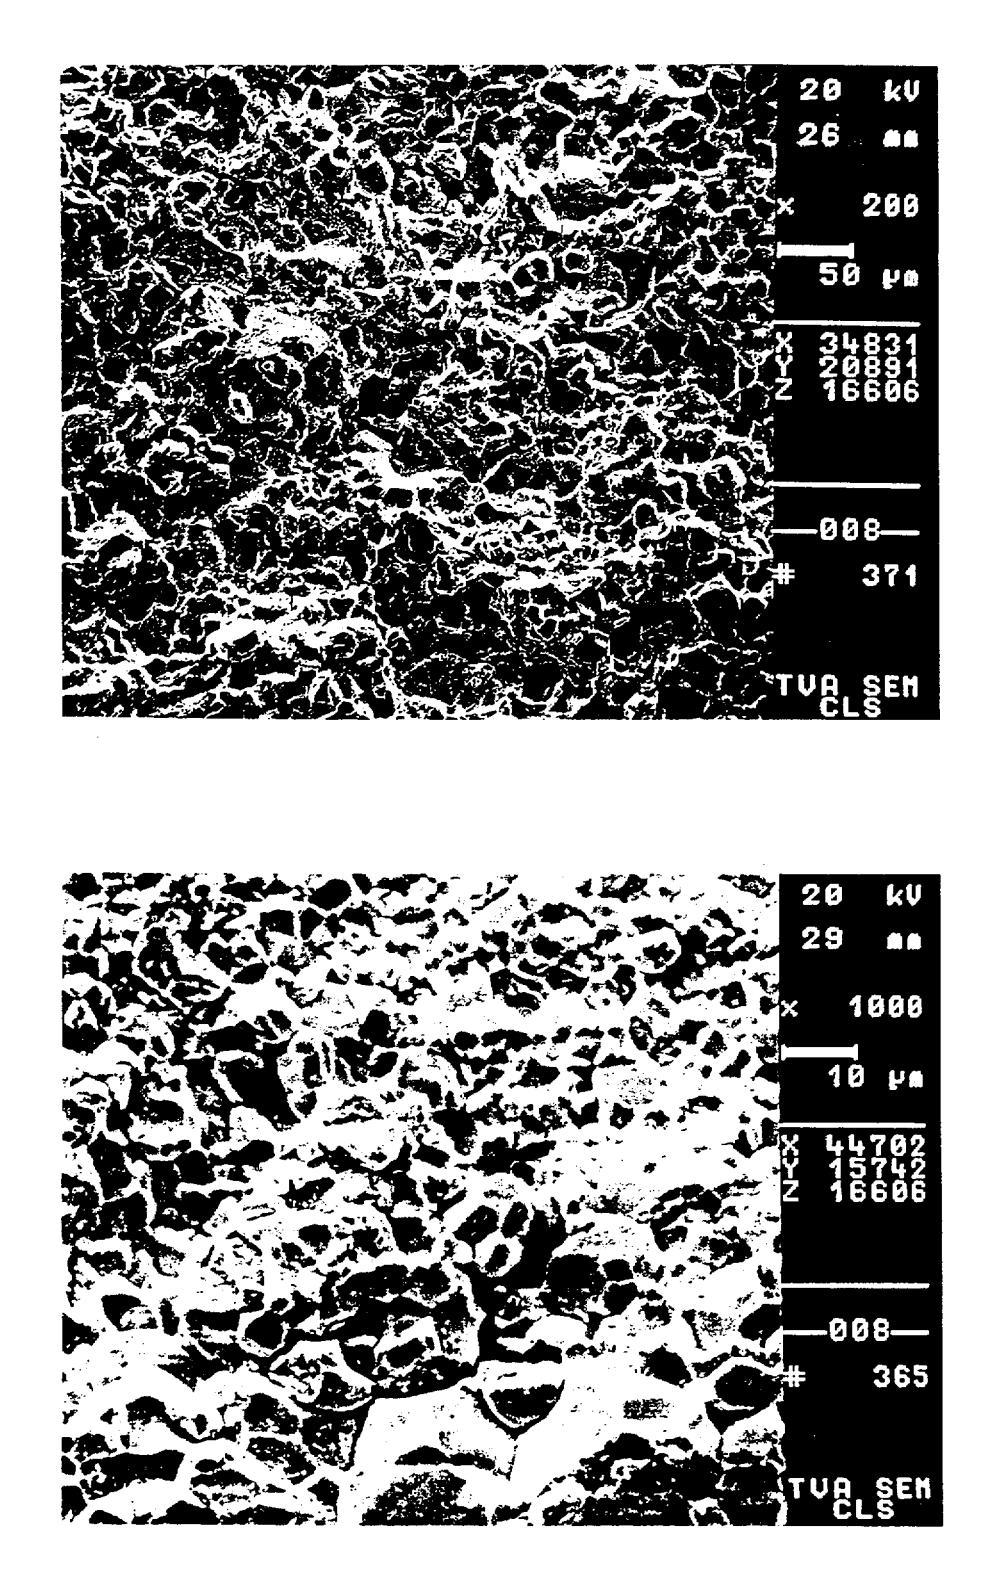
Figure 3: Ice Condenser Basket Screws, Watts Bar Nuclear Plant, Unit No. 1. Customer Identification No. 95-07, Laboratory Report No. 95-1021.

SEM photographs of typical fracture topography seen on failed screws in set "A." The "rock-candy" appearance indicates that these screws failed in a brittle, intergranular manner. Top: 200X; Bottom: 1000X.

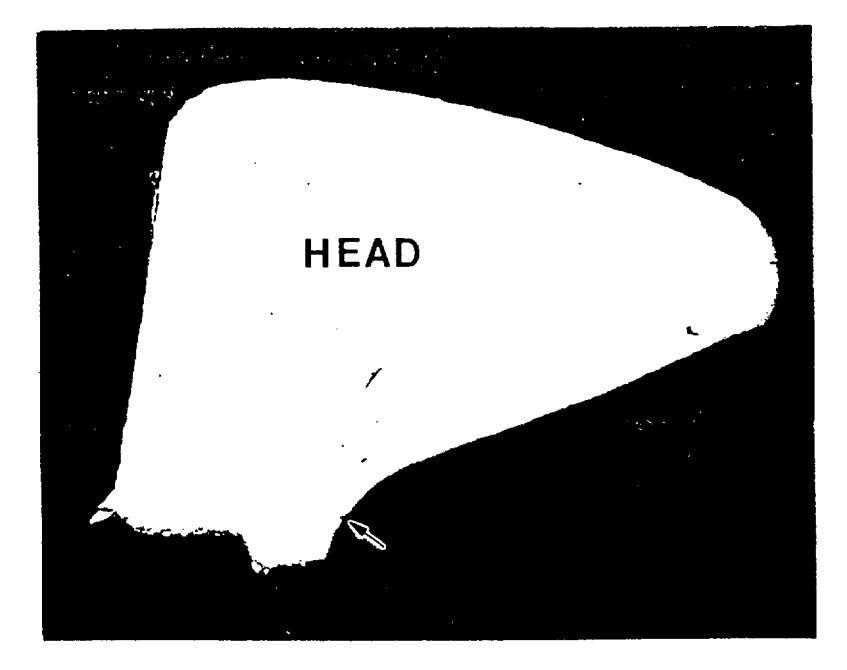
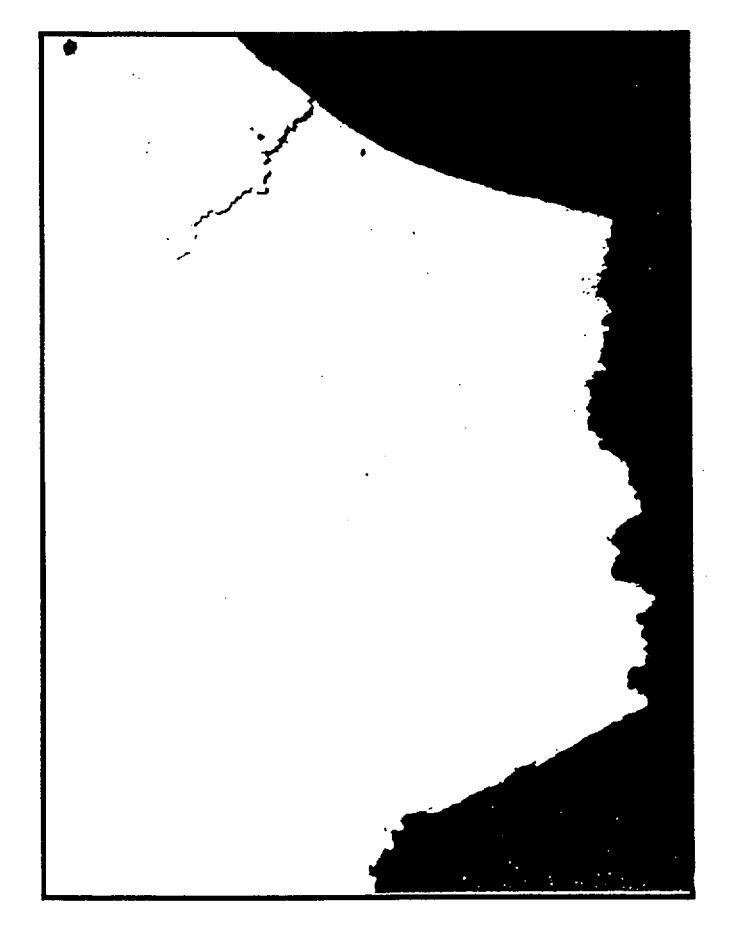
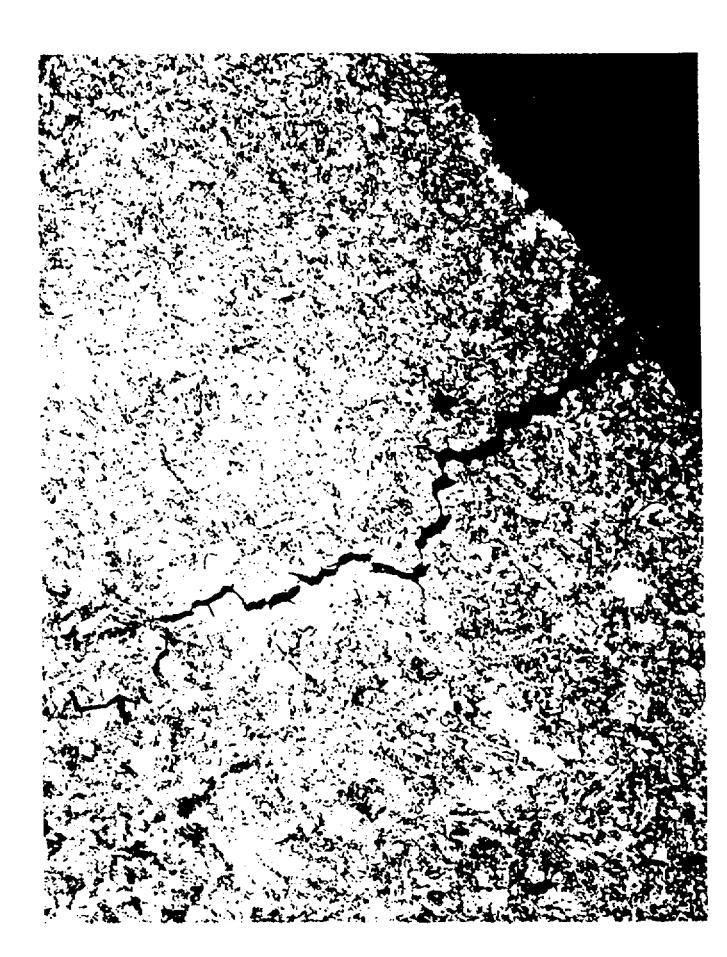
Figure 4: Ice Condenser Basket Screws, Watts Bar Nuclear Plant, Unit No. 1. Customer Identification AGE (8)-07, Laboratory Report No. 95-1021.

An arbitrarily selected fractured screw (that was in service) from set "A" was cut so that a longitudinal cross-section through the fracture surface could be examined. Note that a secondary crack of intergranular nature was noticed above the fracture surface as seen in Figure 4. A screw from set "G" was similarly sectioned, and two cracks were found in adjacent thread roots as seen in Figures 5 and 6. Similar intergranular cracks were discovered in a transverse section of the whole screw from set "A" and at the thread roots of a screw from set "H" (Figure 7).

Screws from sets "C", "G", and "H" contained intergranular cracks similar to those seen in Figures 5, 6, and 7. Note that the intergranular crack found in a representative sample taken from a fractured screw in set "A" seen in Figure 4 differed from the intergranular cracks seen in Figures 5 through 7 because it was probably a secondary crack (since it is above the primary fracture and perpendicular to the curved neck of the screw rather than at the thread roots).

Longitudinal cross section through a fractured screw. The arrow points to a secondary crack above the fracture surface. 20X. As-polished.

Close-up views of secondary crack seen in the upper view of this Figure. Left: As-polished, 125X; Right: Vilella's etch, 400X.

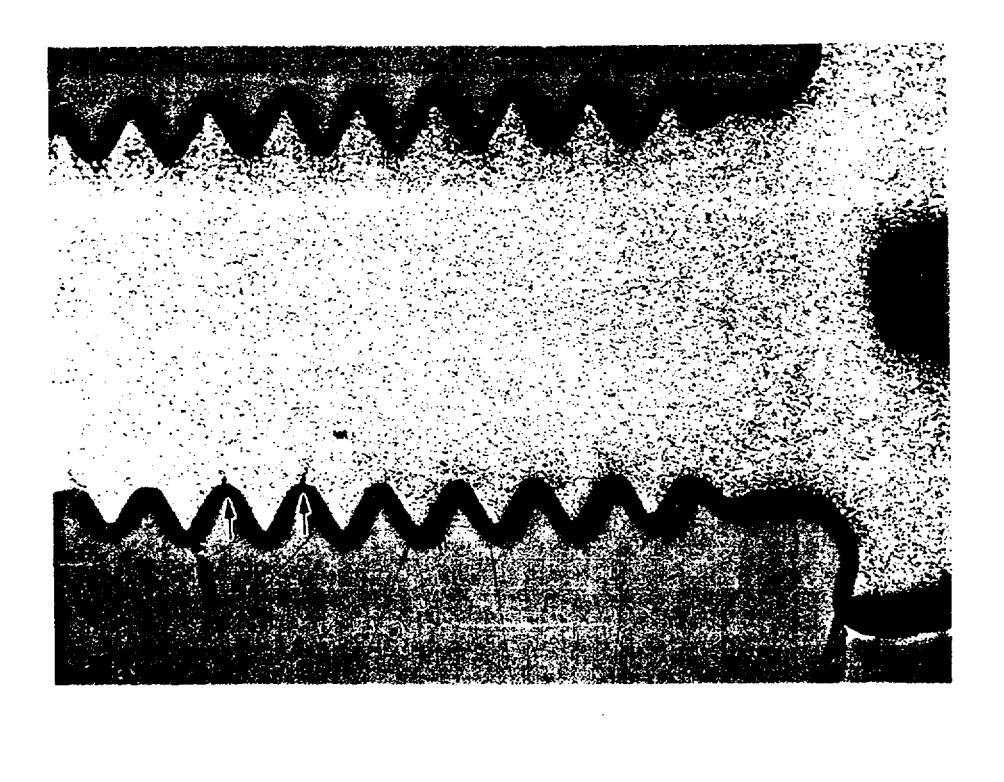
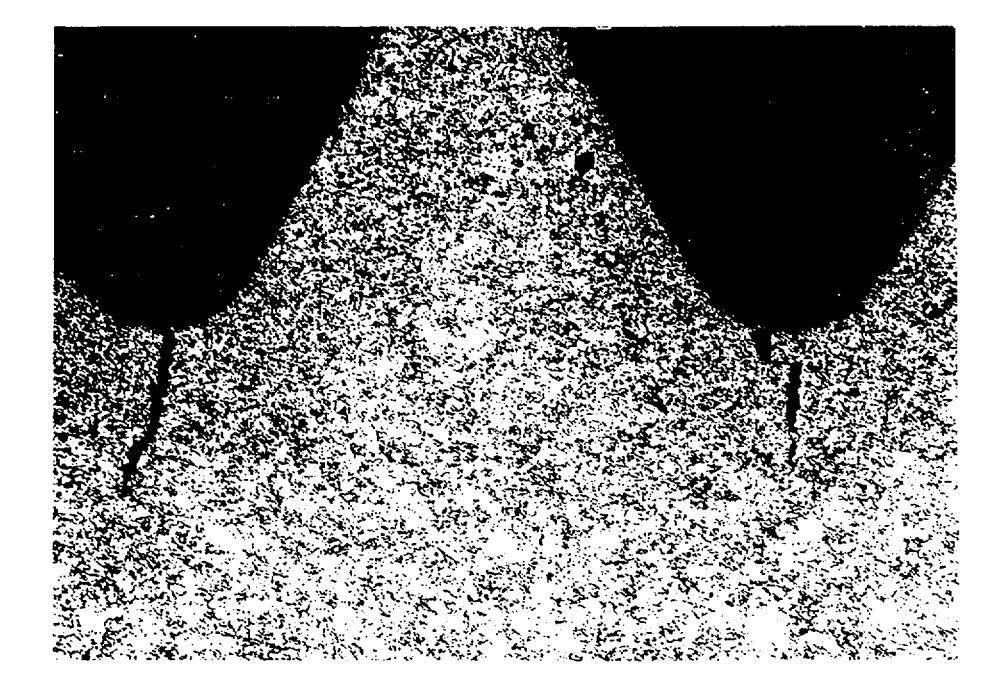
Figure 5: Ice Condenser Basket Screws, Watts Bar Nuclear Plant, Unit No. 1. Customer Identification No. 95-07, Laboratory Report No. 95-1021.

EDX* analysis of the material in one of the cracks seen in the longitudinal cross section of a screw from set "G" revealed the presence of zinc as seen in Table I. Note in the upper view of Figure 6 that a lapped area was present at the thread roots of a screw from set "G". Similar lapped regions were discovered at the tip, face, and roots of every screw that was examined and is typical of the thread rolling process.

Longitudinal view of cracks present in one of the screws that were removed from service in set "G". Top: 12X; Bottom: 100X.

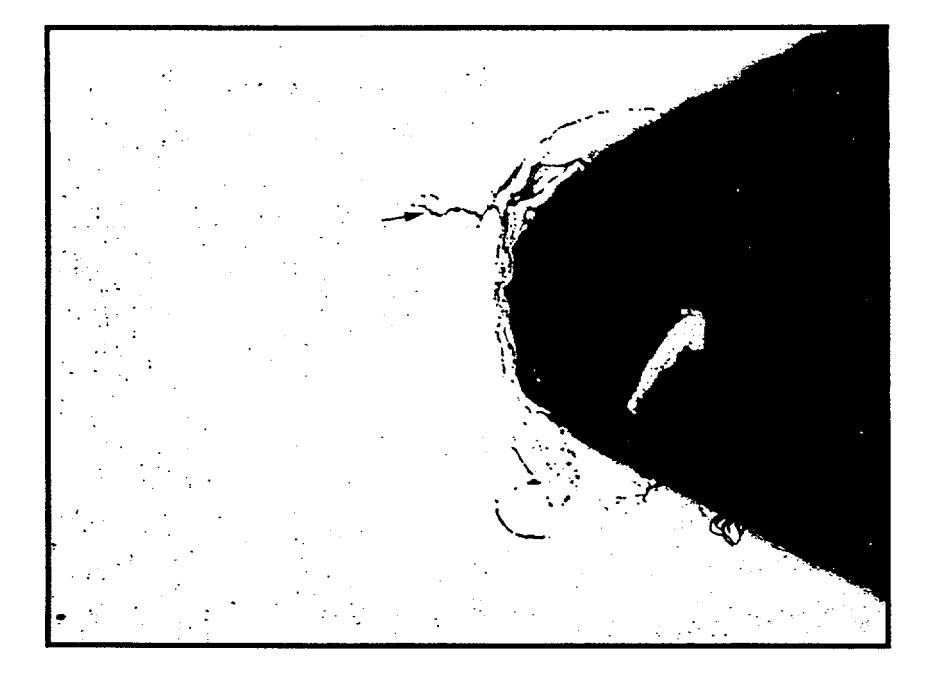
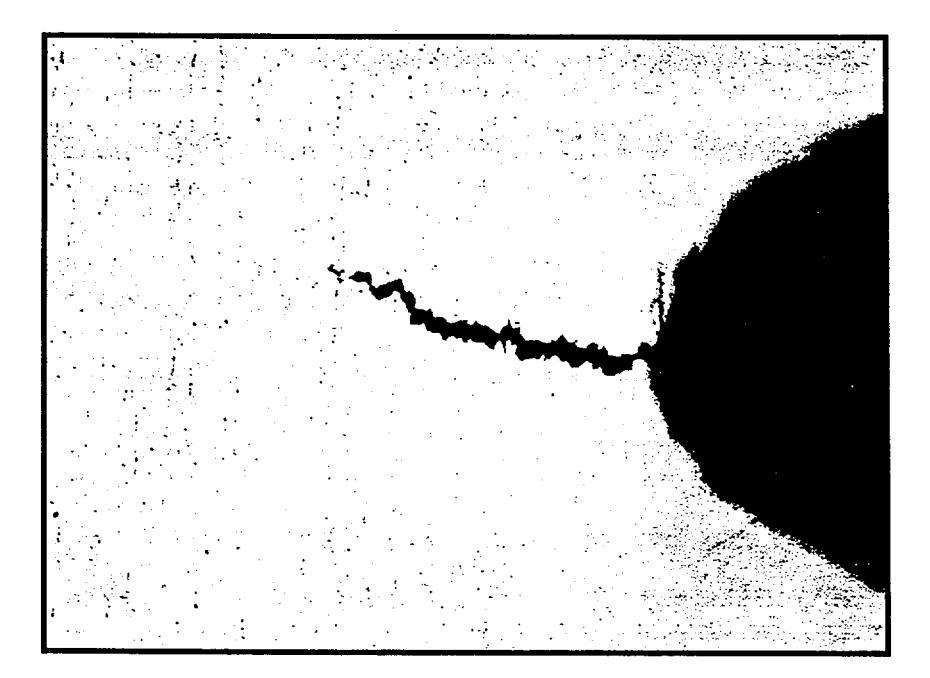
As-polished, longitudinal view of lapping present at tooth root of a screw that was removed from service in set "G". 200X.

As-polished, longitudinal view of crack present at tooth root of a screw that was removed from service in set "G". 200X.

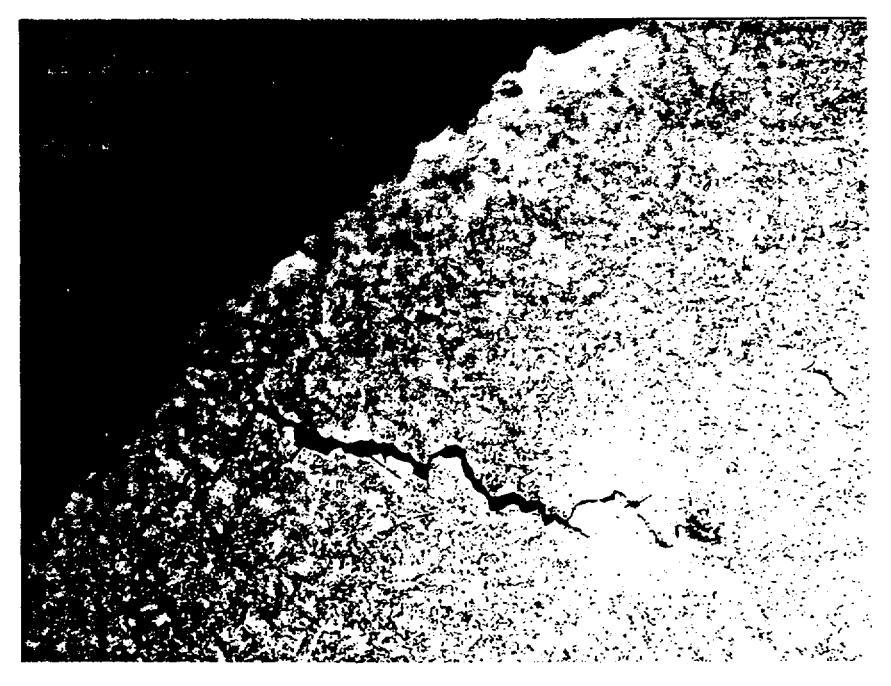
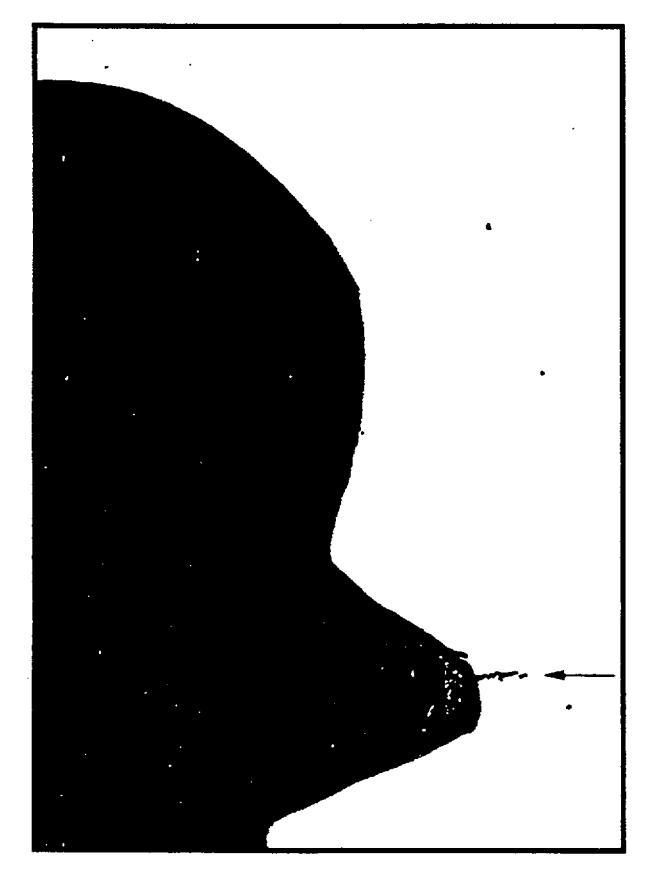
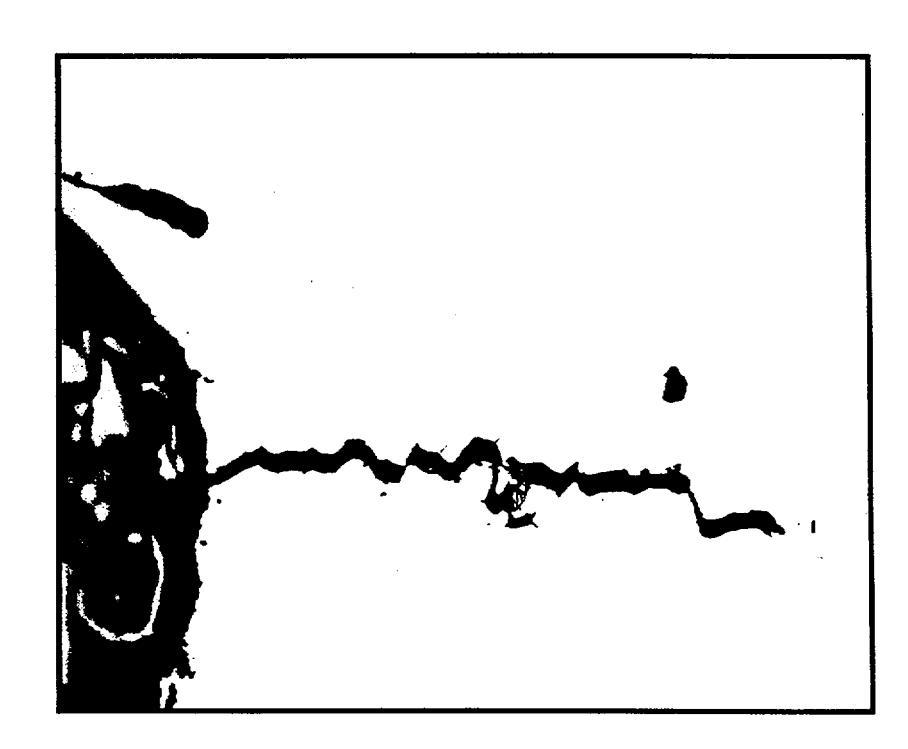
Figure 7: Ice Condenser Basket Screws, Watts Bar Nuclear Plant, Unit No. 1. Customer Identification No. 95-07, Laboratory Report No. 95-1021.

Transverse cross-sectional view of a crack present in the screw that was not in service from set "A". 400X. Vilella's etch.

Intergranular crack found at thread root of first thread below head in a longitudinal cross section of a screw that was removed from service in set "H". Left: 50X; Right: 500X. As-polished condition.

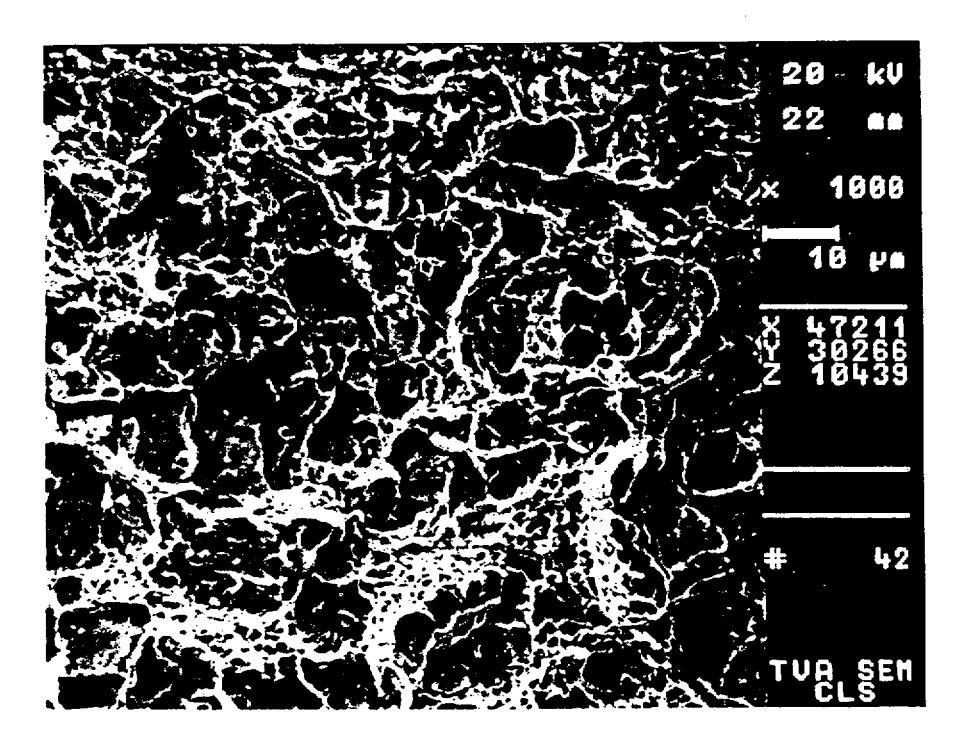
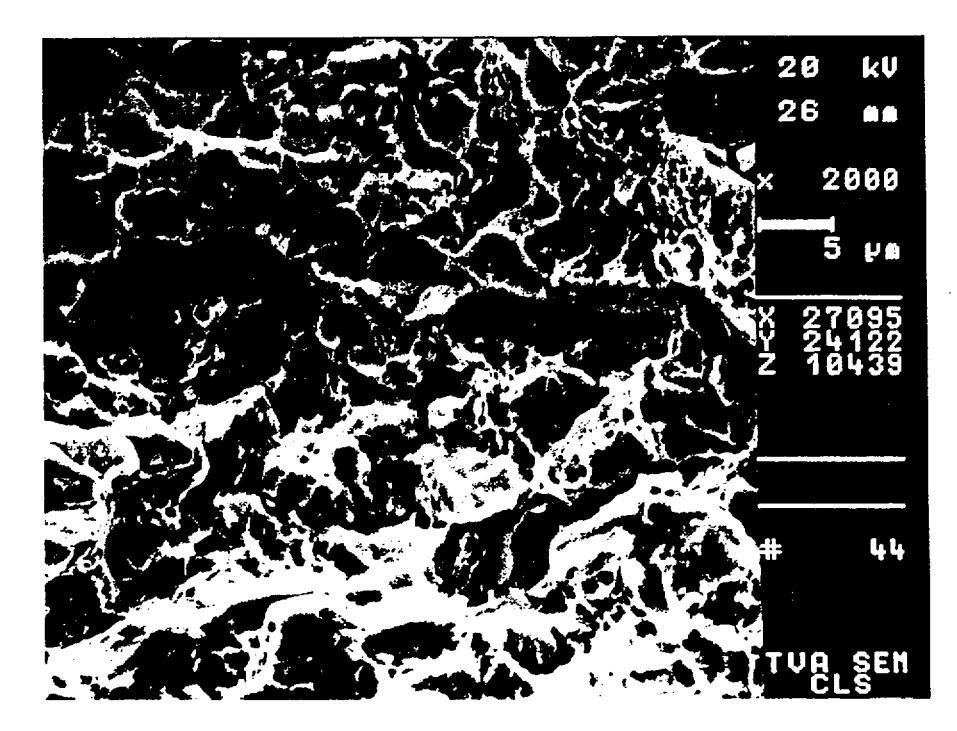
Figure 8: Laboratory Report No. 95-1021.

Two screws, one from set "A" and one from set "G," were intentionally fractured with a hammer in order to determine the failure mode. SEM photography shows in Figures 8 and 9 that the screw from set "G" failed by intergranular fracture in the case and mixed-mode fracture (cleavage and void coalescence) in the core, while the whole screw from set "A" failed by quasi-cleavage in the case and void coalescence in the core. At the customer's request, additional screws were broken (two from set "C" and two new screws from set "B") in the same manner, except at 15°F. Subsequent SEM analysis of the resultant fracture surfaces revealed that the screws failed by void coalescence.

SEM photograph of fresh fracture surface showing quasi-cleavage in the case of a new screw. 1000X.

SEM photograph of fresh fracture surface showing intergranular separation (with some void coalescence) in the case of a screw that was removed from service in set "D". 2000X.

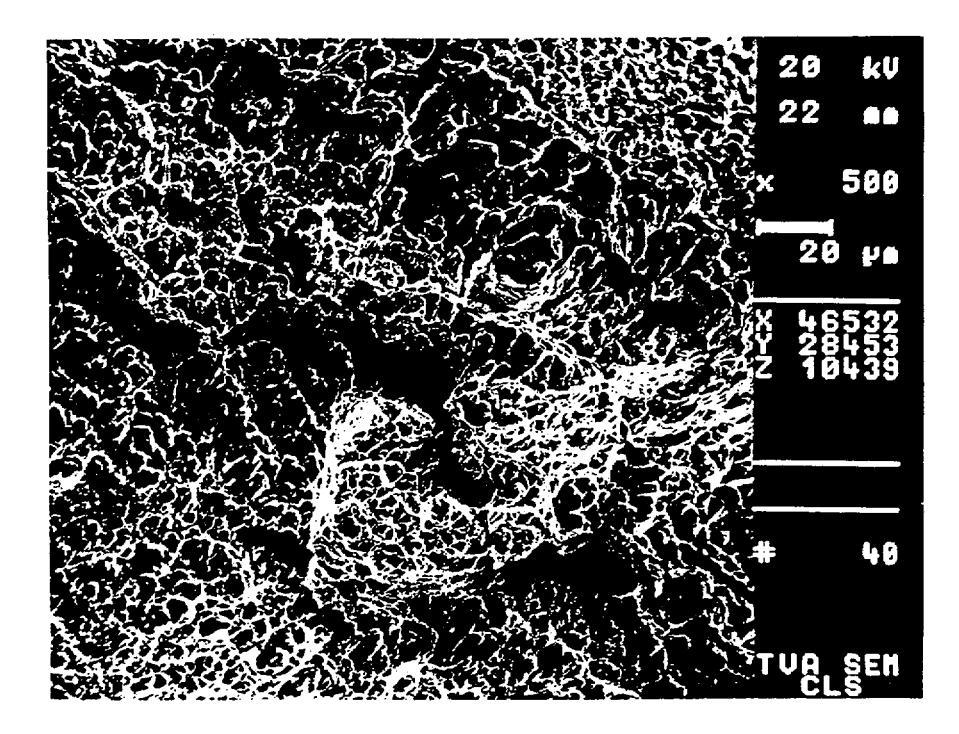
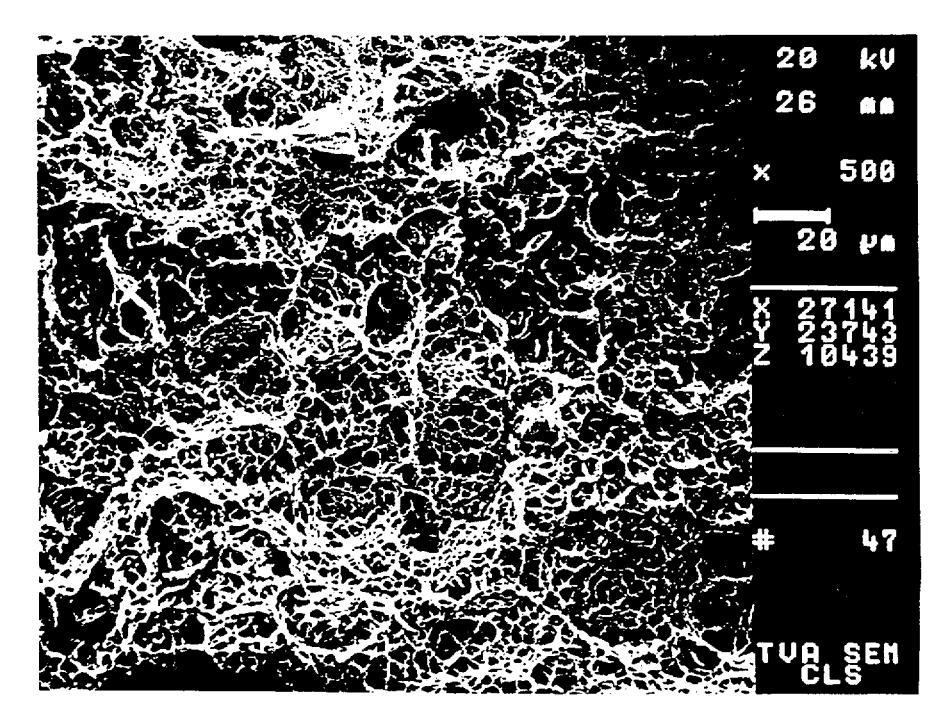
Figure 9: Ice Condenser Basket Screws, Watts Bar Nuclear Plant, Unit No. 1. Customer Identification No. 95-07, Laboratory Report No. 95-1021.

SEM photograph of fresh fracture surface showing void coalescence in the core of a new screw. 500X.

SEM photograph of fresh fracture surface showing mixed-mode separation (cleavage and void coalescence) in the core of a screw that was removed from service in set "D". 500X.
