11-1

Profiles of tube r34c51 of Steam Generator 22

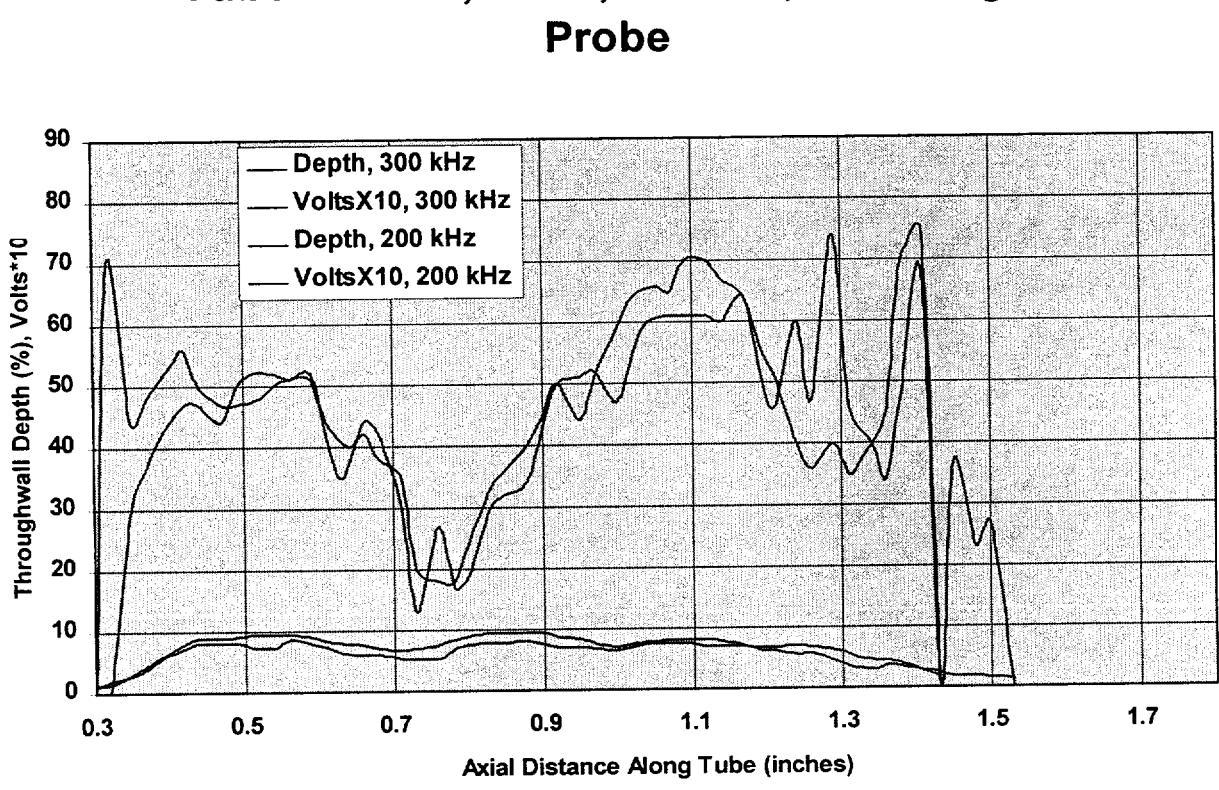
Tube R34C51, SG22, Crack 1, Mid Range

Figure 1 Profile of crack1 in tube R34C51 of steam generator 22.

was one of the larger ones, and had a voltage signal close to one volt. While this crack appeared to grow about 25% in voltage amplitude due to the pressurization, this is not the point were the tube burst.

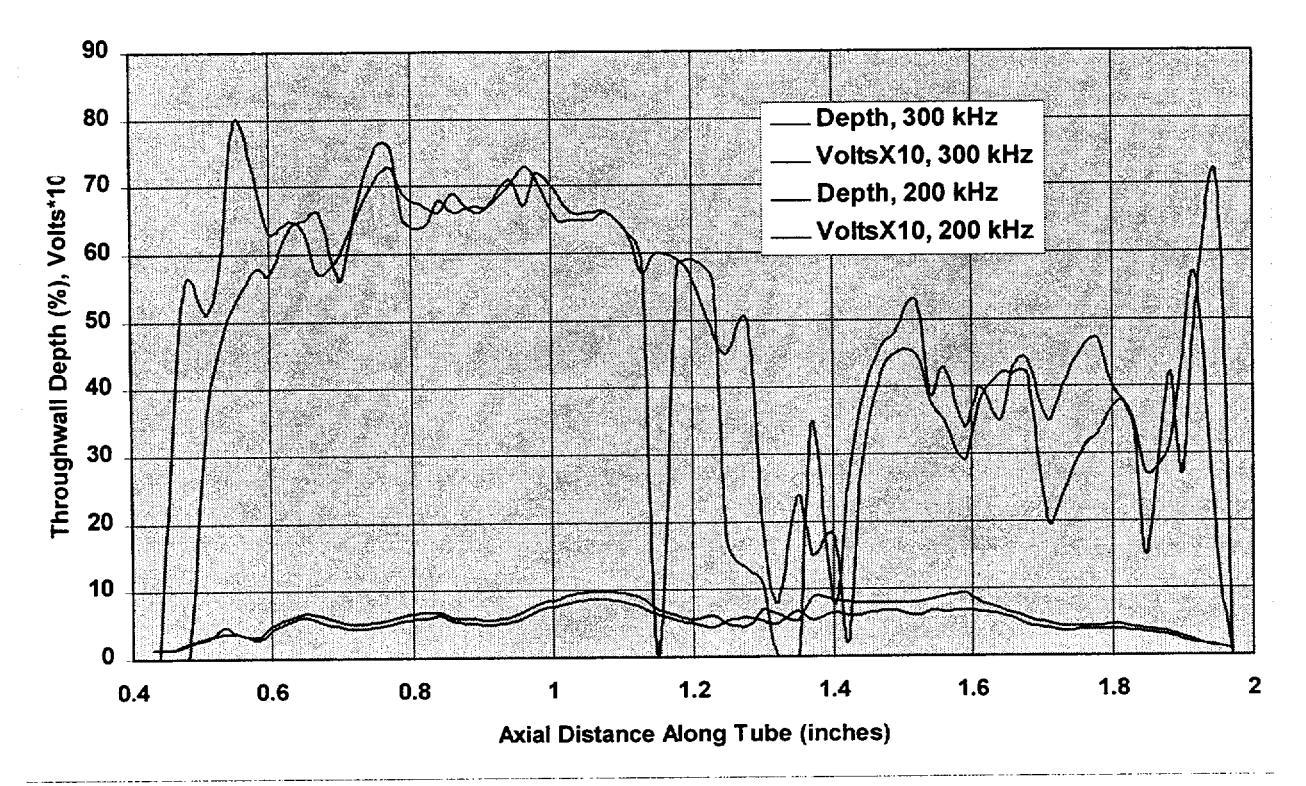
Tube R34C51, SG22, Crack 2, Mid Range Probe

Crack 2, as shown in Figure 2, is slightly longer and slightly deeper. This is the crack that burst. The voltage amplitude of this crack is about the same, and probably averages less than that of crack one. This demonstrates that voltage is not a good measure of crack size, depth or severity. Crack 2 appeared to go through wall, and the voltage amplitude increased by a large factor. This

Figure 2 Profile of crack 2 of tube r34c51 in steam generator 22.

tube also had a large voltage increase of a crevice crack due to the pressurization.

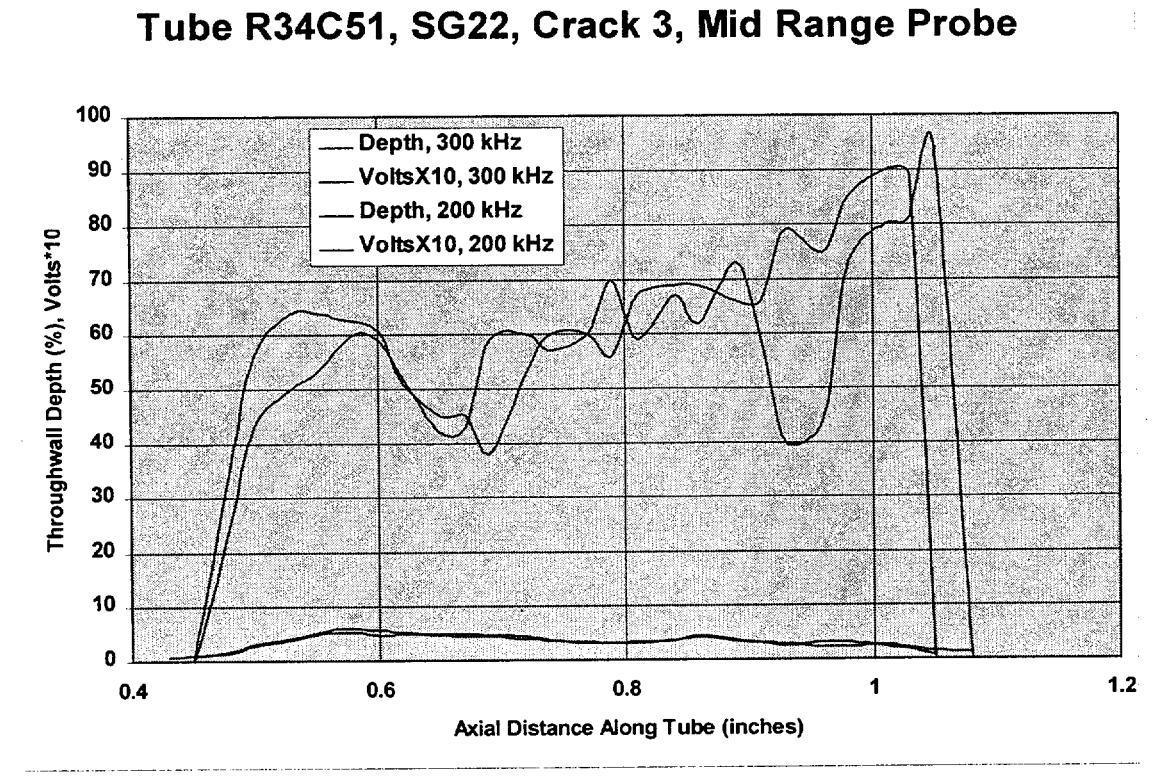
In Figure 3 and Figure 4 we show smaller cracks. In the post pressure-test scan these cracks were still visible, but could not be profiled due to the large increase in signal from crack 2. Its signal distorted the phase of the smaller cracks, which were adjacent to it.

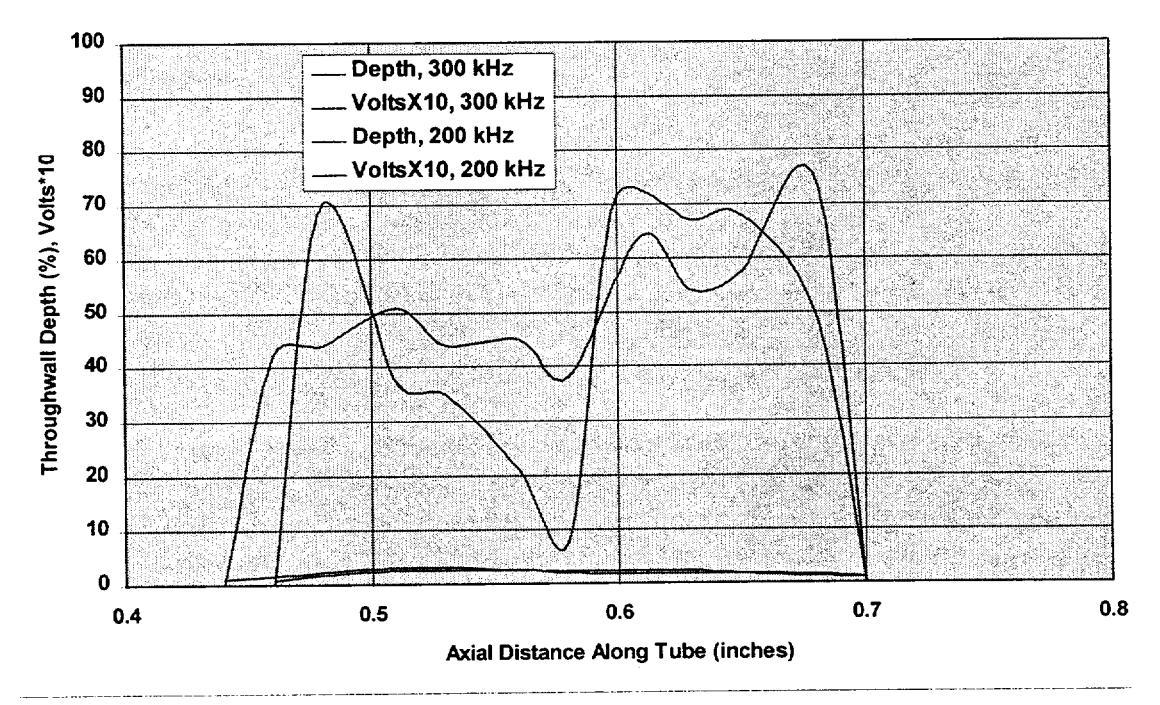
Figure 4 Profile of crack4 in tube r34c51 of Steam Generator 22.

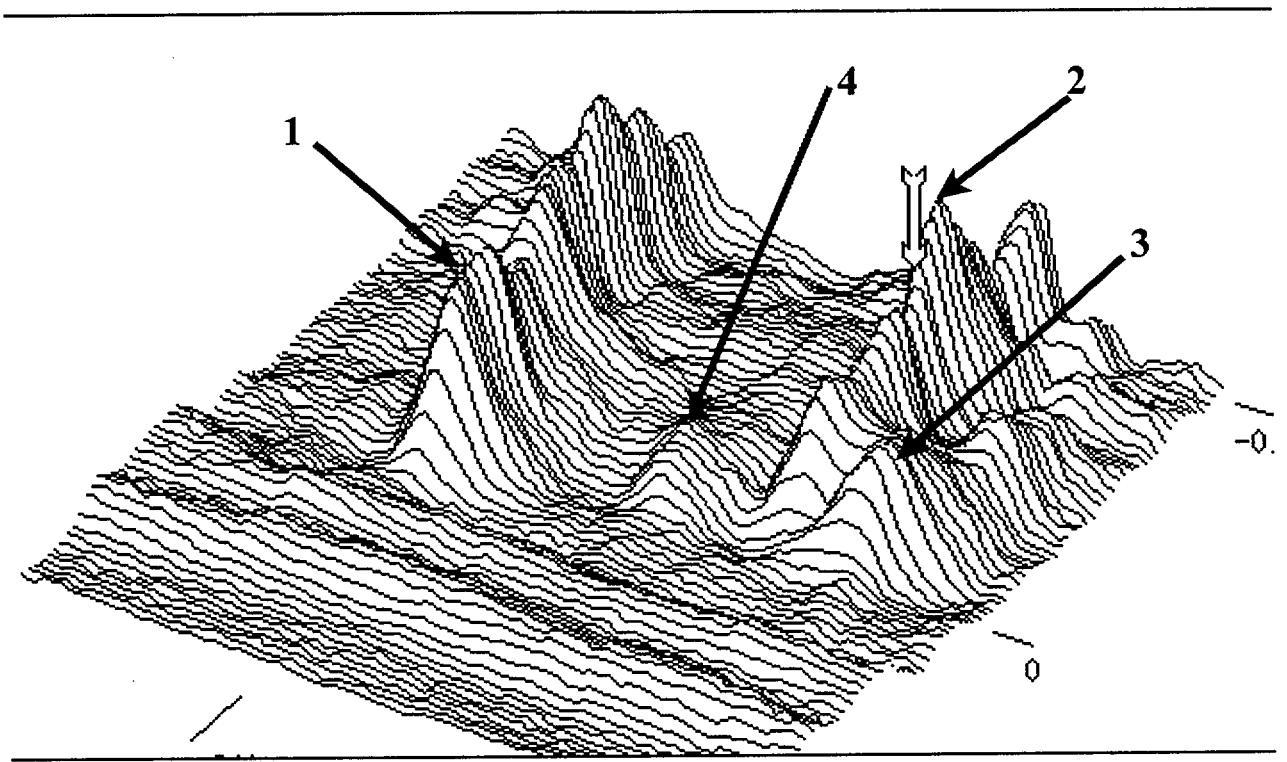
The positions of each of the cracks is labeled in the C-scan that is shown in Figure 5. Note the large voltage signal from the cracks in this tube, and the low noise. Other tubes do not have as good a signal-to-noise ratio and are more difficult to inspect in this region.

Figure 5 C-scan to tube r34c51 of steam generator 22 before pressurization.

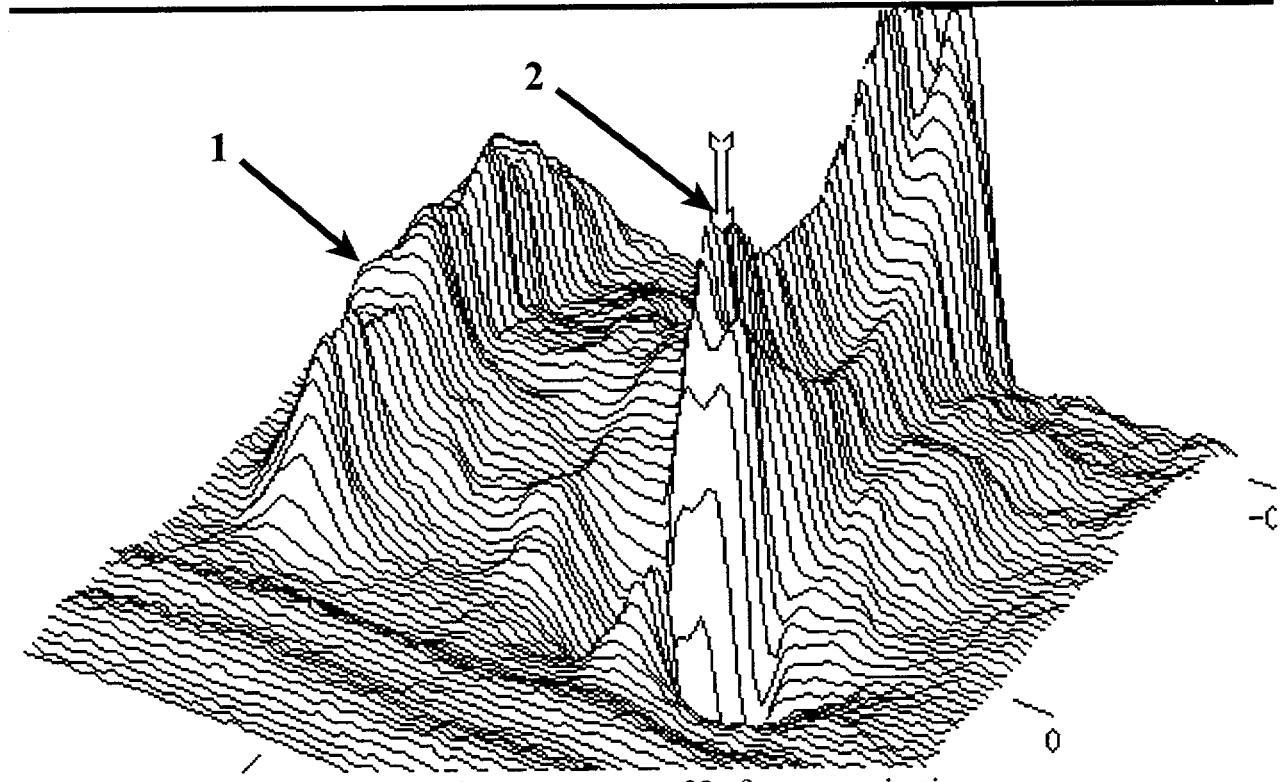
In Figure 6 we show the post pressurization scan of this tube. The signal form crack 2 is now much greater than the other cracks, indicating that this was the crack where the tube leaked. It appears that the crack opened to within about 0.3-inches of the tube sheet, and the voltage increased from near 1-volt to over 10-volts in places.

Figure 6 C-scan of tube r34c51 of steam generator 22 after pressurization.

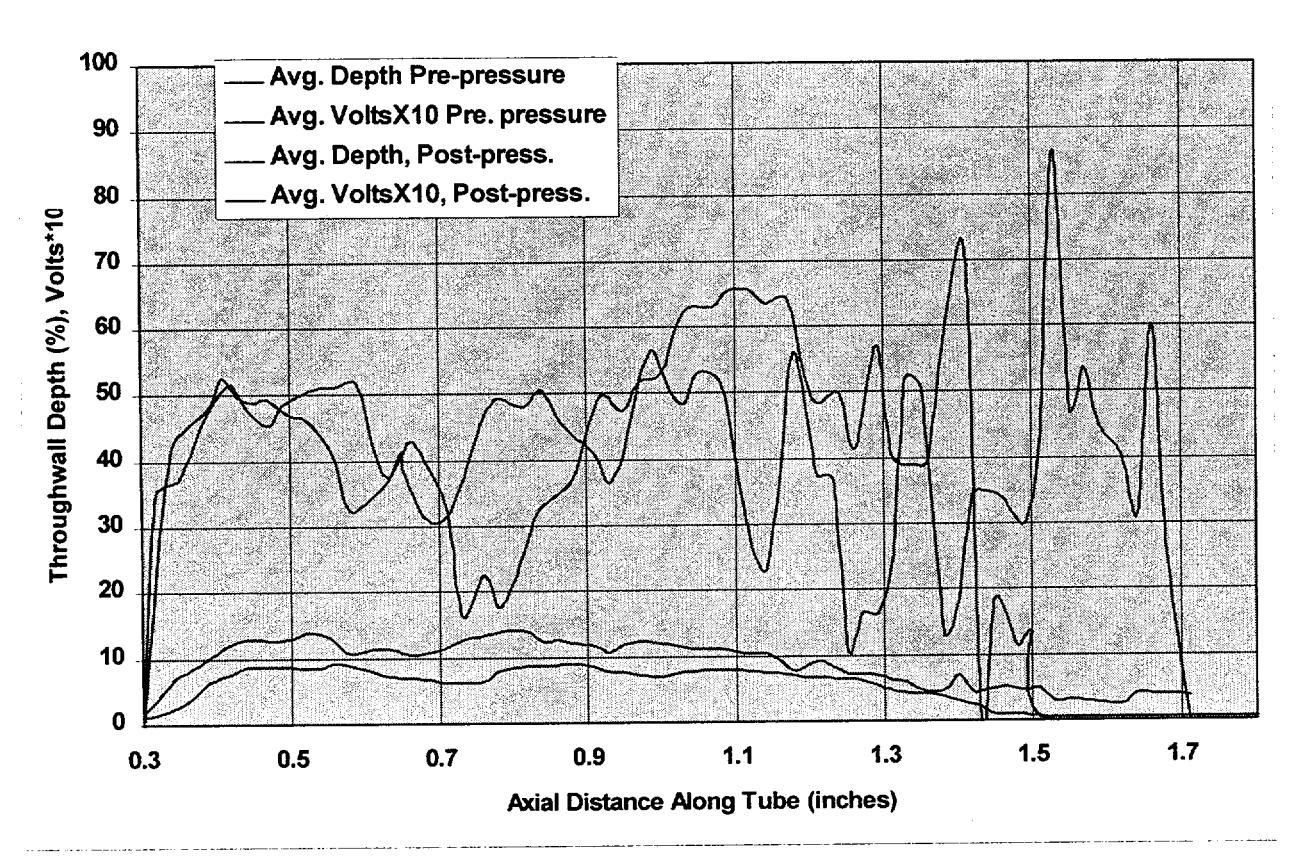
Tube R34C51, SG22, Crack 1, Average Value

Figure 7 Effect of pressurization on Crack 1 for tube R34C51 of steam generator 22.

In Figure 7 we show the profiles averaged for the plus-point probe for the 300 kHz and the 200 kHz frequencies. The first part of the crack nearer the tube sheet seems to be about the same. For the second part of the crack, the readings seem to have become unreliable. The signals form all the coils were reviewed. The pancake coils showed a deeper crack, but there also was evidence of increased lift-off. The crack may have spread apart somewhat, due to the pressure test, and is no longer strictly crack shaped. The amplitude of the signal increased for all of the coils. This increase was about 25% for most of the crack for the plus-point coils. There probably would have been more increase if Crack 2 had not opened up, relieving the stress.

Measurements made on this crack with the 0.080-inch high frequency probe showed a very sharp spike-like response before pressurization, and a more broad response afterwards, also indicating some spreading of the crack. A comparison of Crack1 in figures 5 and 6 show that the base of the crack is much fatter as the distance from the tube sheet has increased. Another crack parallel to Crack1 may have opened in this region, causing errors in the depth readings.

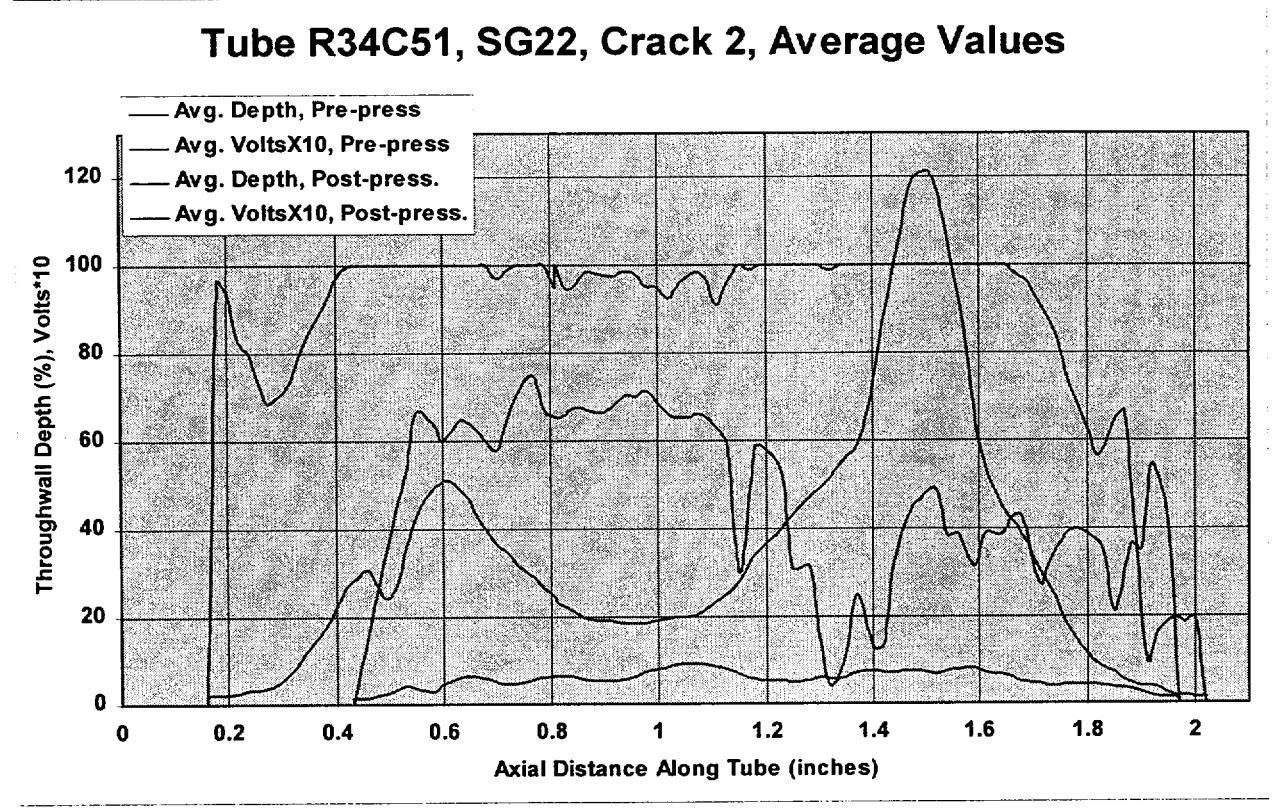
In Figure 8 we show the profiles for Crack 2, for the plus-point probe, averaged over the 300 kHz and the 200 kHz frequencies. These readings appear to be more regular, but they were also considerably distorted. This crack reading switched from od to id a number of places along the

Figure 8 Effects of pressurization on Crack 2 in tube R34C51 of Steam Generator 22.

length, and the crack signal was not the classic shape that occurs on the calibration standards. When the signal went to id, the crack was assigned a value of 100%.

The amplitude of this crack signal increased to 12 volts. The amplitude calibration was set for a 100% EDM notch to have a voltage of 20-volts. Even a through wall crack must have some current bridging across the crack face to cause the signal to decrease to this value.
