Review of 1997 inspection of U-bend tubes at Indian Point2

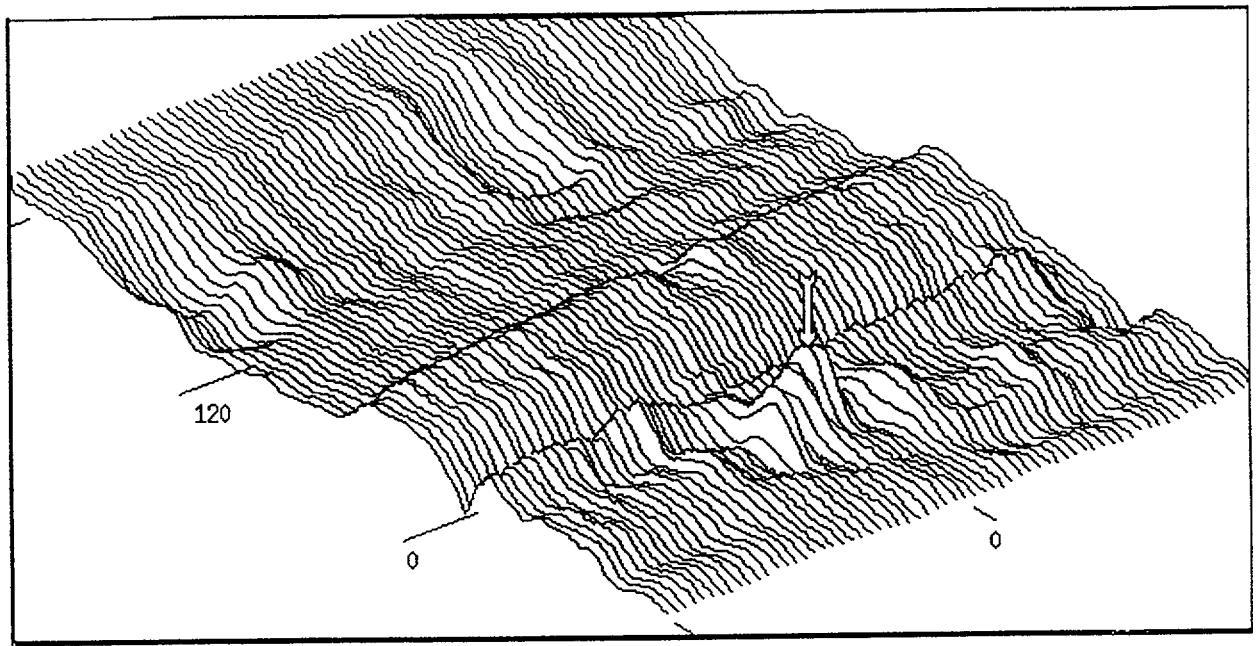
Tube 2-69 of steam generator 24

The 400 kHz C-scan of tube 2-69 of steam generator 24, made in 1997, is shown in Figure 1. While the amplitude of this signal is small (1.2-volts), it does stand up above the noise, enough at

Figure 1 400 kHz C-scan of tube 2-69 of steam generator 24 made in 1997

least for the analyst to look at the Lissajous of the signal.

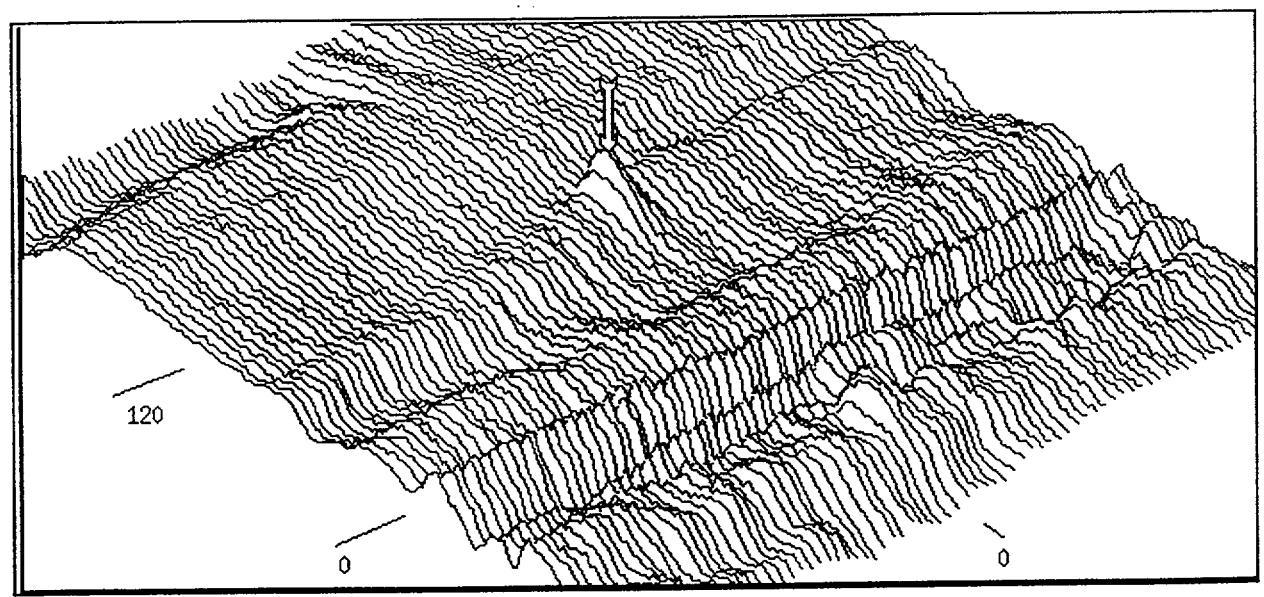
Tube 2-87 of steam generator 21

Figure 2 400 kHz C-scan of tube 2-87 of steam generator 21 made in 1997

The C-scan of tube 2-87 of steam generator 21 is shown in Figure 2. This tube has a defect signals of about 1-volt in a relatively clear part of the tube. This signal looks very much like the one found in tube 2-67 during the 1997 outage. A careful examination of the C-scan of this tube will show enough of a signal for the analyst to look at the Lissajous signal. This tube also has several long cracks at about the same axial location as the defect that is in the clean section. They are partially obscured by a noise ridge.

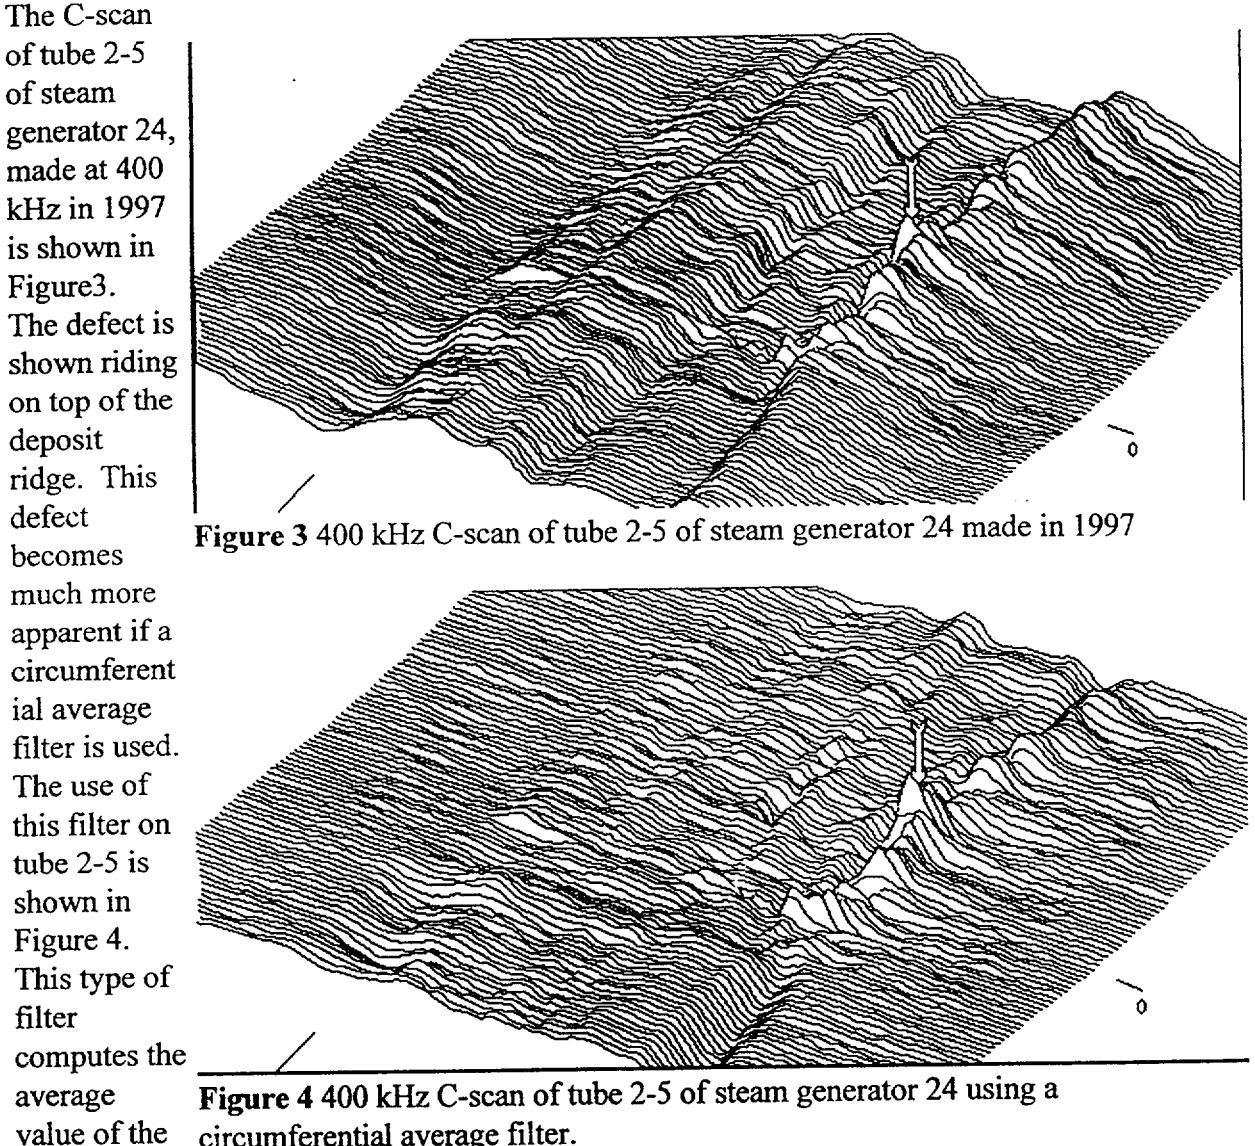
Tube 2-5 of steam generator 24

circumferential average filter.

vertical component of the signal over all of the axial extent of the scan, for each point around the circumference of the tube. This average value is then subtracted from the scan, and the scan of the difference is re-plotted. This is particularly effective in removing the long ridges of noise from the scans. The differences in the axial direction are then emphasized. The 1997 guidelines state that "Mixing and filters are not required but are optional." In general, Westinghouse does not encourage the use of filters.

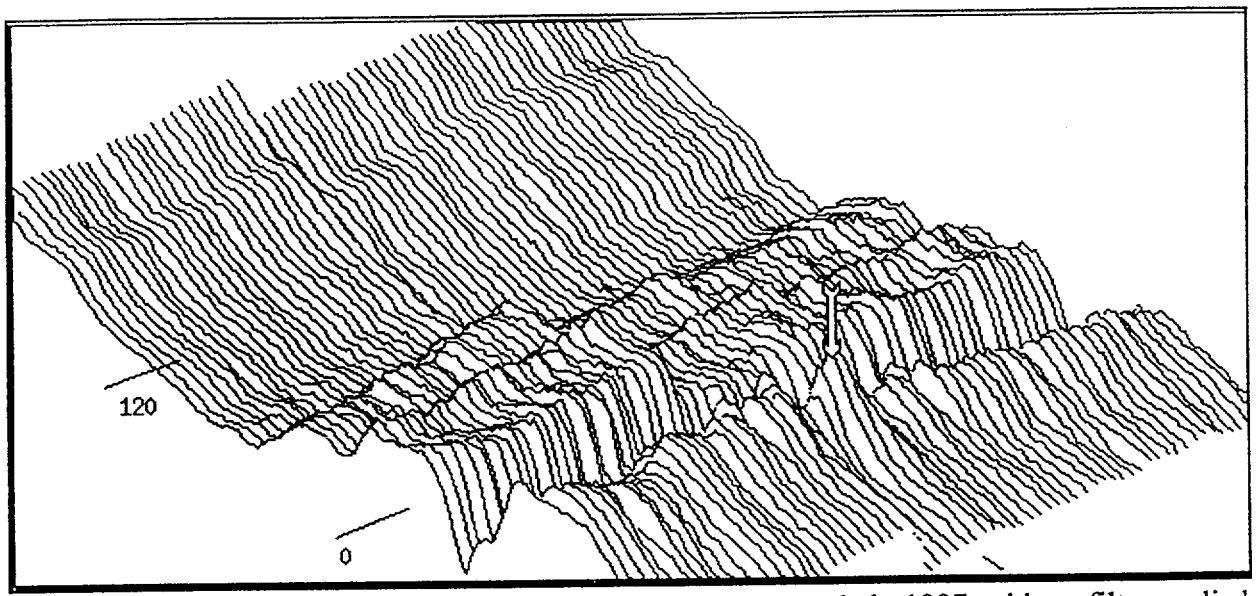
Tube 2-72 of Steam generator 24 is similar to tube 2-5, and could possibly be detected from the C-scan, without the need of any filter, although a circumferential average filter would have

Figure 5 400 kHz C-scan of tube 2-72 of steam generator 24 made in 1997, with no filter applied

helped here also. This tube is shown in Figure 5.

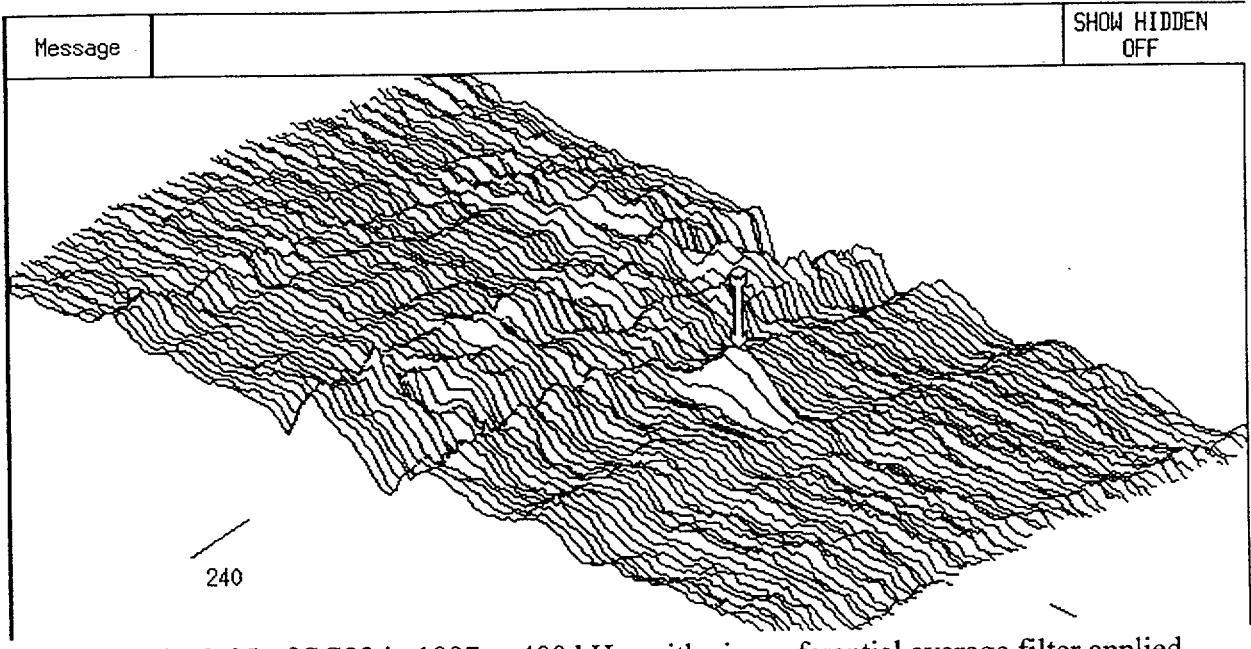
Tube 2-85 of steam generator 23 also needs the circumferential filter for detection, as shown in Figure 7.

Figure 7 Tube 2-85 of SG23 in 1997 at 400 kHz, with circumferential average filter applied.

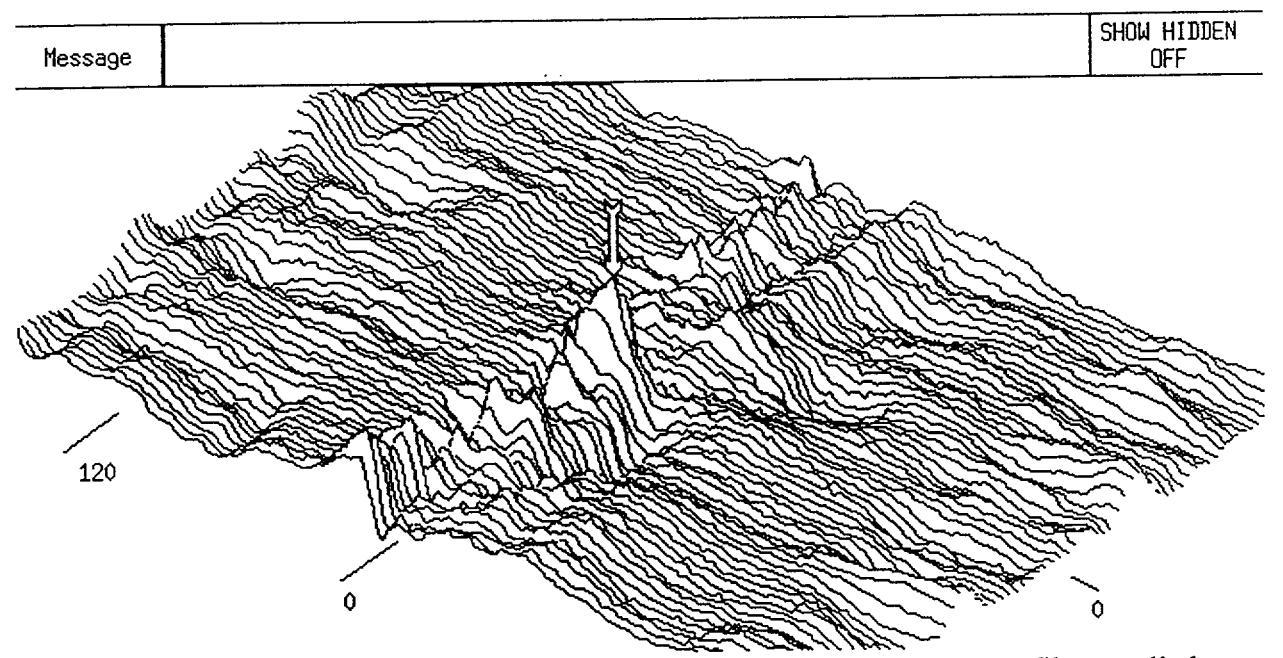
Tube 2-71 of steam generator 24

Tube 2-71, as shown in Figure 6 needs the circumferential average filter applied for detection.

Figure 6 Tube 2-71 of SG24 in 1997 at 400 kHz, with circumferential average filter applied.
