UNITED STATES NUCLEAR REGULATORY COMMISSION REGION I 475 ALLENDALE ROAD KING OF PRUSSIA, PENNSYLVANIA 19406-1415

SUBJECT: SPECIAL INSPECTION 05000245/2001013, DOMINION NUCLEAR CONNECTICUT, INC., MILLSTONE POWER STATION UNIT 1, WATERFORD, CONNECTICUT

Enclosure: Inspection Report No. 05000245/2001013

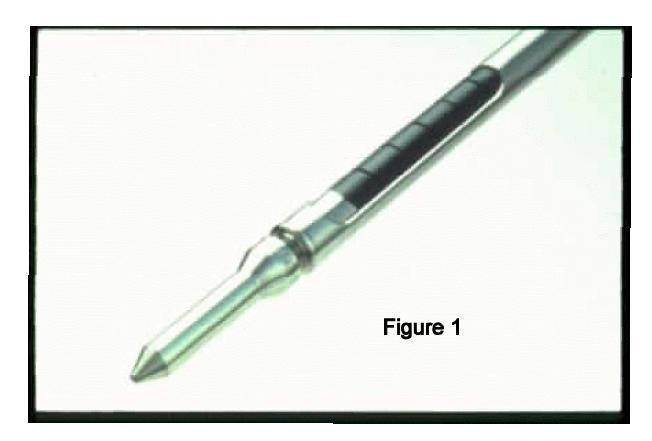
4 Inspection Report No. 05000245/2001013 C:\Program Files\Adobe\Acrobat 4.0\PDF Output\LDPR-21.2001013.wpd the assembly. Figure 1 is a cutaway illustration of a fuel rod, and Figure 2 illustrates the components of a fuel assembly. Removal of the tie plate would have disturbed the corrosion film covering the tie plate and fasteners, markedly changing the appearance of the assembly hardware and enabling clear identification of assemblies that had been

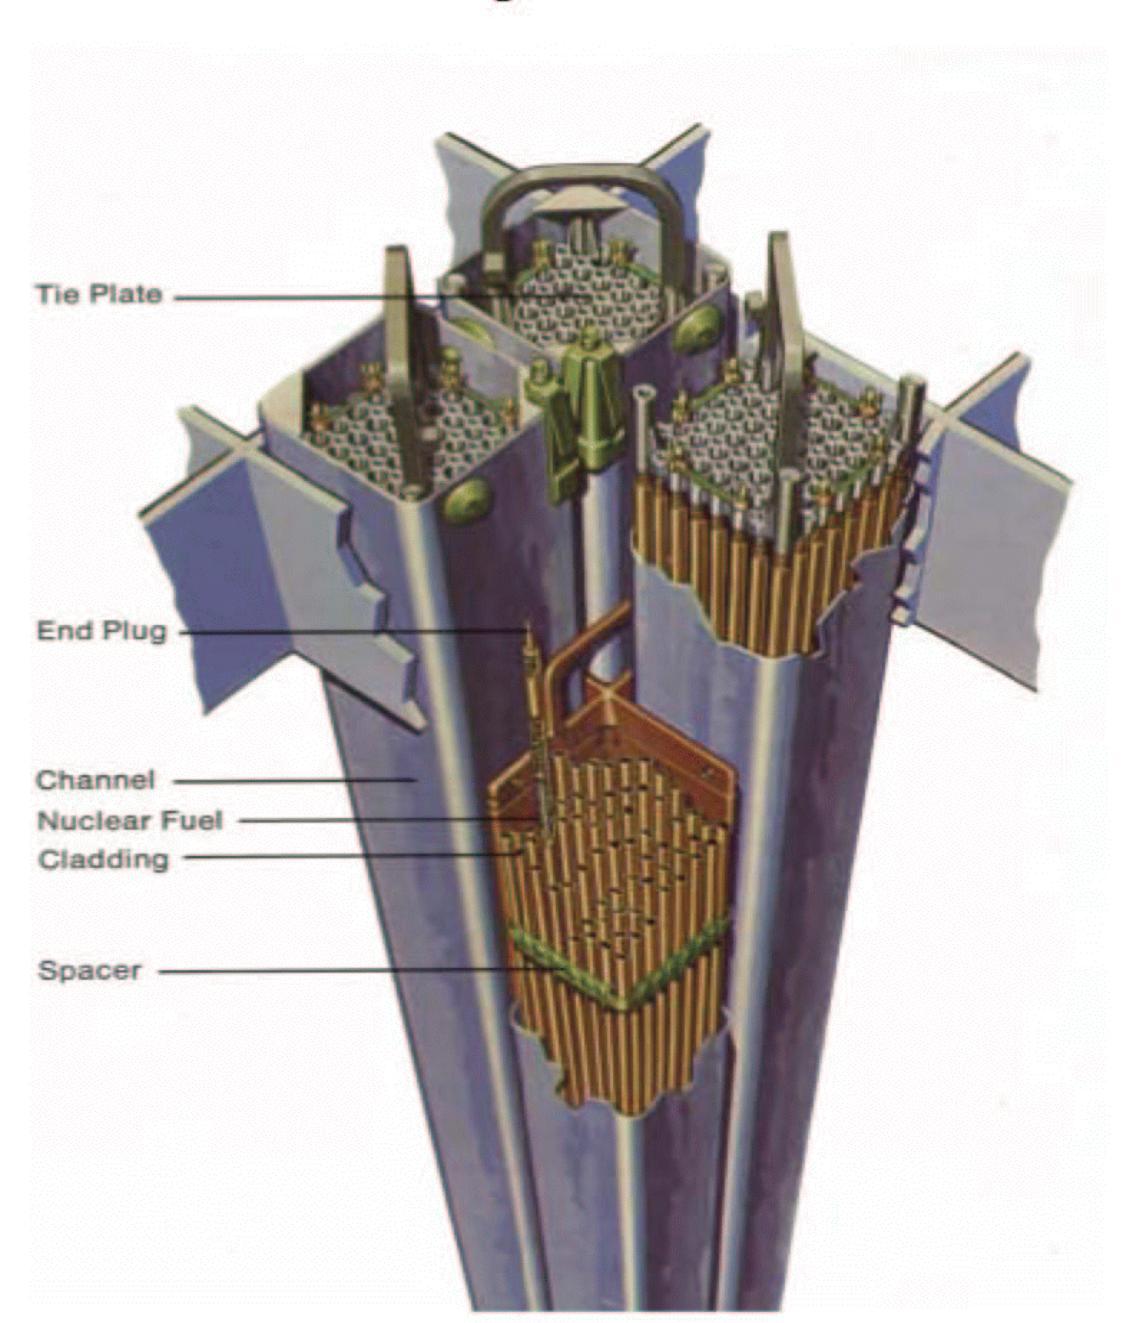
Figure 2

altered. The licensee concluded that only those assemblies on which these components were shiny and without a corrosion film could have been candidate assemblies within which to place an individual rod. Assemblies not showing evidence of disassembly were presumed to be intact and unchanged since discharge from the reactor. These inspections included observation of the tops of all 2884 assemblies in the pool for indication of prior disassembly. Twenty-nine assemblies showing evidence of disassembly were as expected, including recorded high resolution video examination to view and count each rod in these assemblies. The licensee did have records indicating disassembly of some fuel in the spent fuel pool for a variety of reasons since the plant began operation. In all cases, assemblies identified by inspection that showed evidence of disassembly confirmed the records indicating that these assemblies had been altered, and additionally the number of fuel rods in each assembly was verified.
