CONDITION REP	NO.	1999	- 1300	P	age 1 of 17	
DESCRIPTION OF COND	DITION:					
Several filters from the CT Southwest Research Instil SRI, the analysis was con	IMT radiation monitors and tute (SRI) for analysis as p npleted on 7/29 with the fo	d a sample part of the l flowing res	rom the White Bird L RE4597AA/BA action sults:	used for CTM plan. Per tel	Fpressure reli icon with Dr. F	eases were sent ic Richard Page of
The RE 4597BA filter from There was also some most corrosion.	7/3/99 centained primaril asurable Chlorine. The Iro	ly Iron Oxid In Oxide pa	de (10-100 microns wi articles had a granular	th some smal appeance in	er particles do dicating the so	own to 1 micron). surce is from
The RE 4597BA filter from sample from the white bird to be a large quantity of Bo	n 7/9/99 also had three dan 1 filter also contained iron (oron on the filter to delect	rker spots o oxide. No i it. SRI will	on it which were analy Boron was detected, I I send a written report	zed to contair however, Dr. 1 by next Frida	n potassium ai Page indicated y.	nd chlorine. A I there would have

ANALYSIS OF FILTER DEPOSITS

Final Report \$wRI Project No. 18-2321-190

The Toledo Edison Company Davis-Besse Plant 5

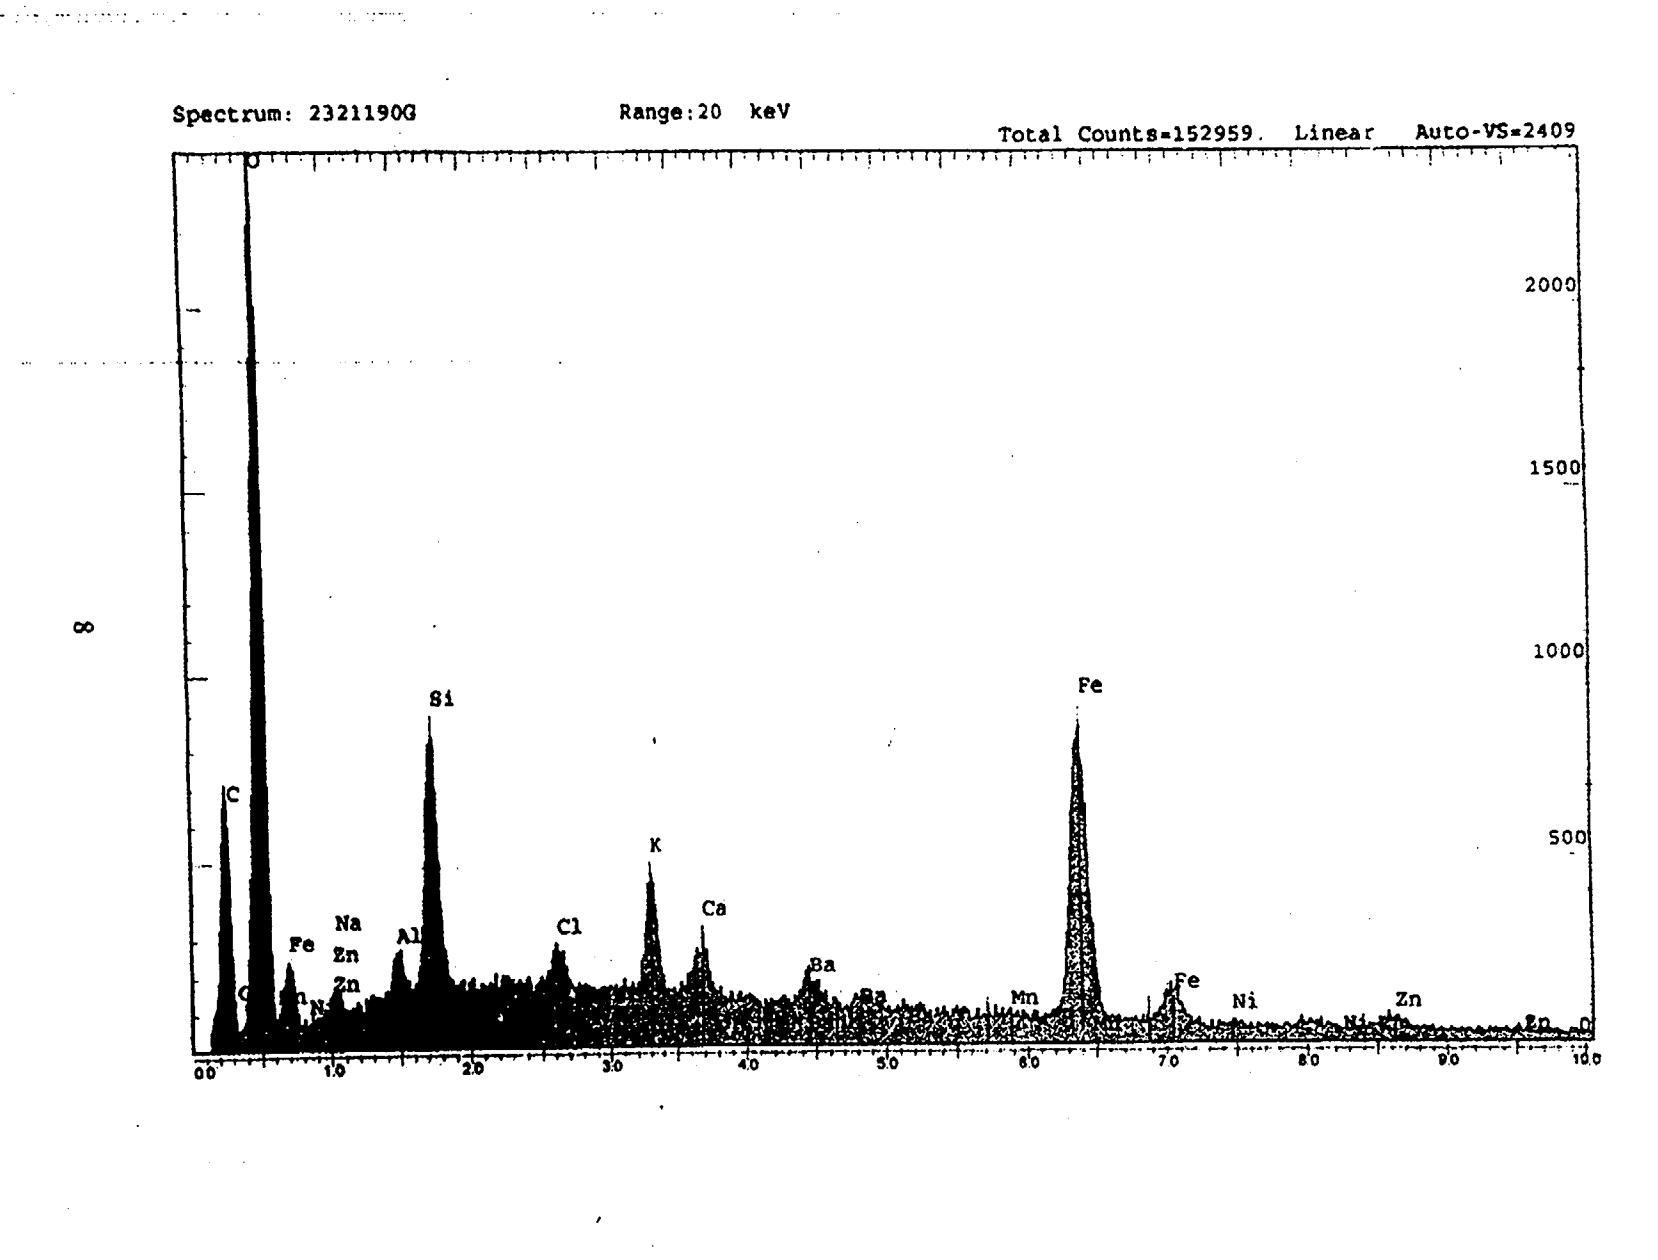
An EDS spectrum from an overall area of deposit on filter 4597BA 7/9/99@2016, Figure 6, was essentially identical to those obtained from filter 4597BA 7/3/99@1400. Spectra were also obtained from two of the dark particles on the filter, Figures 7 and 8. These particles were different from the overall deposit in that the iron peaks were reduced and high potassium and chlorine peaks were present.

Figure 6. EDS spectrum from an overall area of deposits on filter 4597BA 7/9/99@2016.

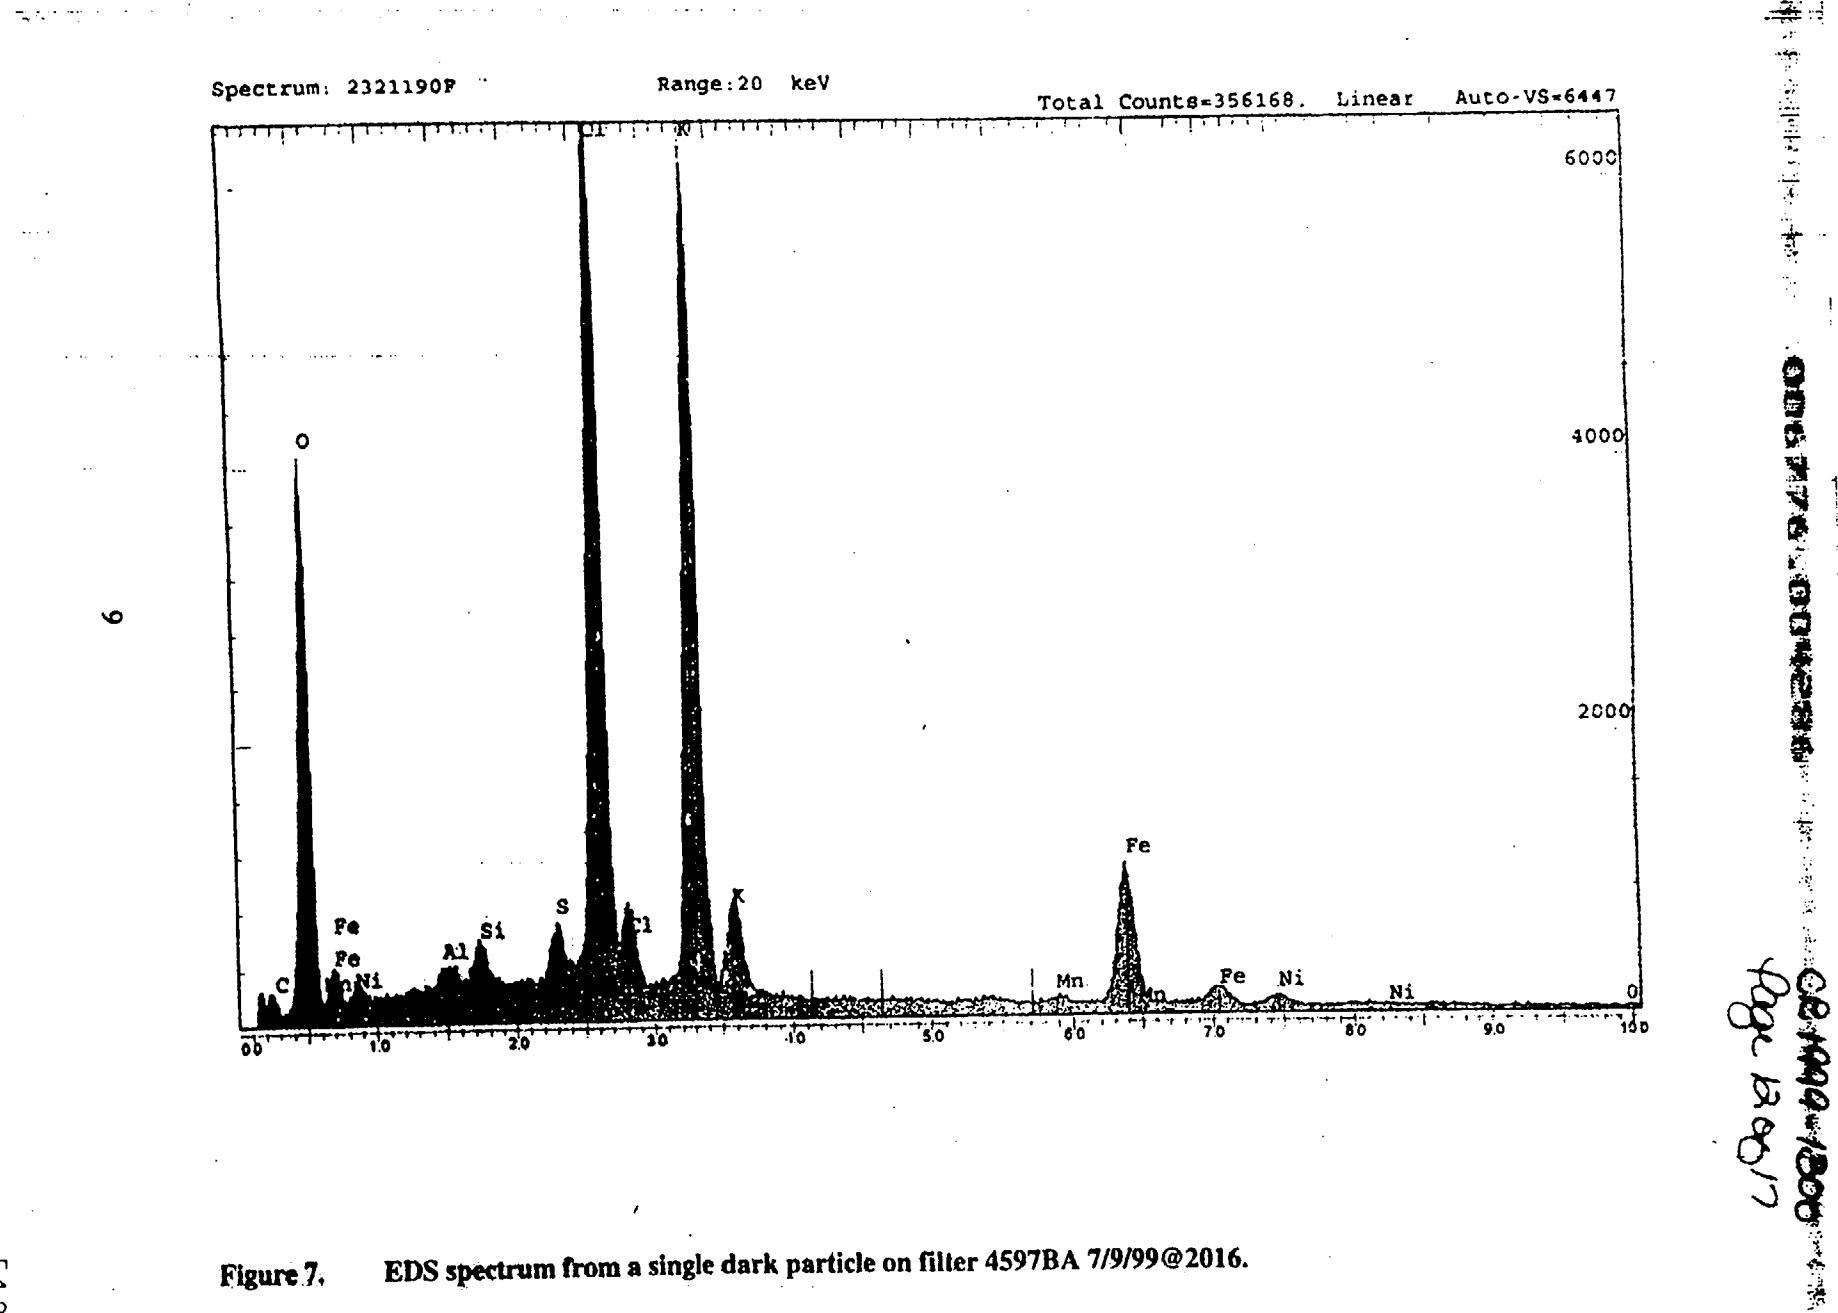
EDS spectrum from a single dark particle on filter 4597BA 7/9/99@2016. Figure 7.

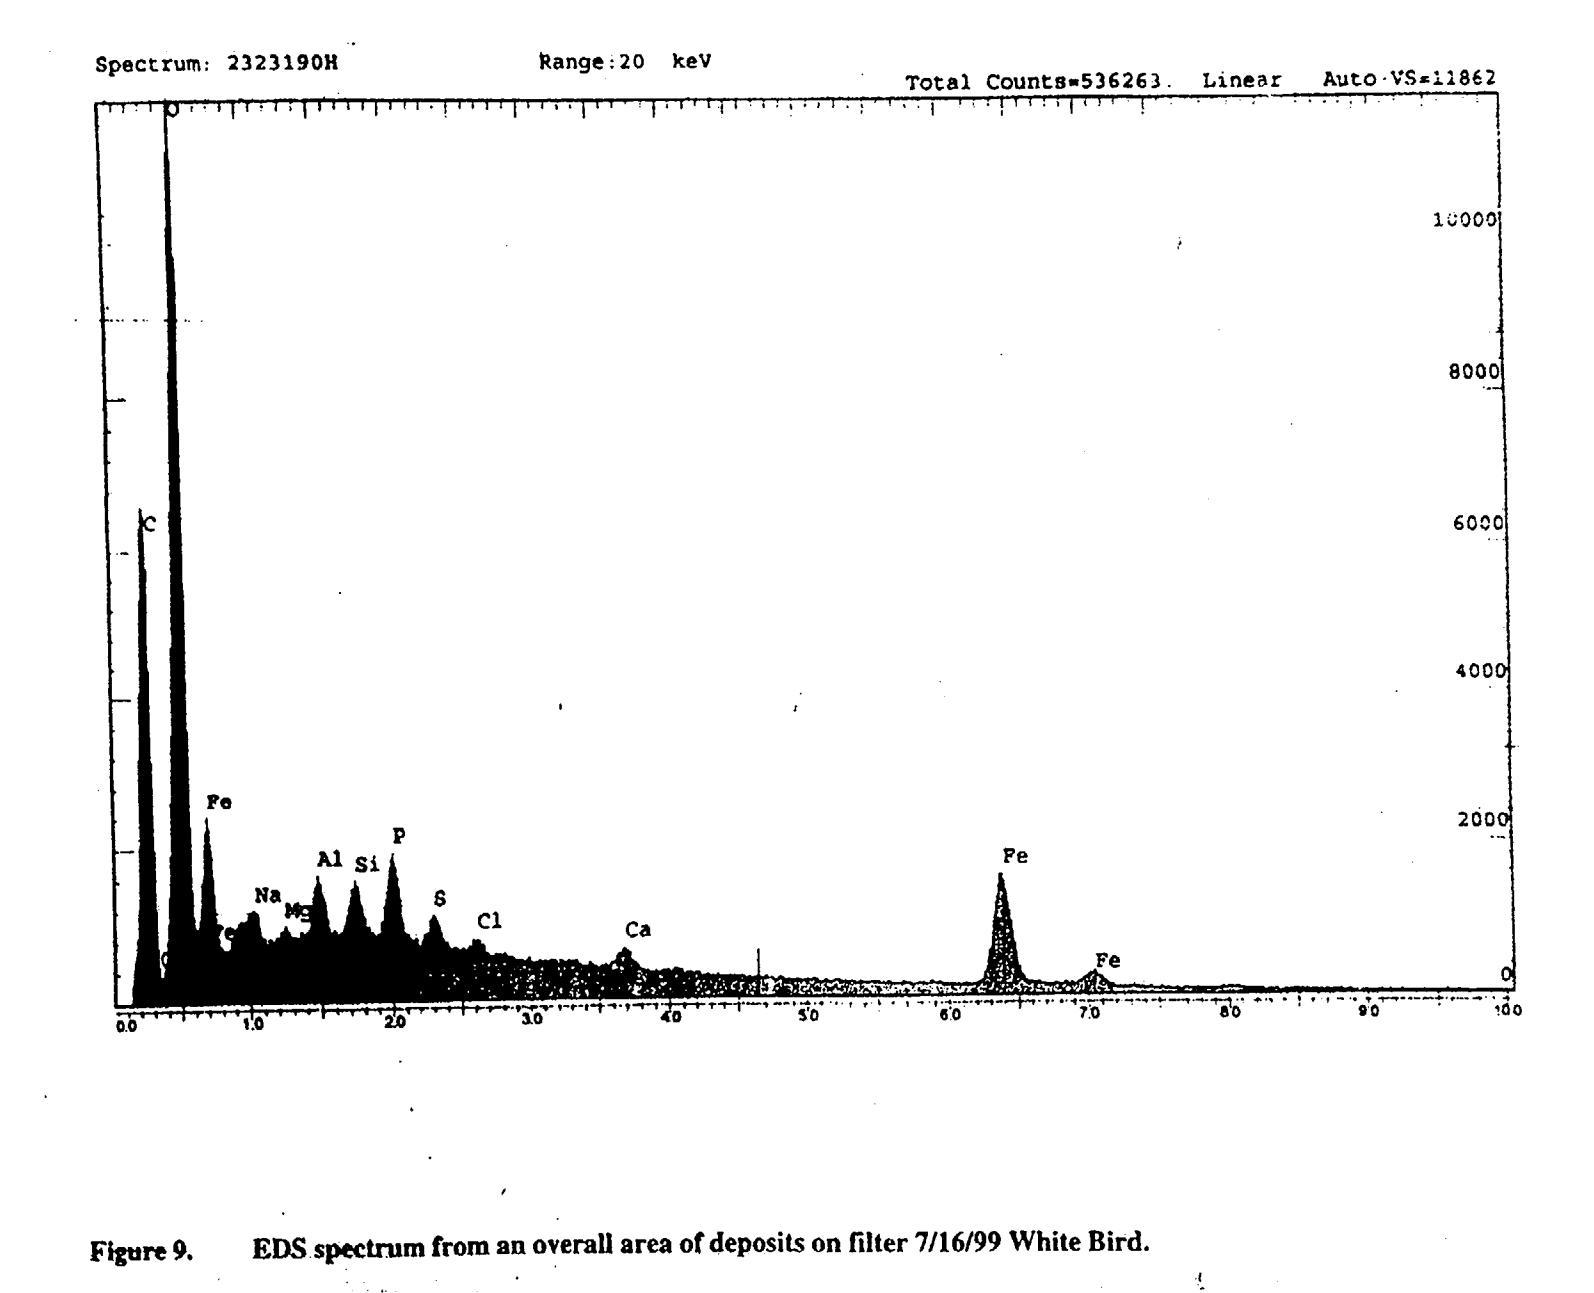
EDS spectra were also obtained from an overall area, Figure 9, and on an isolated particle Figure 10, on filter 7/16/99 White Bird. It is evident from these spectra that the deposits on the filter were also predominately iron oxide.

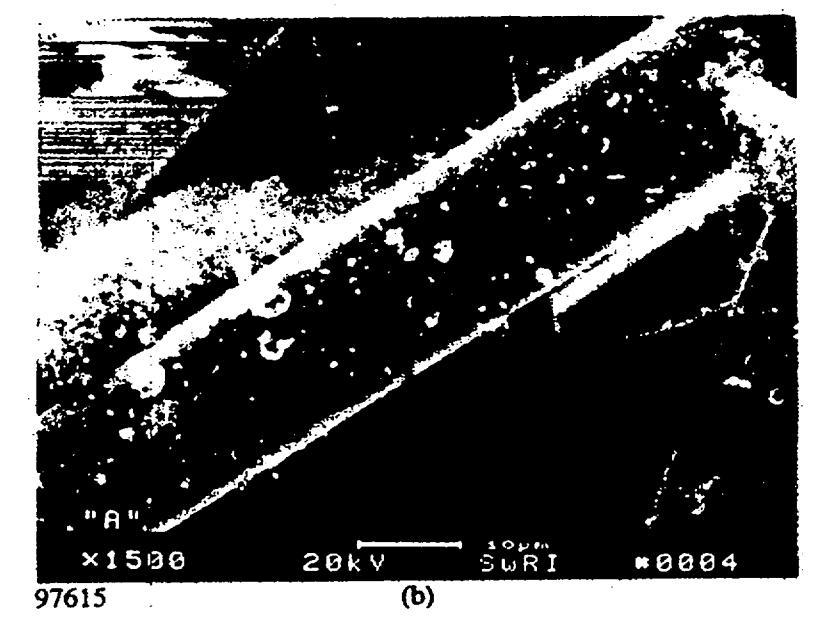
Imaging of the as-teceived filters in the SEM was limited by the low conductivity of the filter medium. To overcome this impediment, a gold palladium coating was applied to one of the filter samples, 4597BA 7/3/99@1400, following the EDS measurements. Electron micrographs obtained from the coated filter sample are shown in Figures 11 and 12. The deposits were generally less that 50µm in size and exhibited a very powdery appearance.

Figure 11. Scanning electron micrographs of an area of deposits on filter 4597BA 7/3/99@1400 following application of a gold/palladuim coating.

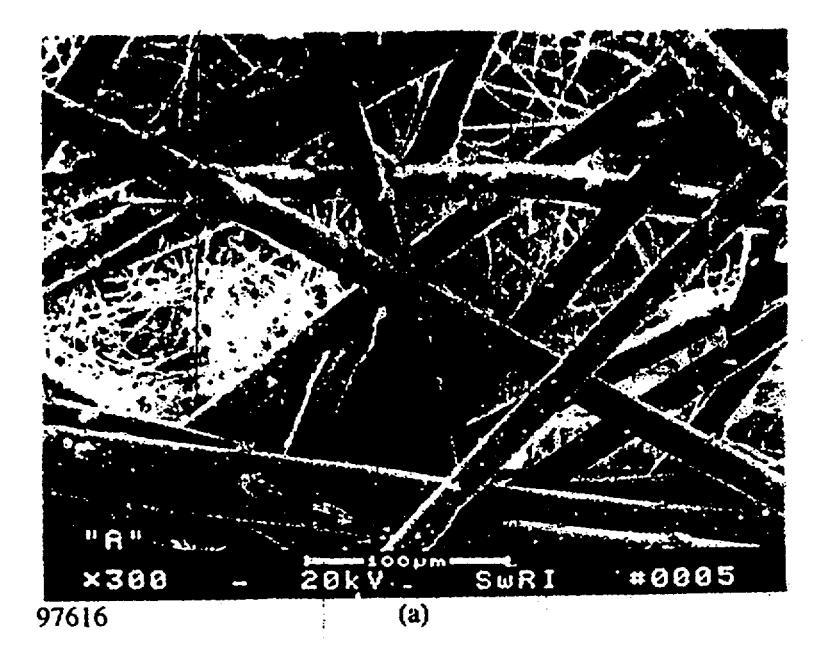
Figure 12. Scanning electron micrographs of a second area of deposits on filter 4597BA 7/3/99@1400 following application of a gold/palladium coating.
