In the Matter of NEBRASKA PUBLIC POWER DISTRICT (Cooper Nuclear Station)

ORDER FOR MODIFICATION OF LICENSE

SAFETY EVALUATION

CHANNEL BOX WEAR

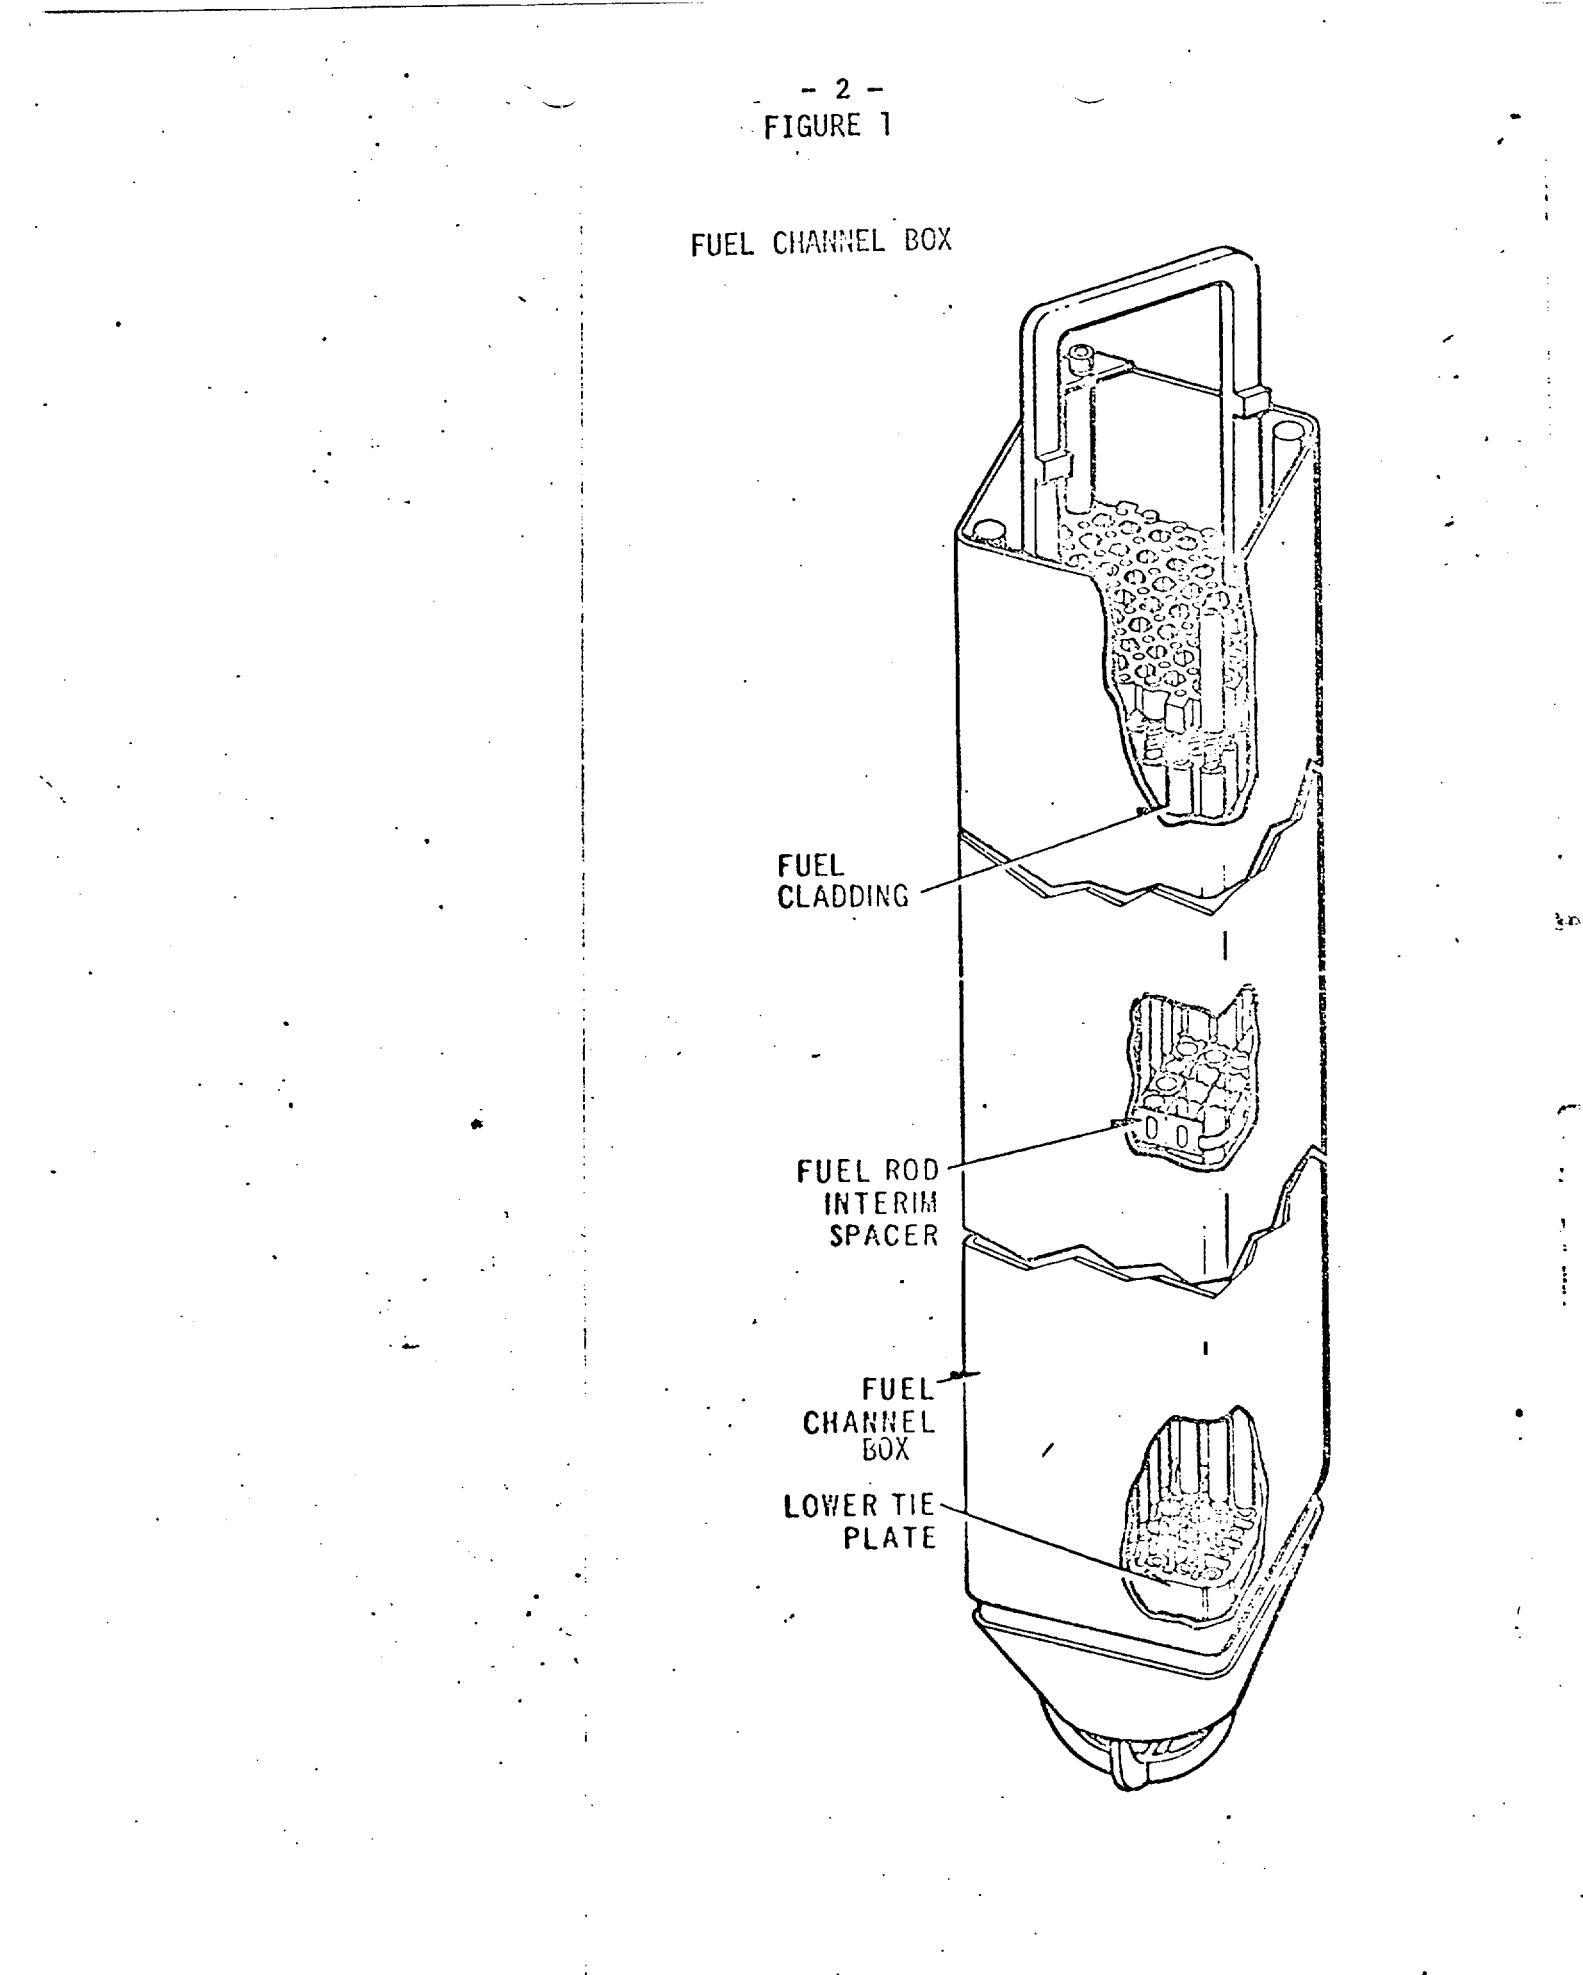
The fuel bundles of boiling water reactors are encased in square Zircaloy-4 tubes known as channel boxes (Fig. 1) which separate parallel coolant flow paths in the core, provide guide surfaces for the motion of control rods, and protect fuel bundles during handling. Each channel box slides over the surface (lower tie plate surface, Fig. 1) of a fitting which rests on the core support plate. The zone between the channel box assemblies is referred to as the bypass region and, in all boiling water reactors, contains the control rods and in-core instrumentation. In some facilities, the bypass region also contains temporary control curtains (Fig. 2), which are removed after initial operation of the first core and are used to provide supplemental control.

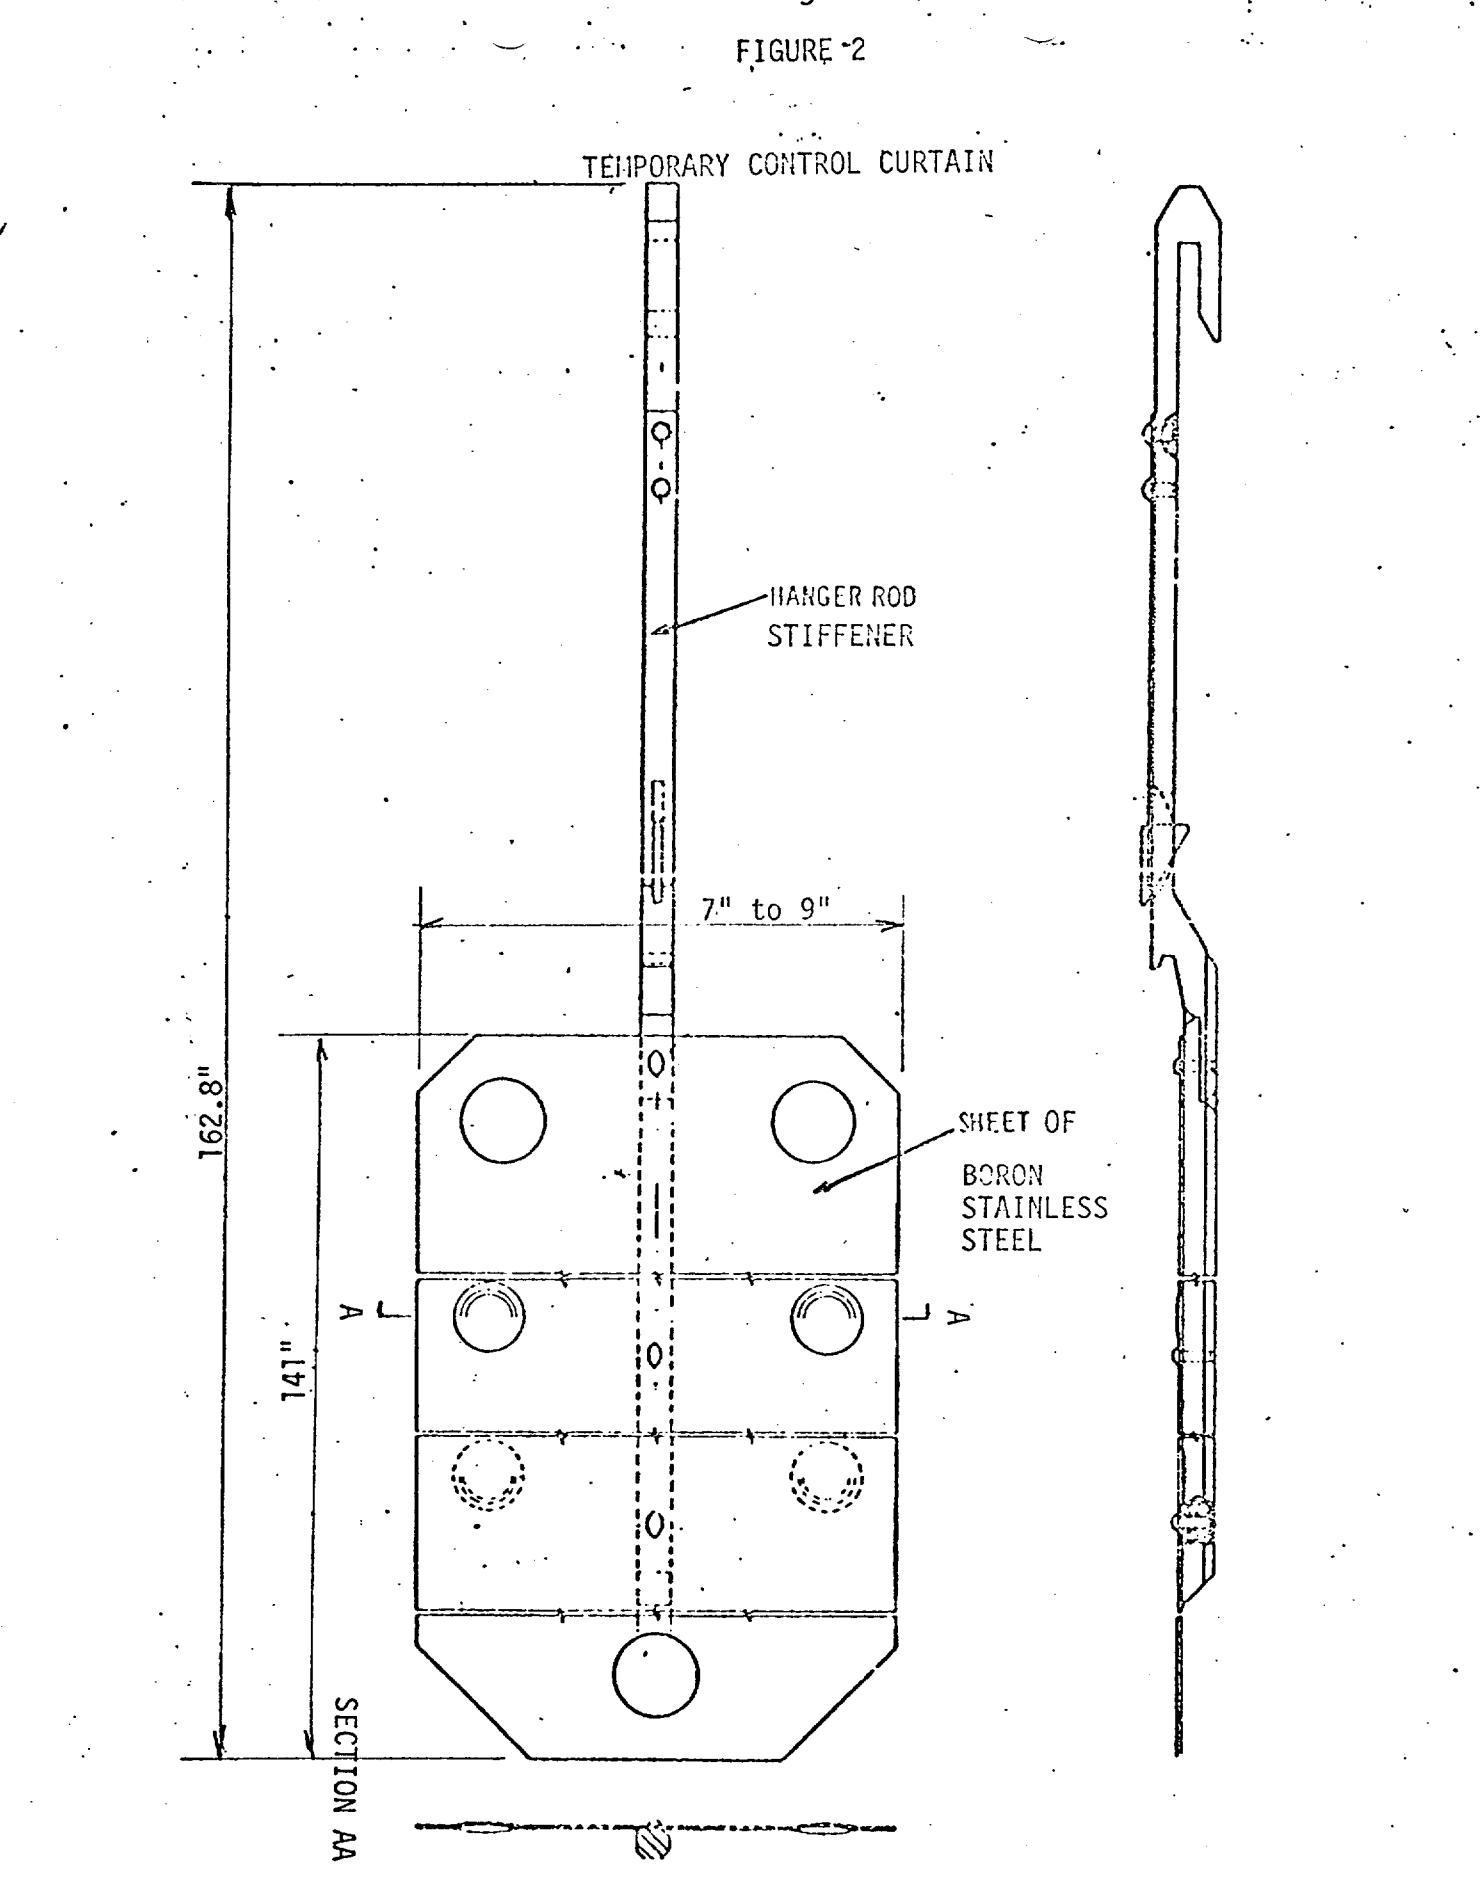
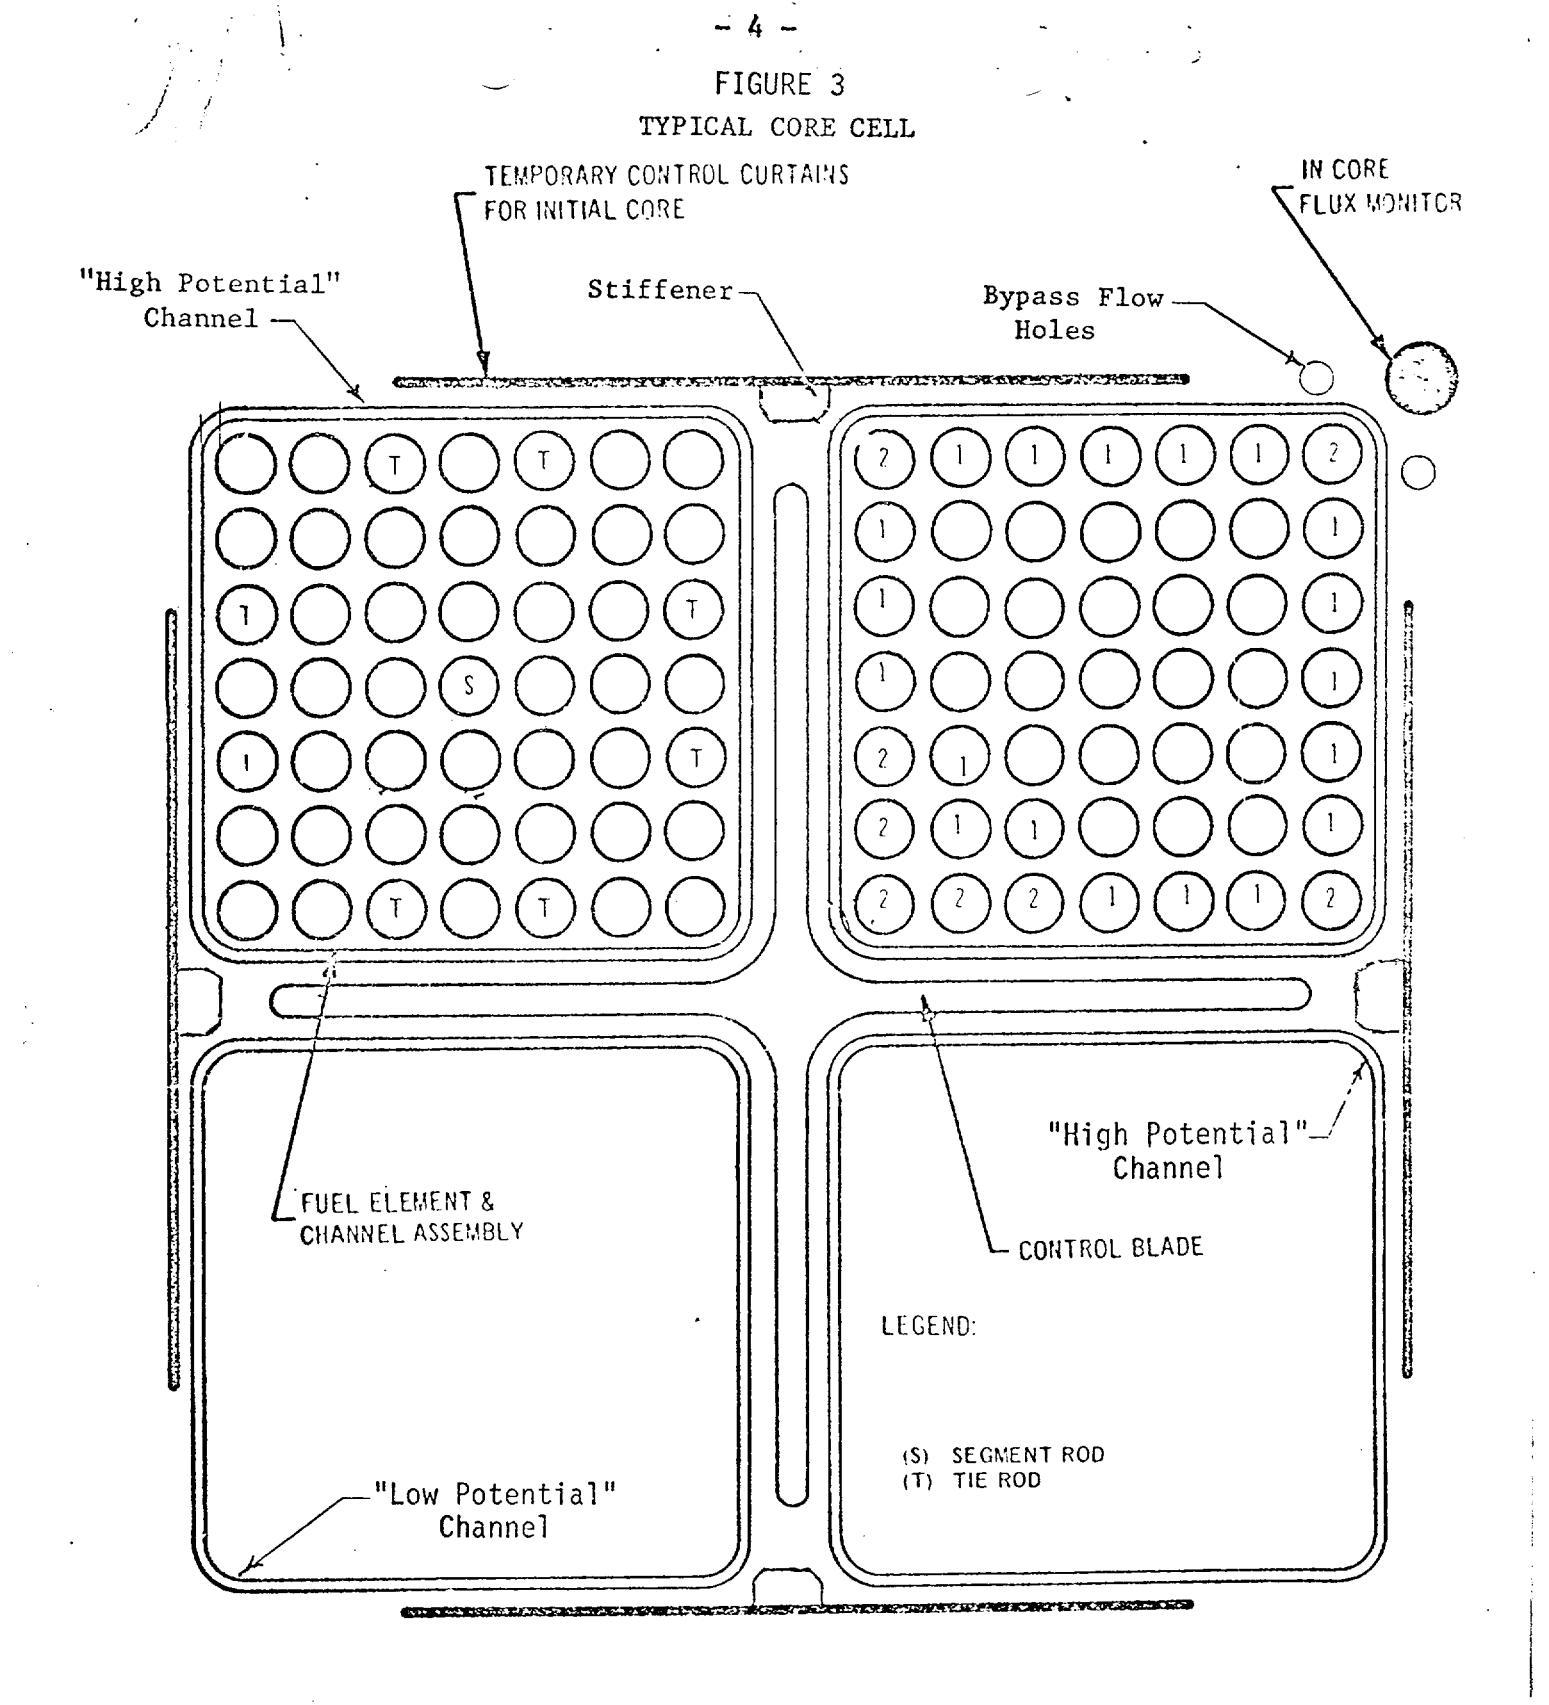
Figure 3 depicts a cross-section of a fuel cell containing all of the elements discussed above. This particular arrangement, combining bypass flow holes with temporary control curtains, is found

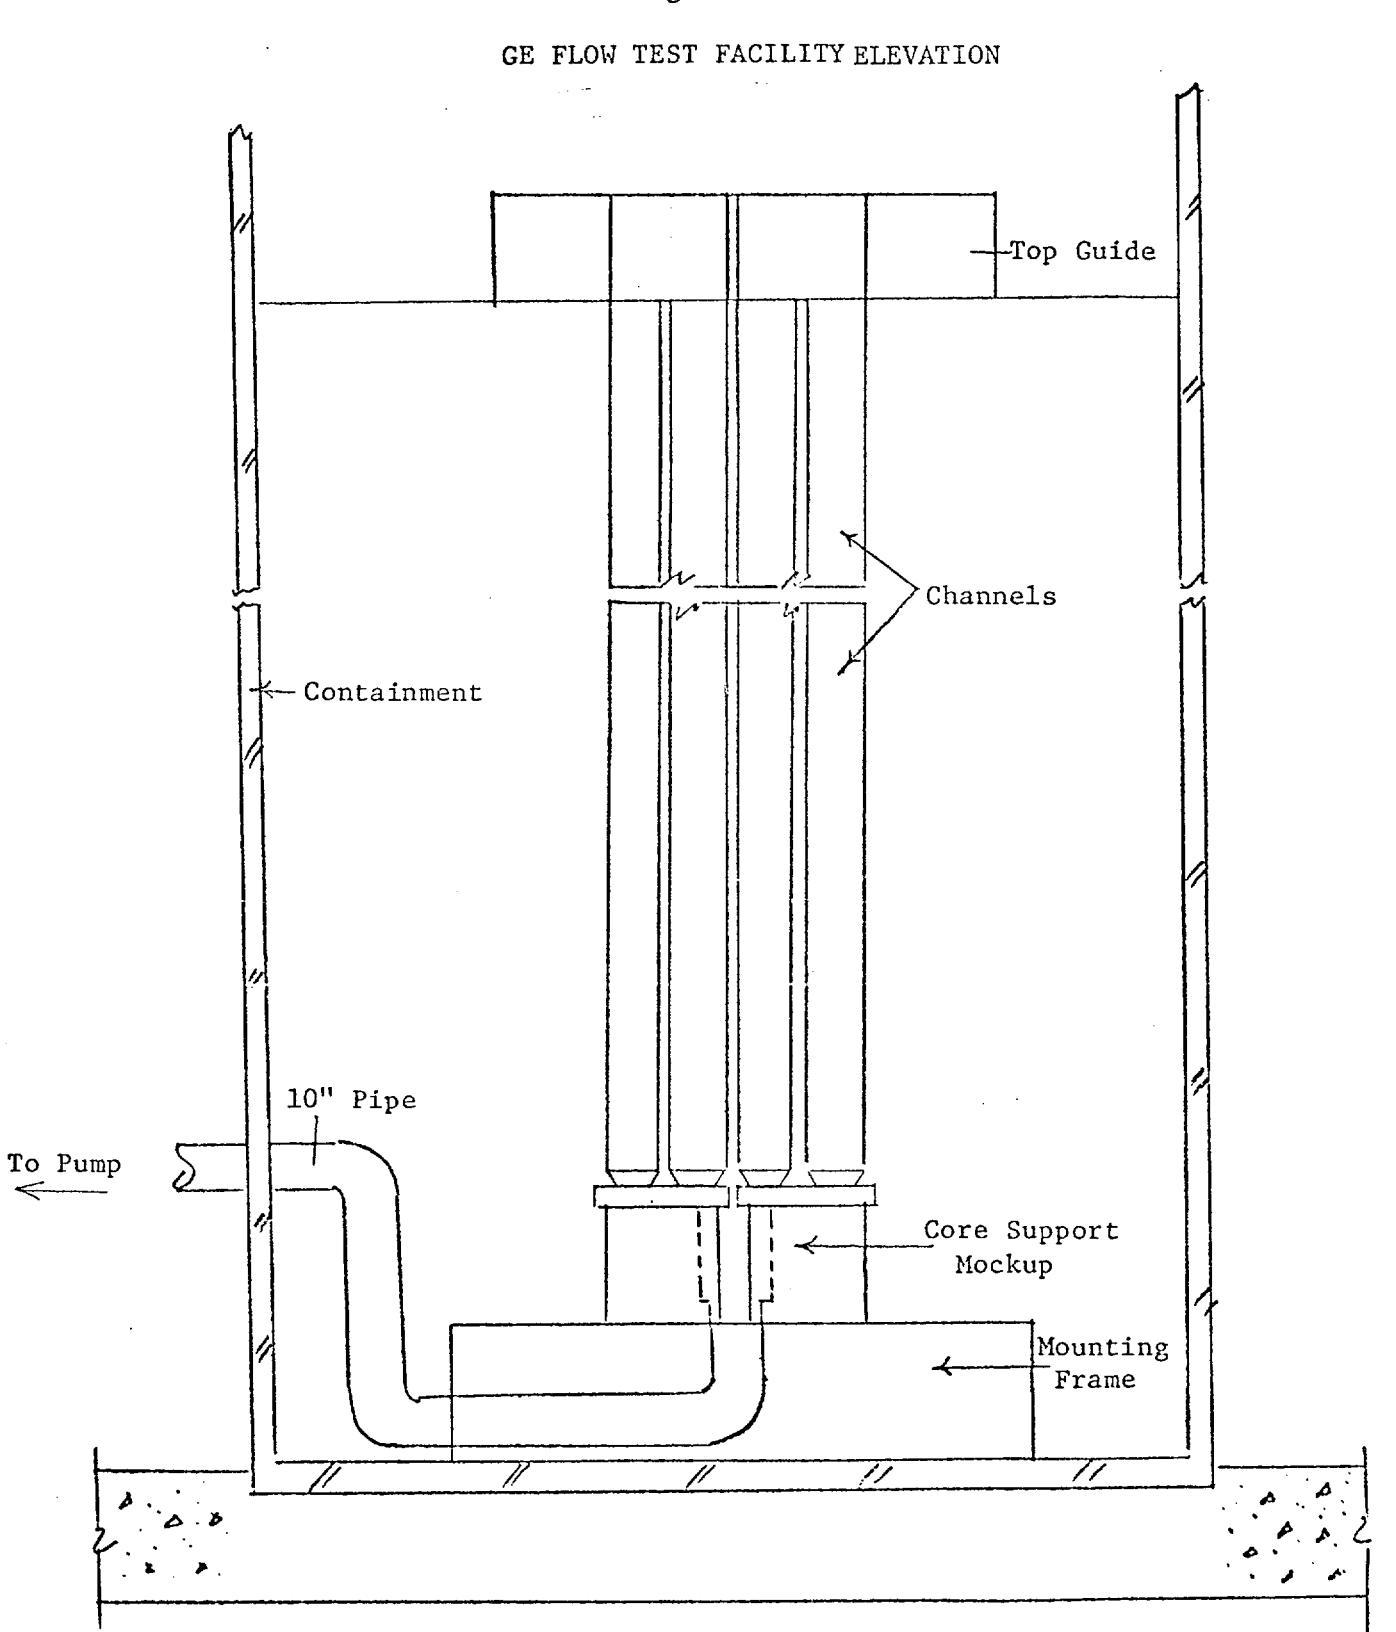
The configuration of control curtains, bypass flow holes and fuel assemblies has been simulated by General Electric in a test facility (Figure 4). The facility consists of twelve fuel assembly channels, four temporary control curtains, and a support plate with four, oneinch-diameter flow bypass holes (Figure 5). A pump and piping provide
